## Fences and Walls of the St. John's Ecclesiastical District

Heritage NL

By Michael Philpott

This report describes the walls and fences of the district as observed during a field survey on June 8th, 2021. Description is divided into the following sections: the Anglican Cathedral and its churchyard, St. Andrew's Presbyterian Church (the Kirk) and environs, the Basilica and related Roman Catholic properties, and Belvedere Cemetery.

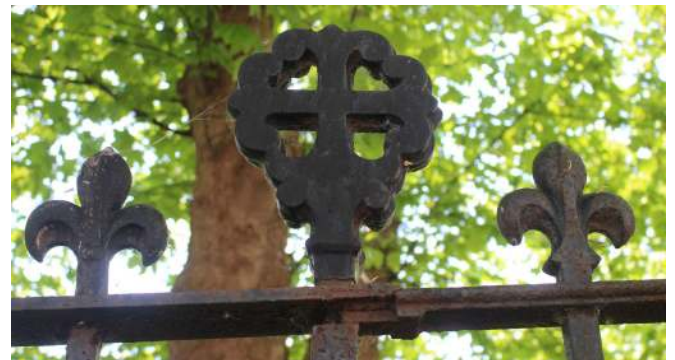
**Fig. 1. Fleur-de-lis and cross finials of the Anglican Cathedral. Source: Heritage NL**

The Anglican fence consists of square palings topped by *fleur-de-lis* finials. Sections of fence are supported by larger-diameter posts topped by large *cercelée* crosses. Low-height sections of fence are supported by two horizontal rails while taller sections are supported by three rails and have pointed half-height palings between each full paling. Rail profiles vary, with many having been replaced with rectangular or hollow stock. Earlier sections are solid iron with bullnose details. The fence is braced to the ground and supported against the Cathedral, in places, by curved iron brackets.

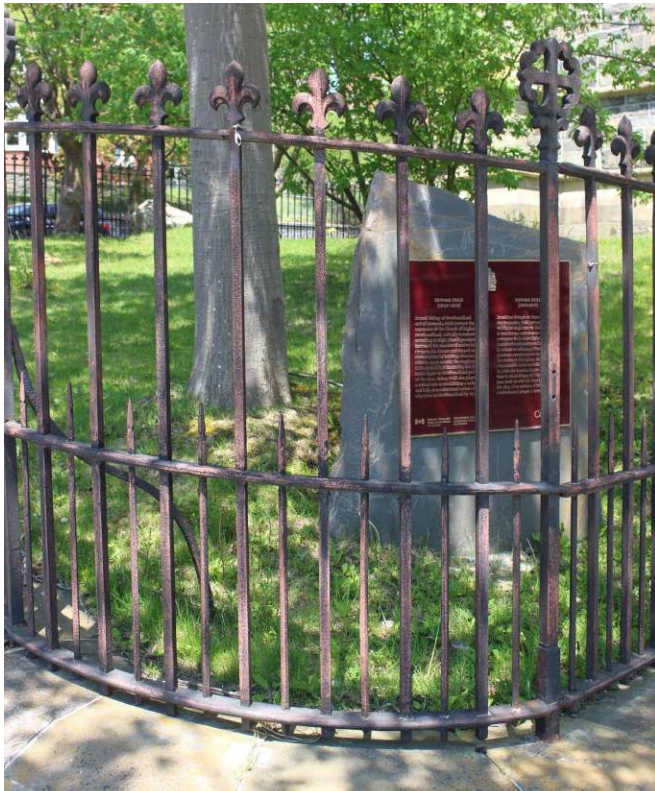
**Fig. 2. Taller sections of fence have three rails and half-height mid-palings. Source: Heritage NL**

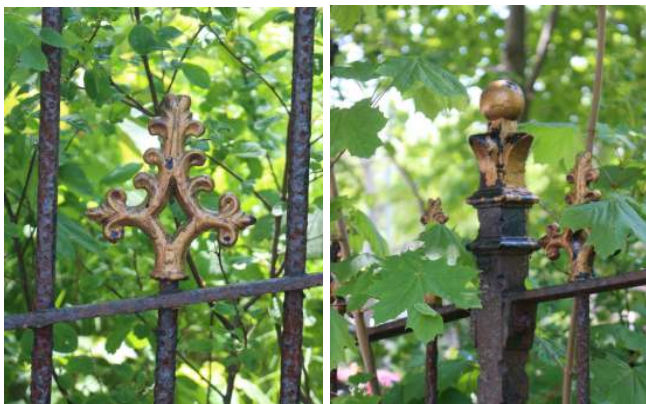
**Figs. 3 & 4. Painted finials of The Kirk. Source: Heritage NL.**

The Kirk's most substantial section of iron fence leads up the steep incline from Queen's Road to the level of the church. Here, floral crosses top alternating, tall and short, round palings. An orb finial softens otherwise more geometric, square posts with chamfers and notches. The finials of the fence at the Kirk are painted gold, though this may be a modern design choice. A unique feature of The Kirk's fence is a round handrail attached to the bottom of each post. This section of fence was likely installed in 1880 when the installation of a "handscope and substantial iron fence" was observed (figure 5).

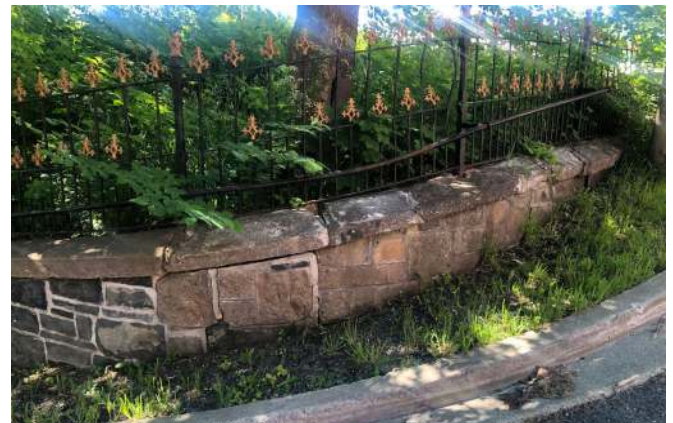
The Kirk's fence is set in the cement cap of a low, grey ashlar wall with strap or ribbon pointing. At the top of the hill, the stone transitions to a brown ashlar similar to that used for the church's foundation (figure 6).

**Fig. 6. The transition from grey to brown ashlar. Note the handrail detail. Source: Heritage NL**

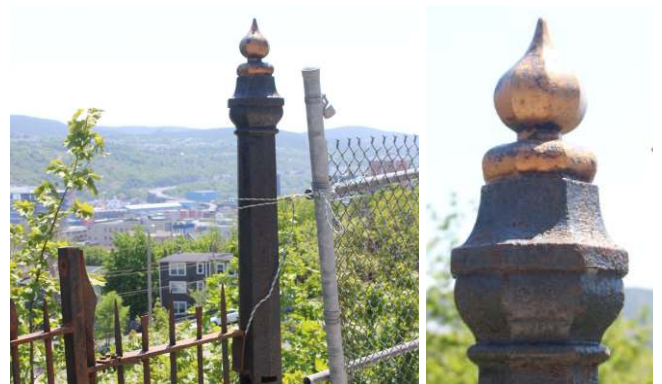
Above the Kirk is a further section of spear-headed fence, though of a simpler style with alternating simple points and spearheads. These sections are supported by posts similar to those leading up the Kirk with a large endpost. The eight-sided, tapered post is topped by onion dome or flame (figures 10 & 11) and likely formed part of a gate or marked the end of the property. The same posts were once installed at the front of the Methodist College (figure 12).

Fig. 10 & 11. Source: *Heritage NL*

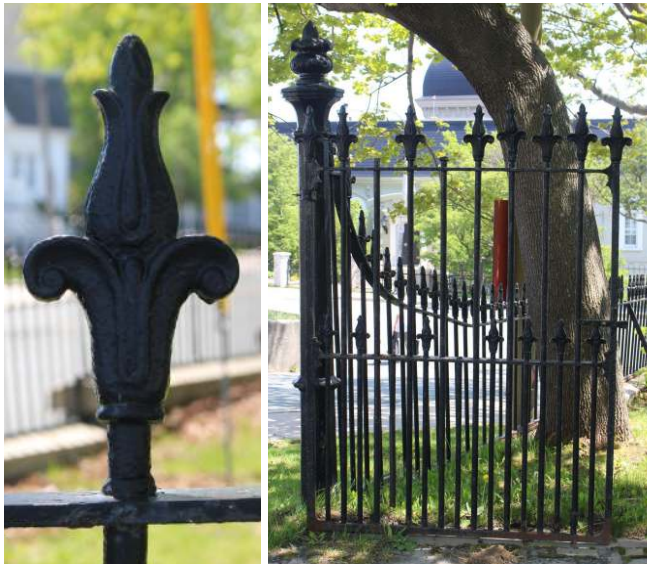
**Figs. 13 & 14. A finial and gate exhibit the lily motif of Hugh Dougherty. Source: Heritage NL**

The round palings of the Basilica's fence are topped by lily or *fleur-de-lis* finials (figures 13 & 14), though of a more literal sort than the

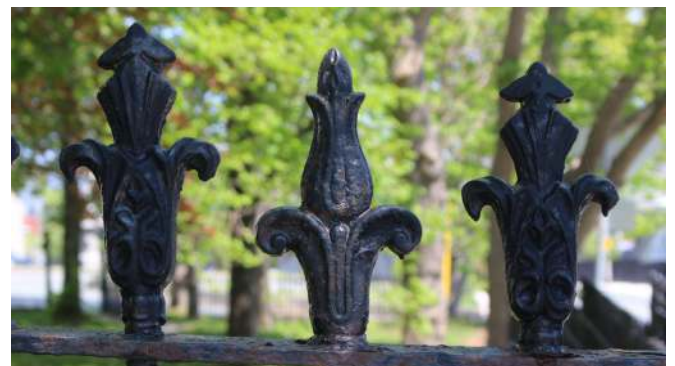
While Dougherty's finials are the more common type, they are interspersed in places with another variety (figure 16). These appear to be later replacements and their source is unknown, though they too resemble stylized lilies.

**Fig. 16. Replacement finials alongside Dougherty's. Source: Heritage NL**

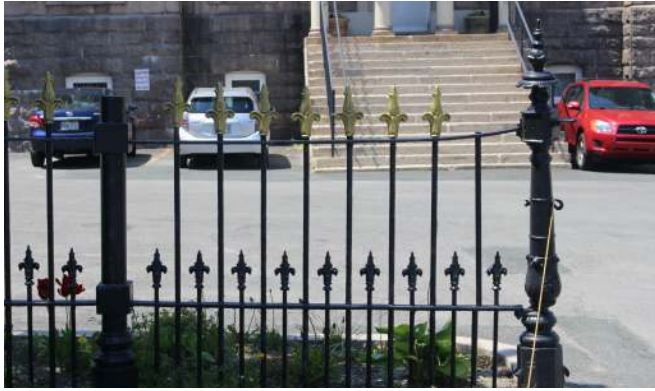
**Fig. 17. Fence in front of the Presentation Convent**  
*Some posts have been replaced with simple modern forms. Source: Heritage NL*

Dougherty's finials make another appearance in front of the Presentation Convent where they are painted gold and supported by iron posts with floral and fountain-like elements (figure 17). Adjacent the nearby Mercy Convent chapel are yet more takes on the *fleur-de-lis* (figure 18). These smaller and more stylized lilies transition back to Dougherty's dominant form as the fence turns the corner onto Military Road. Here, fence sections are supported by posts resembling those leading to the Kirk (figure 19). Given the Kirk was fenced during the AIFC's period of activity it is possible Dougherty was responsible for both.

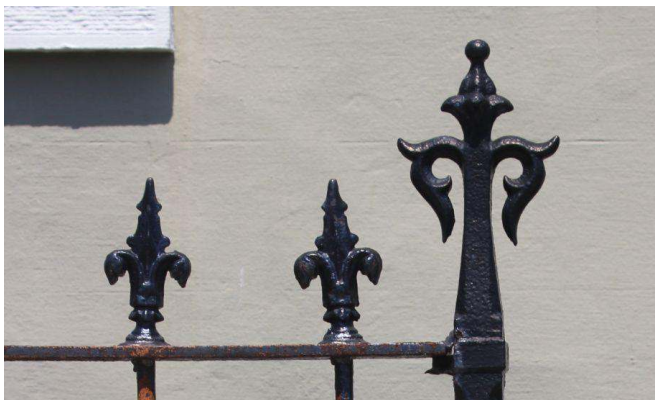
**Fig. 18. Finials next to Mercy Convent chapel.**  
*Source: Heritage NL*

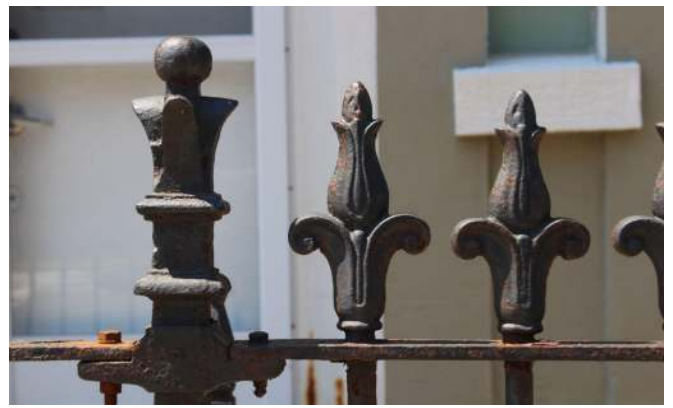
**Fig. 19. Finials and post of the Mercy Convent on Military Road. Source: Heritage NL**

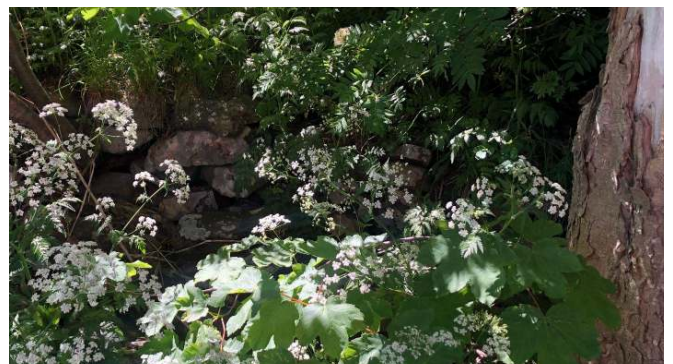
**Fig. 20. Remnants of a dry-laid stone wall along the lane to Belvedere. Source: Heritage NL**

On the lane between Bonaventure Avenue and the former Belvedere convent/residence lies what appear to be remnants of a dry-laid stone wall (figure 20). Though hidden, this fragment may hint at a historic landscape which has largely been lost to development.

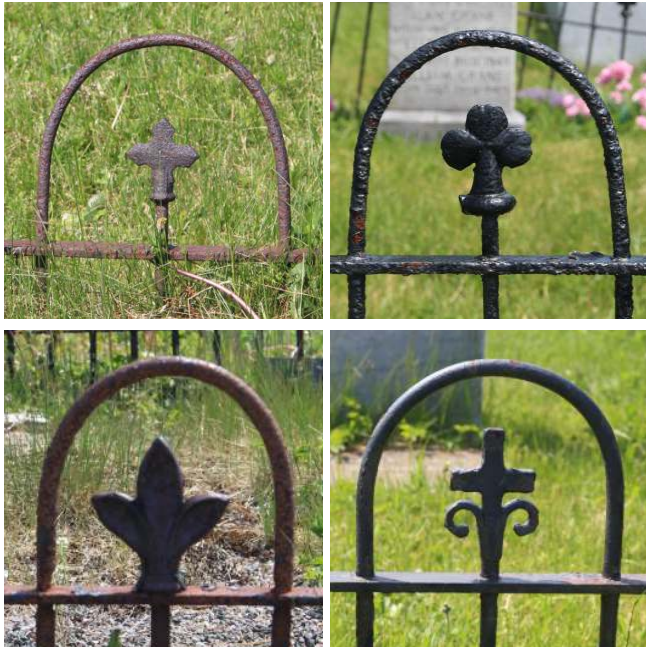
***Figs. 21-24. Simple finials of the Belvedere cemetery. Source: Heritage NL***

Many fences in the Belvedere cemetery exhibit simplified versions of symbology found throughout the Ecclesiastical District - crosses and lilies (figures 21-24). In some cases the shamrock, a symbol of Ireland and the holy trinity, takes the place of the cross, likely in reference to the nationality of those interred. Wrought iron is used alongside cast iron in the cemetery. Many examples of the former were likely crafted locally.

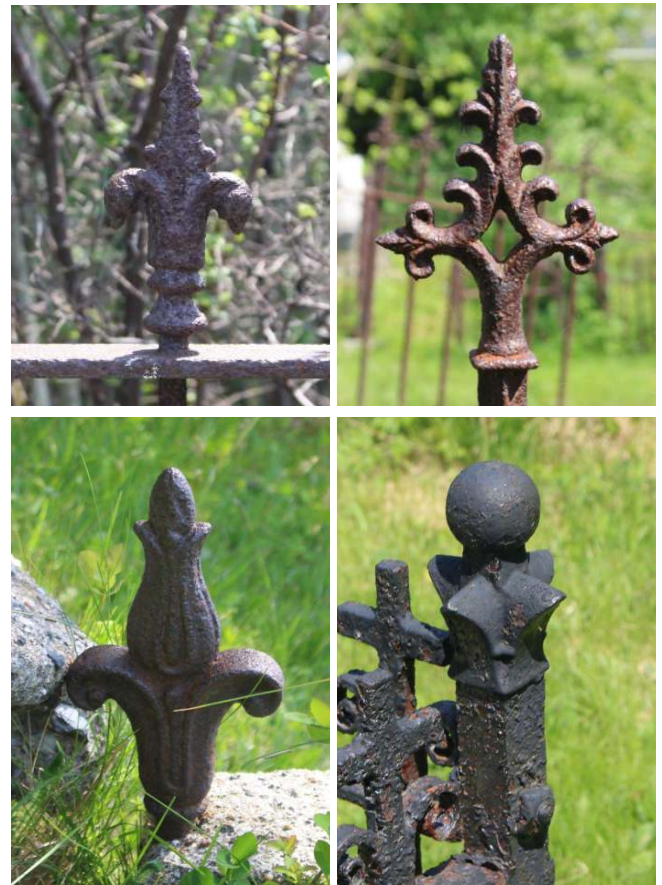
Other fences exhibit identical elements to those found elsewhere in the District. The small *fleur-de-lis* of the Mercy Convent (figure 25), the floral cross of the Kirk (figure 26), Dougherty's lily (figure 27), and the posts found at both the Kirk and the Mercy Convent (figure 28) each make appearances. These are often combined with other design elements at the same gravesite.

***Figs. 25-28. Belvedere elements found elsewhere in the District. Source: Heritage NL***

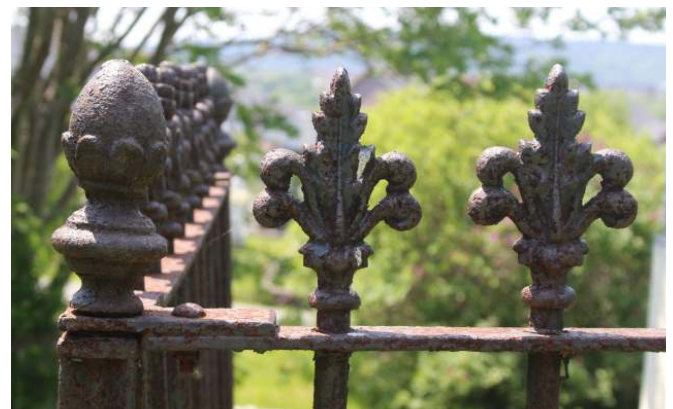
Still other plots exhibit fine cast iron unique within the District (figure 29). A larger survey may find these elements elsewhere in St. John's, though they may also have been custom works ordered by families of those interred.

***Fig. 29. Cast iron unique within the District exhibits fine floral elements. Source: Heritage NL***
