***REPORT ON AN ASSESSMENT OF
GRAND FALLS HOUSE
in
GRAND FALLS-WINDSOR, NEWFOUNDLAND
by
Rex Passion
for
Heritage Newfoundland and Labrador
on
June 18, 2025***

**Report submitted
July 31, 2025**

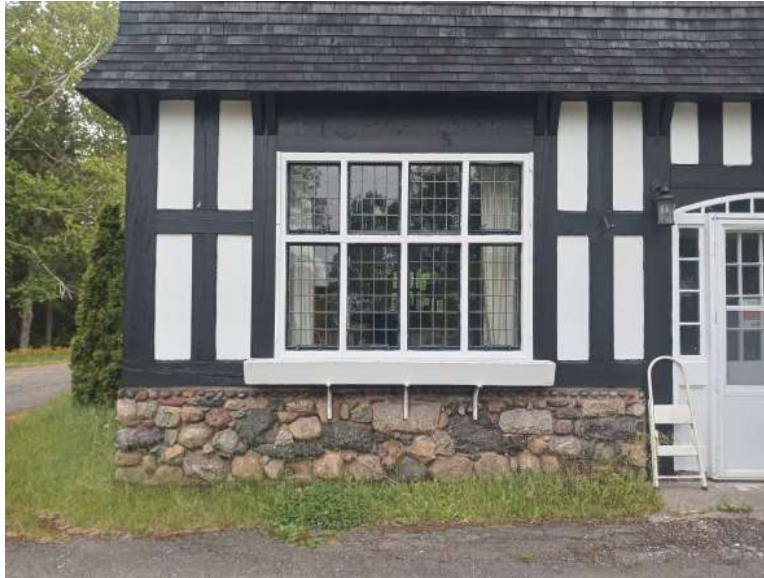
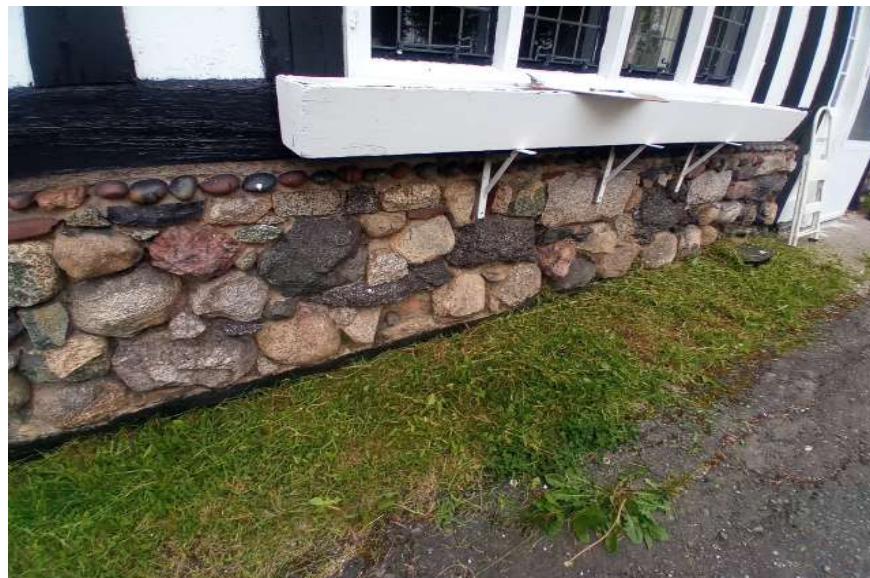
The foundation is poured concrete painted black. It is in fine condition throughout the building. The height of the foundation above grade varies from 37 inches at the west corner to 9 1/2 inches on the east corner of the house. On the back where the addition meets the house the tall exposure continues and at the north corner it is again 36 inches.

The quality of the concrete is first rate; not surprising given it was probably made by the same people who poured the dam at Grand Falls.

On the front elevation, at its tallest point, the concrete foundation is clad in field stone. Its height above grade on the left hand corner is 37 inches. The drip line at the foundation (where the water running off the roof hits the ground) is about 18 inches from the base of the foundation. The height of the foundation above grade and the large roof overhang prevent any splash from roof runoff contacting and damaging the wood.

The main house foundation is in excellent shape and needs no work. It is high-quality poured concrete with no evidence of cracking, spalling or other deterioration. It is being well preserved by being well painted.

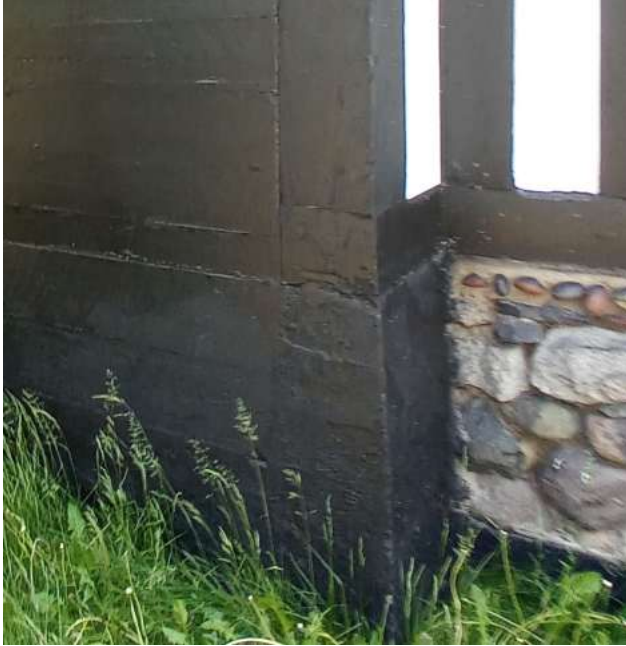
36 inch exposure on the back elevation to the right of the addition

It is curious that the foundation is 9 1/2 inches above grade on the rear elevation to the left of where the addition was added, but is 36 inches above grade on the same elevation on the other side of the addition.

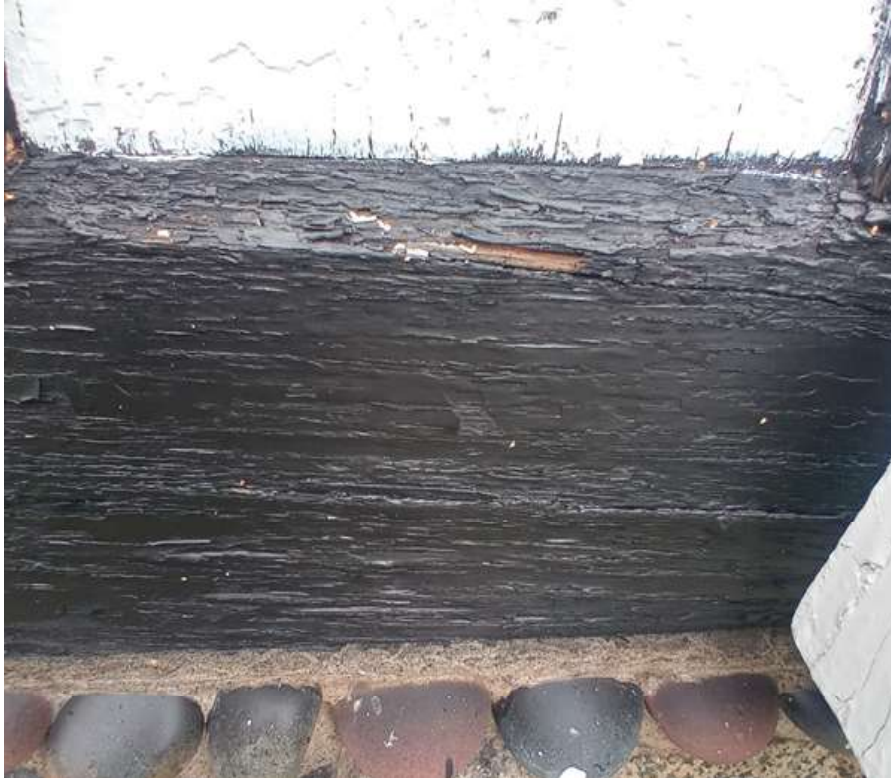
Most of the timbers appear to be English oak, which is a very durable wood with great longevity. They show a good deal of cracking, some of which is wide and deep. However, the wood is hard inside the cracks and I saw no signs of rot in any of the oak timbers with one possible small exception on the rear of the building. I have seen pictures of sound 500-year-old oak timbers with similar cracks. In some places, the cracks at Grand Falls House have been filled with caulking material.

The oak timbers of Grand Falls House typically have cracks, some of which are quite deep. I probed these cracks and found the wood inside was as hard as the wood at the surface. This cracking is typical of oak timbers and does not effect their strength. In some places, the cracks have been filled. I believe this is unnecessary and could possibly damage the wood by allowing water to accumulate behind the fill. I would recommend careful removal of filling from the cracks without damage to the wood.

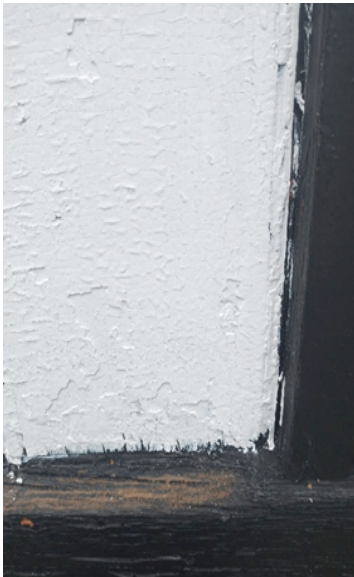
In some places, where the timbers are exposed to the worst of the Newfoundland weather, the wood appears fragile but despite some flaking it is very hard without any sign of rot.

*I think this is an original wood
infill panel*

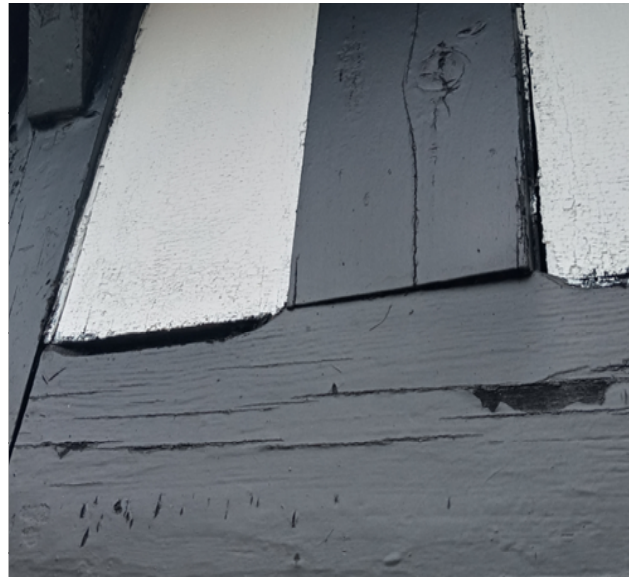
*In this one, there is
plywood over the original panel*

In the left front corner of the house, the wood infill panels appear to be original solid oak boards, but most of the other panels have been covered over recently with plywood or fiberboard. I have no idea of the original material or it's condition. Perhaps it is traditional wattle and daub (see below).

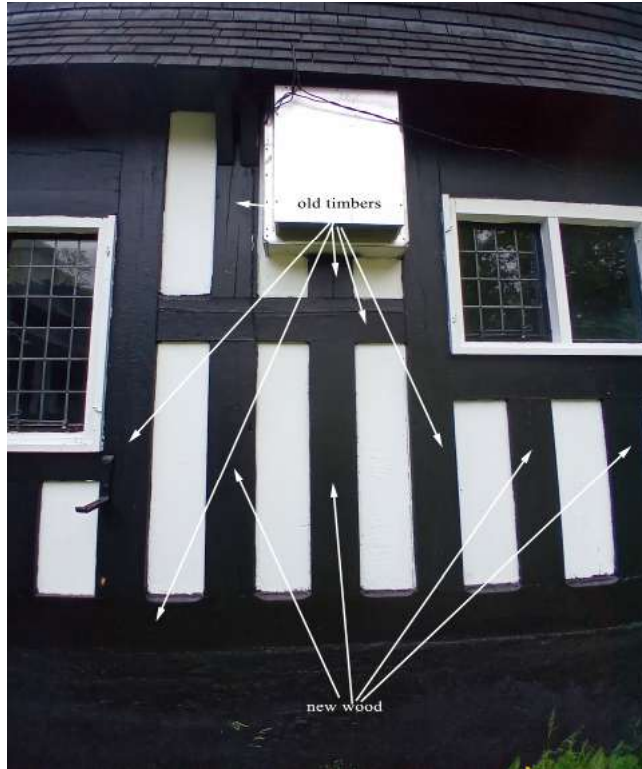
On the rear elevation, just northeast of the addition, some of the original oak timbers appear to have been repaired, or in some cases, replaced with modern, local wood, which is not as durable as the oak. Some of this repair work was done in a slipshod manner; other areas need to be repaired.

I believe prior to a 1980s renovation, some structural damage to the timbers on the back of the house was repaired, probably using modern lumber and framing. To keep the Tudor half-timber look of the building, smooth planed boards were used as faux timbers over the modern repairs. This accounts for the difference of the texture of the wood visible at the rear. Most of the repair work has been professionally done but some is slipshod resulting in some places where the wood is open to the weather. These need to be sealed to prevent damage.

There are some open joints in the repairs done to the timbers at the rear of the house. These need to be sealed to keep out the weather. A quick seal using caulking is the best option for the short term, but a more permanent solution should be found.

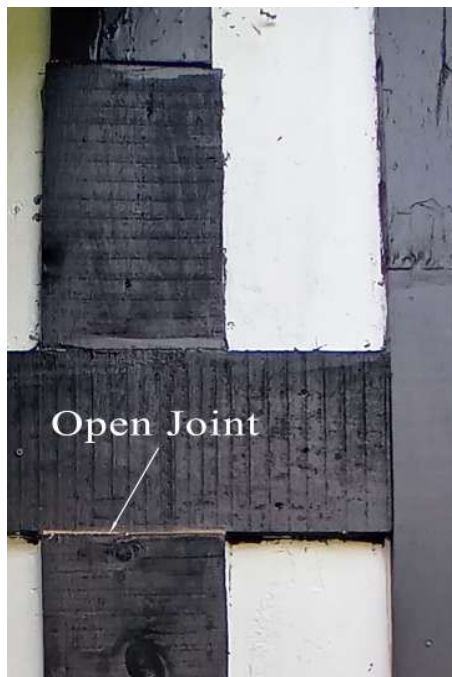
There is an open gap exposing raw wood which invites decay.

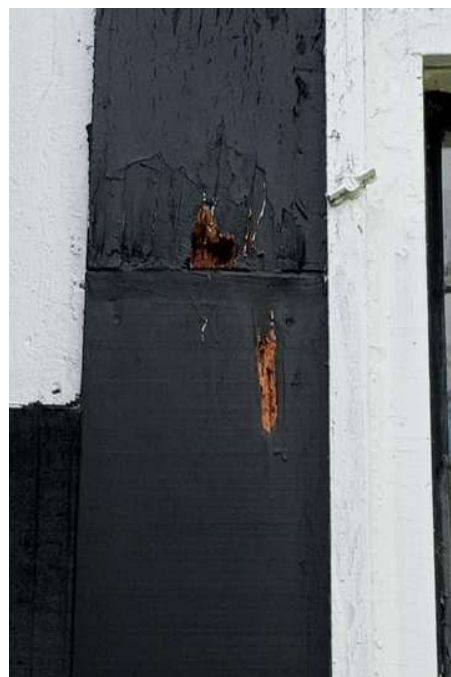
There are two small rot pockets in the timbers next to the window, nearest the addition

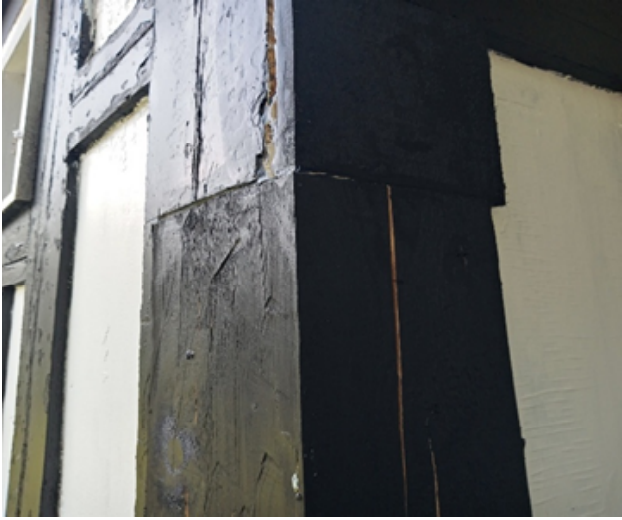
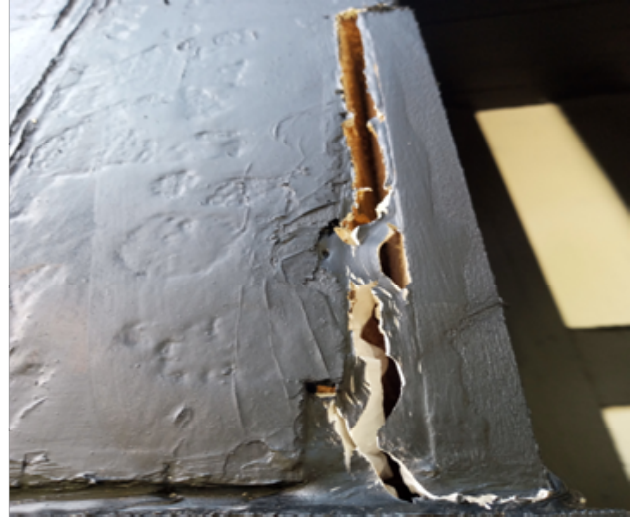
On the back elevation next to the recess behind the fire escape, it appears the bottom part of the corner timber has been replaced with a spruce or pine timber of the same dimension. Above this, the old oak timber has been patched with a piece of wood. This repair was poorly done and the open gap at the outside corner needs immediate attention to avoid water entry into the woodwork.

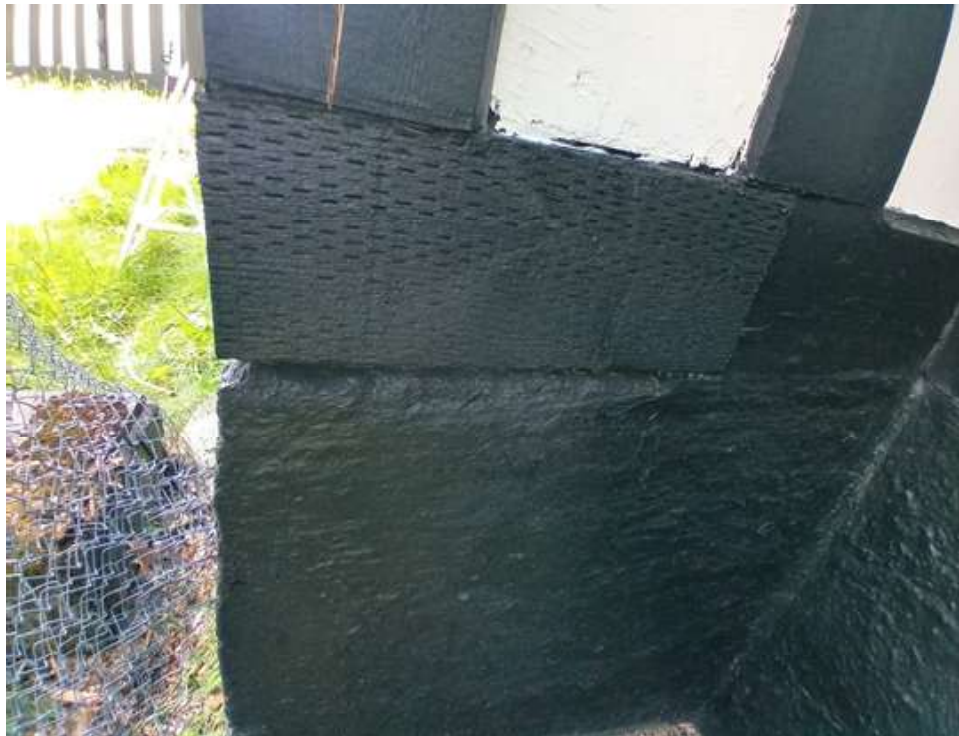
On that same corner a short piece of the bottom oak timber has been replaced with a piece of pressure treated wood, which is inappropriate. This corner timber area should be carefully investigated and repaired properly.

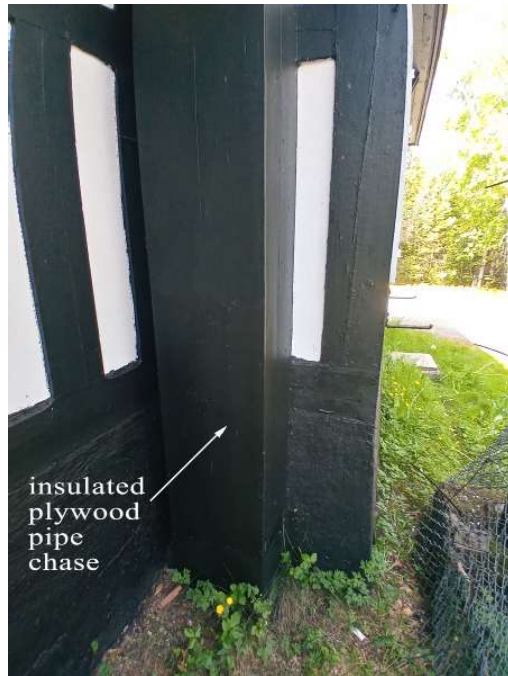
On the western end of the recess there is a plywood box concealing pipes, a chase. There is also one on the front elevation near the chimney and at the northwest corner. The front chase is filled with fiberglass insulation and I assume the others are as well.

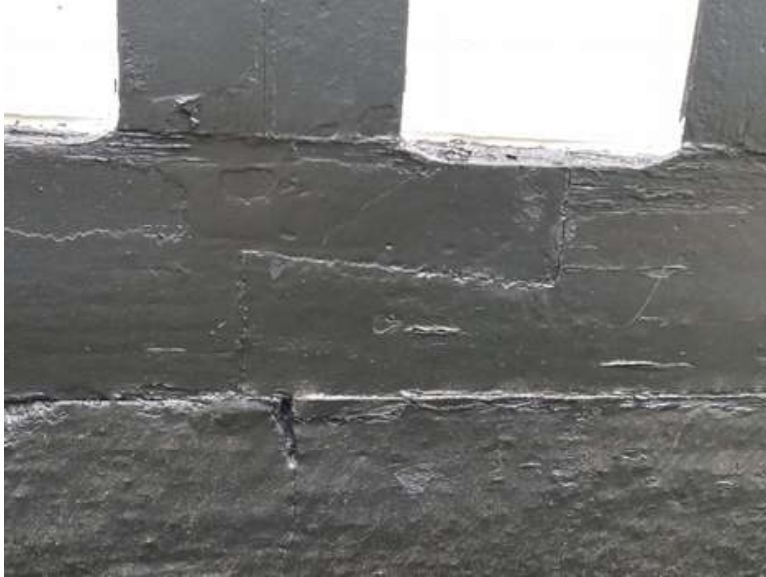
On the left (northwest) elevation there is a very nice splice joint in the original oak bottom timber. You can tell its age by the rough texture of the wood and the bevel between the vertical timbers.

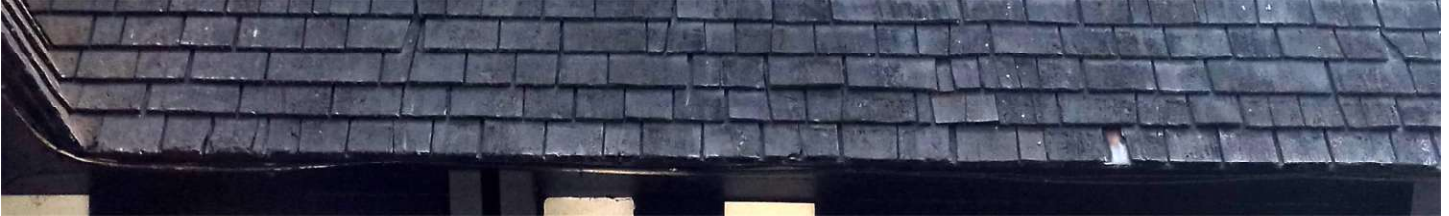
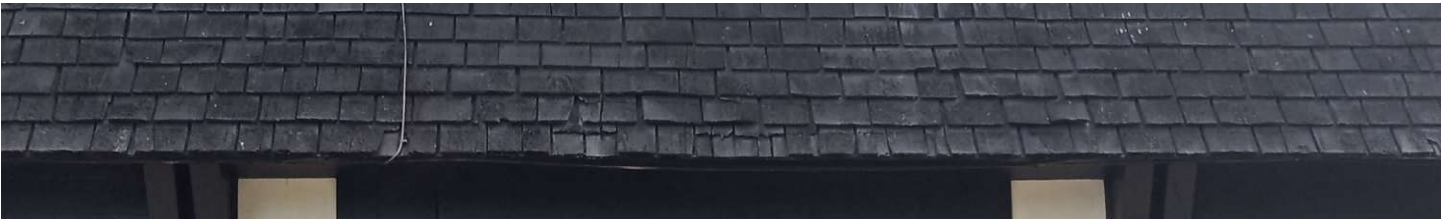
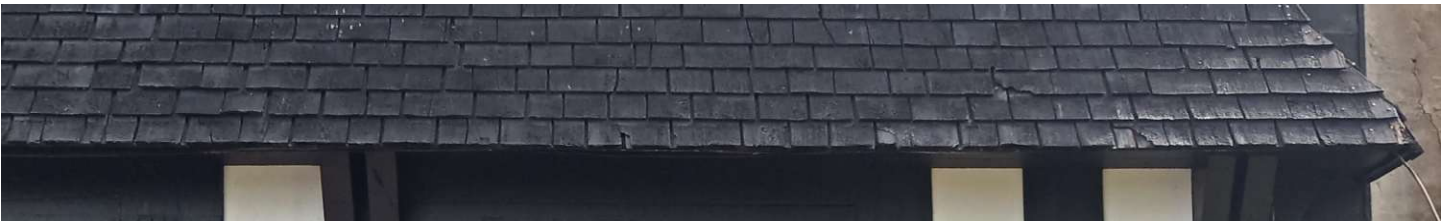
On the front elevation, most of the shingles above the first floor windows are in good condition but some in the lower courses, where the walls flare out, are cracked or missing. The rest of the shingles on the other elevations appear sound.

The wood shingled walls above the half timbered first floor are generally in good condition. There are some cracked shingles where the roof flares at the bottom on the front elevation and some discoloration on the rear. I recommend replacing any cracked shingles and painting the shingled walls with an oil-based paint to protect the wood .

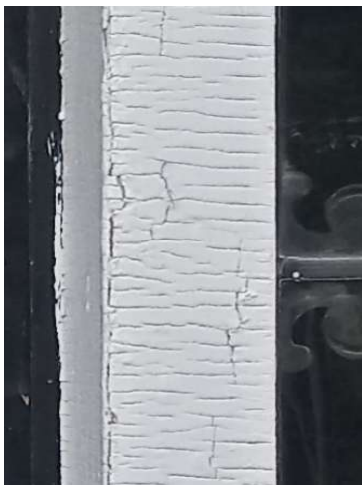
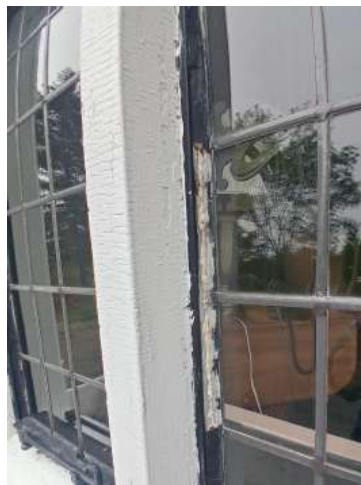
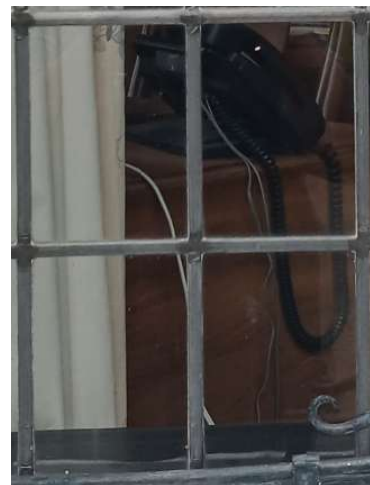
Condition Type 1F1: the wooden window frame paint is cracked and peeling, the glazing holding the leaded glass panel is cracked or missing, the leading between panes was universally in good condition and is well sealed. All the windows I tried opened easily and closed tightly.

In general, the metal window frames and sash frames are in good condition and need no work other than painting. The glazing compound holding the leaded glass panels to the metal sash frame has failed in nearly all the windows creating the possibility that the glass panels could fall out. In many cases, this glazing needs to be removed and replaced and the leaded glass panels reset on new beds of glazing compound. This includes the window at 3B4 which has modern glazing putty which is poorly done.

The wooden window frames are likely oak and are in good condition. In many cases, they need to be painted as the paint is cracked and in some cases peeling. Cracked or peeling paint can allow water to penetrate the surface and the resulting freezing and thawing can loosen the paint still further. Best painting practices include scraping with a hand scraper and sanding with a palm sander. The use of angle grinders or belt sanders can damage the wood and should be avoided. A good brand of oil-based primer and oil-based paint should be used.

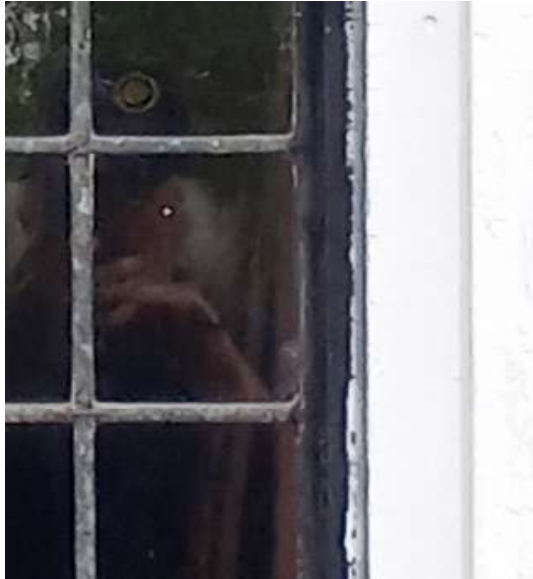
The condition Type 1F3 is the same as 1F1 except the paint is in better shape.

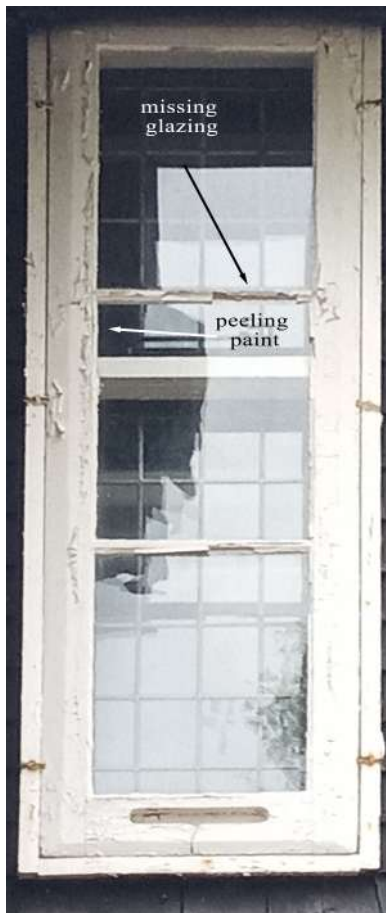
Condition Type 2F3-S: the storm windows are wood instead of metal, their paint and glazing is similar to that of 1F1, badly peeling, cracked and missing. I was unable to examine the exterior window trim as it was covered by the storm window.

In most cases, the storm windows have protected the metal ones, The second and third floor storm windows need to be removed and restored on a bench. Restoration includes removal, reinstallation and reglazing of the glass and painting of the wood frames. Any repairs to the wooden storm window structure or the window trim can be done at this time.

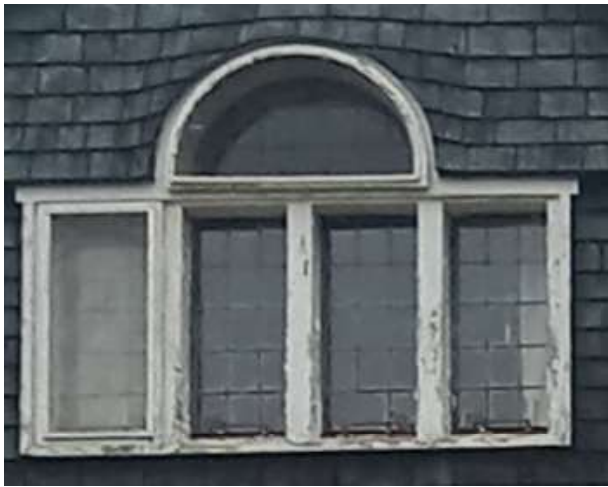
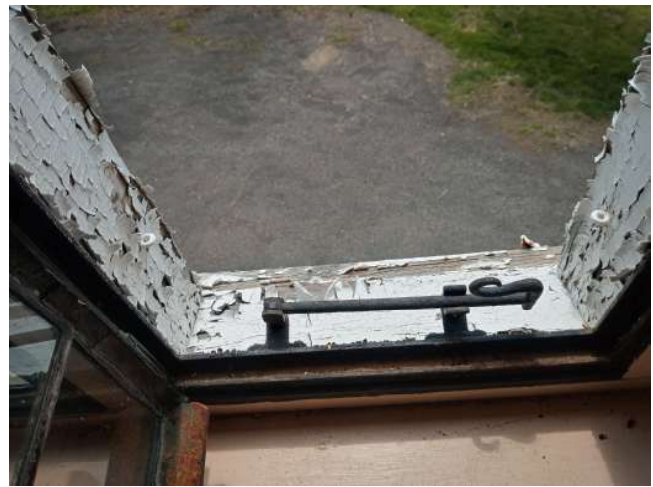
The third-floor Palladian window on the front elevation (3F1) is probably the finest window of the building, but it is missing three of its storm windows. The paint of the window frames is badly peeling and there is some rust on the window braces.

Three storms are missing from the Palladian window (3F1) and the paint on the frames is badly peeling. These storm windows should be replaced and the trim repainted. The frames and trim of the dormer windows need painting as does the wooden window (1L3). The front door (1F2-D) needs painting and the sidelites and transom need reglazing.

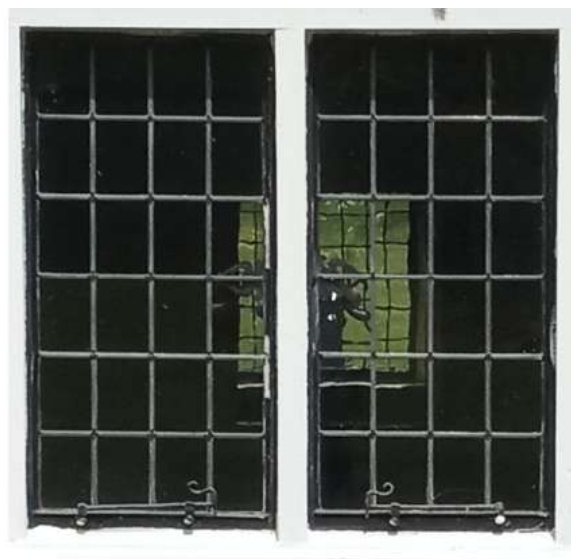
Window 1R1 is typical of 1F1 except one pane of glass is cracked. The reflection shows the irregularity of handmade glass which is typical of all the windows.

Of the nearly 3,000 panes of glass, only one or two are cracked. If they are to be repaired or replaced, a person experienced with leaded or stained glass should be used to do this work.

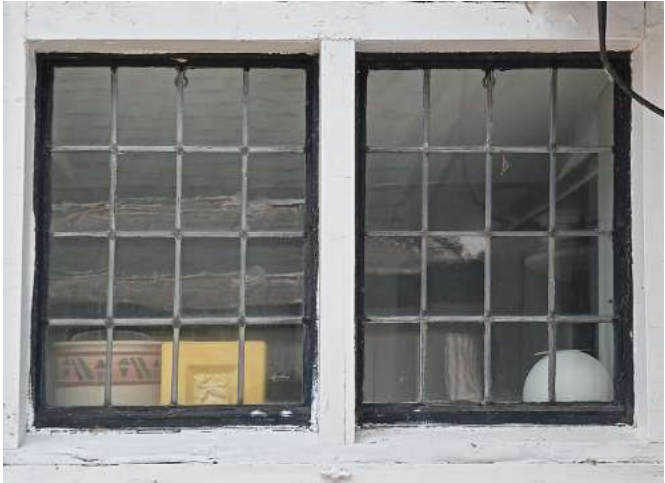
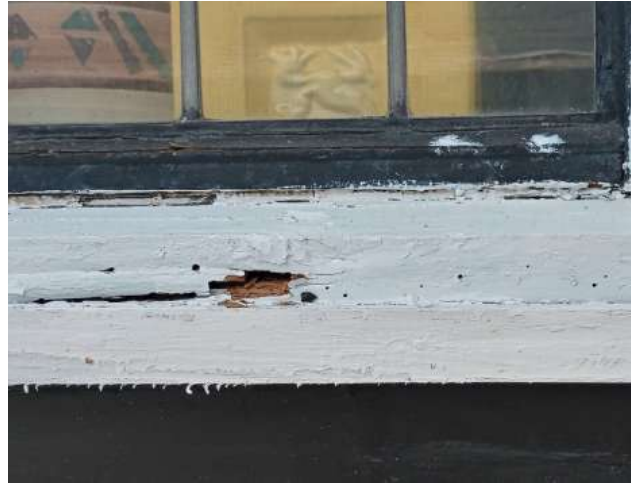
The window sill of window 1B2 has a small area of rot.

The small area of rot on the sill of 1B2 can be repaired using penetrating epoxy and epoxy filler. I recommend the use of West System ® epoxy and filler. The small area of rot on the sill of the dining room door (1F5-D) can also be treated with epoxy.

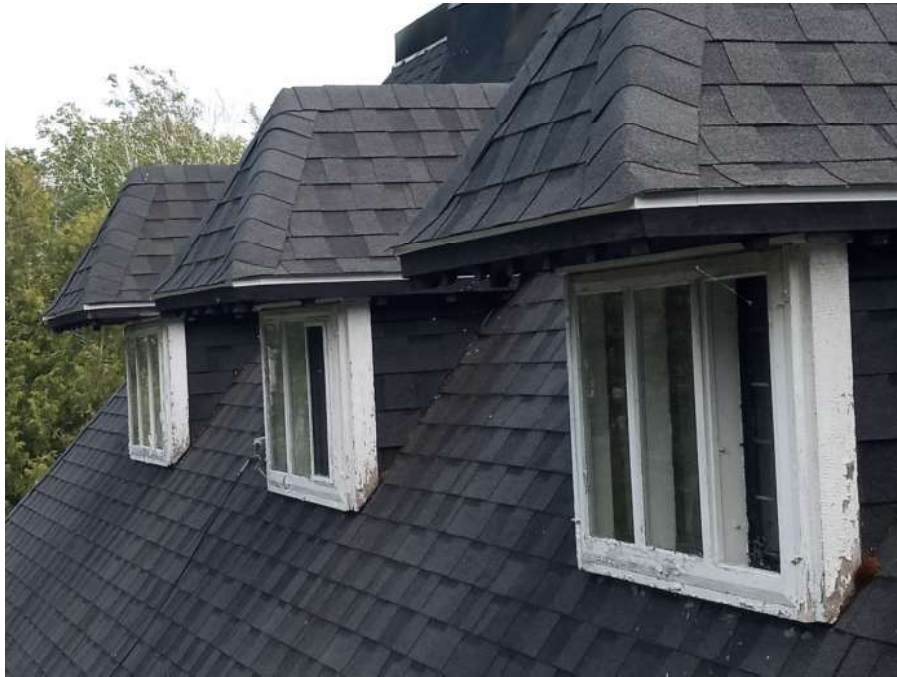
The four dormer windows on the back elevation, 3B1, 3B2, 3B3 and 3B4, have peeling paint on the exterior side trim. The storms are typical of 2F3-S.

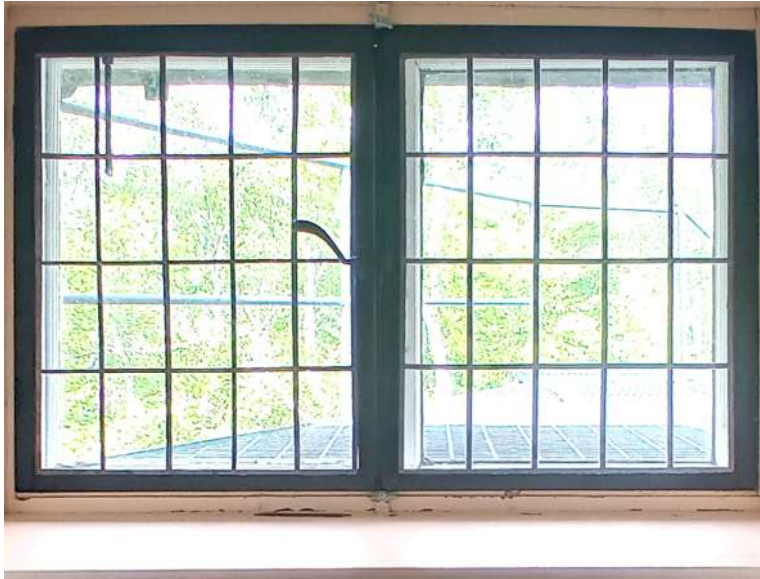
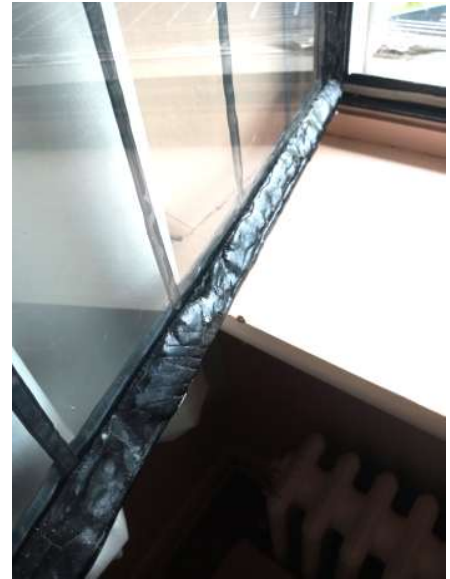
The original right-most dormer window on the back elevation (3B4) has been replaced with another metal framed casement window. I expect this was for egress to the fire escape. The hardware is different and the leaded glass panel is actually a single pane of glass with thin strips of lead attached with tape to simulate true leading. The glazing was recently done and is of poor workmanship.

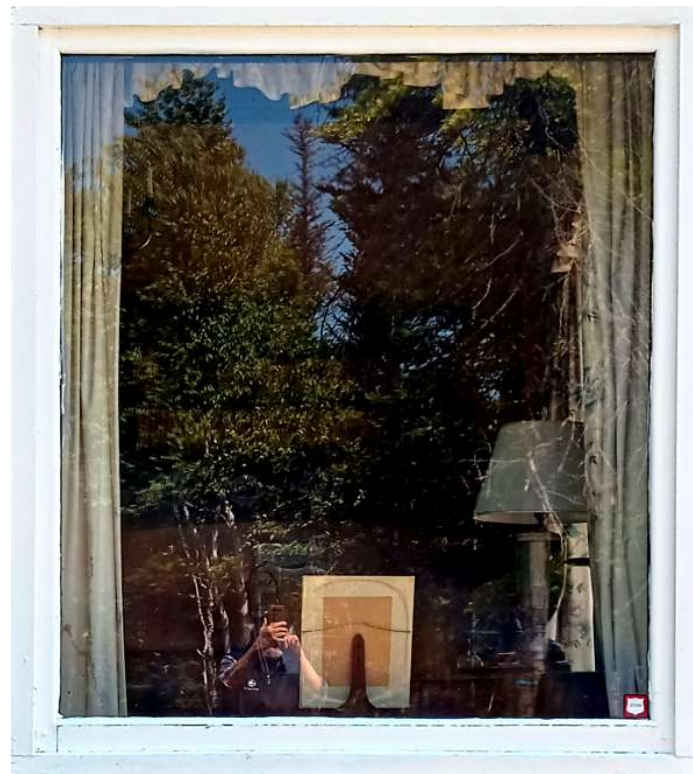
The only window which is not metal framed with leaded glass is the front dining room window (1L3). It is a fixed, single-lite wooden sash. Its condition is fair and it needs painting and glazing touch up. It does not need to be removed to do this work.

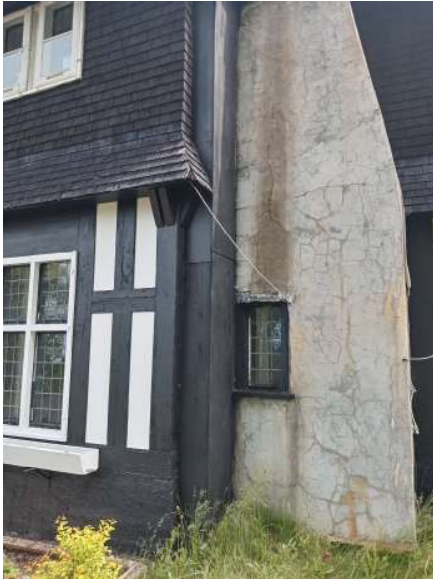
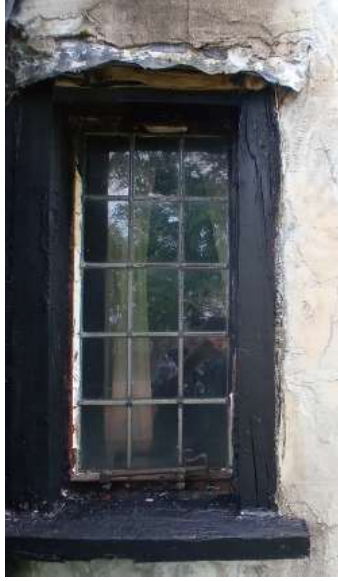
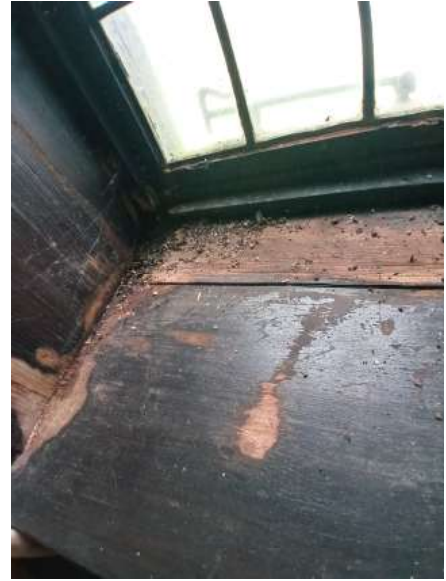
There is an operable window (1F6-A) in the mass of the chimney; it opens into the dining room. The window is in poor condition with a poorly-done metal flashing on its top which has been pulled back to reveal an unpainted header timber. The metal window frame is rusted as is the window brace. The leaded glass panel is in good condition with some remnants of red paint on the upper comes. The side timbers are in contact with the chimney masonry and show signs of deterioration. The sill is heavily painted and caulked but I saw no signs of rot. There is evidence of water on the interior stool shelf, but it is unclear if it is from leakage or potted plants.

The small window in the front chimney (1F6-A) needs further examination to determine the amount of work to be done to restore and weatherproof this window. The windowsill should be stripped of paint and any damaged wood repaired with a wooden patch or epoxy. The metal sash is rusted and should be removed for restoration. The flashing above the window will need to be replaced with proper, lead flashing. This can be done when the front chimney parging is dealt with.

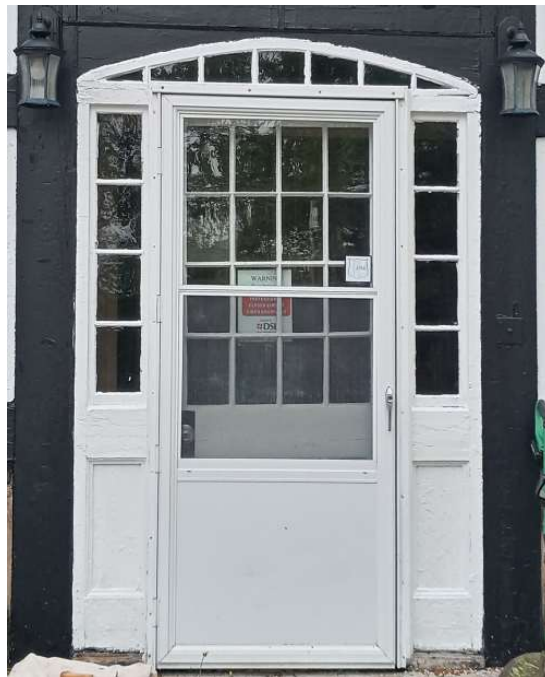
The front door (1F2-D) is wood with sixteen lites. There are sidelites with four lites each, a transom with seven and a modern aluminum storm door. The paint on the door as well as its frame, trim, sidelites and transom is cracked similar to the window, 1F1. The glazing of the lites in the door is on the inside of the building but those of the transom and sidelites are exposed to the weather and are in fair to poor condition.

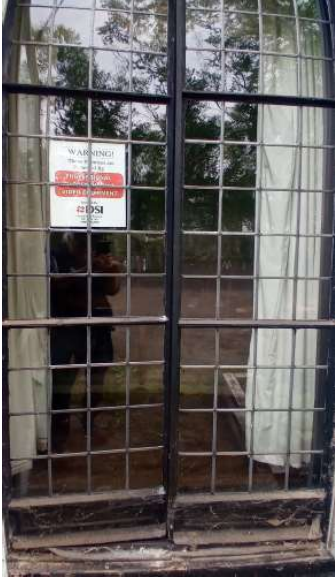
The dining room door (1F5-D) consists of a pair of 52-lite metal-framed leaves hinged to a metal frame which is mounded to an oak frame. The condition of the metal leaves and frame is good as is the wooden frame. There is a slight bit of rot on the bottom of the sill where it sits on the concrete. The inside hardware is in good condition.

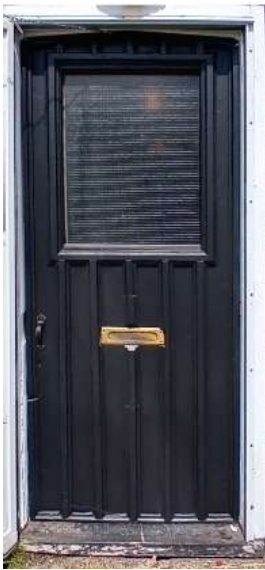
The door on the right elevation (1R2-D) is a wooden door with six vertical panels and a single, wire-glass lite. The door is in good condition, including its paint.

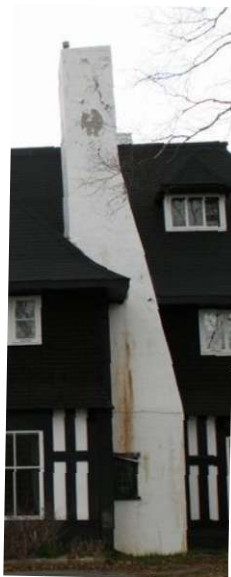
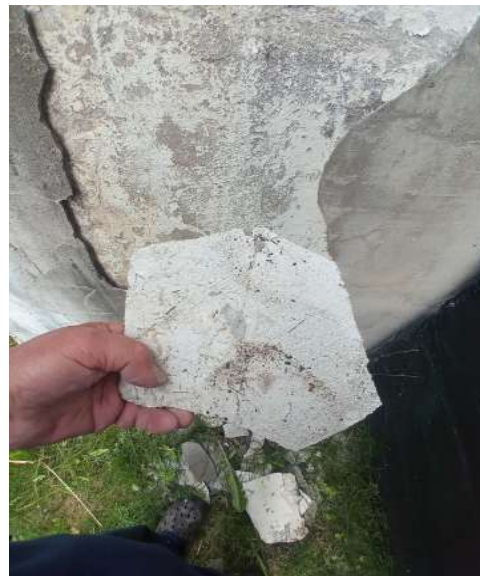
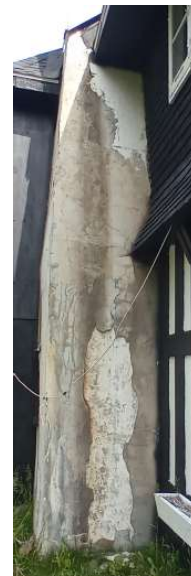
Front Chimney

The most prominent chimney is on the front of the house. It appears to be made of poured concrete covered with parging which is peeling badly. There was white paint on the concrete chimney as well as the parging flakes indicating a poor bond between the mortar and the concrete.

Above the roofline, the chimney is covered with sheets of plywood. I assume these were installed to prevent the falling mortar from damaging the roof or causing injury. This is the only one of the four chimneys which has a plywood covering.

The parging appears sound in all but the front chimney, which is covered with plywood, assumedly to prevent falling mortar from damaging the roof or injuring people on the ground. From the foundation to the second floor, the parging is peeling away from the front chimney. It is apparent the mortar was put on the chimney over paint and the bond with the mortar has failed as it is peeling off in good sized sheets. I assume the same condition applies above the roofline and the concrete chimney underneath the parging is sound. To repair the parging, best practices need to be followed and scaffolding will be required. Best practices include removing any of the old parging which is not well adhered to the concrete, thoroughly cleaning the concrete surface using power washing and wire brushing, applying an approved bonding agent to the clean concrete and applying the mortar veneer according to manufacturer's recommendations. Some examples of parging repair follow: (<https://www.youtube.com/watch?v=I9JxBaFmmz0>, <https://www.youtube.com/watch?v=ICygy660fVI&t=750s>). The other chimneys show no signs of failing parging, but they should be checked and repaired if loose parging is found.

The plywood covering the front chimney is a very temporary solution and when it begins to deteriorate, it will add another hazard which might damage the roof or injure people. I recommend the plywood be removed from the chimney in the near future and the exposed parging repaired. It is important to use best practices to assure good adhesion of the new mortar to the concrete. The other four chimneys are not showing any signs of peeling, but they should be carefully monitored and repaired when damage is first noticed.

The front chimney is covered with plywood to catch the falling parging before it damages the roof or injures people below. As time goes by the possibility of the plywood blowing off increases. This is a liability issue and needs to be dealt with as soon as possible. The plywood covering has to be carefully dismantled and the loose parging removed without damage to the roof.

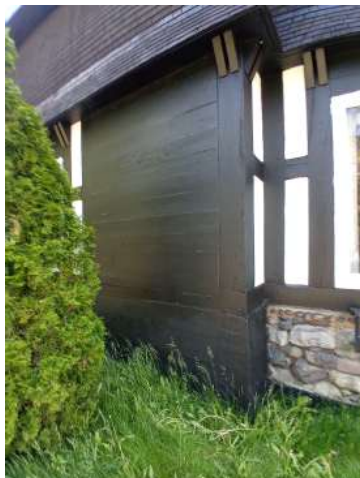
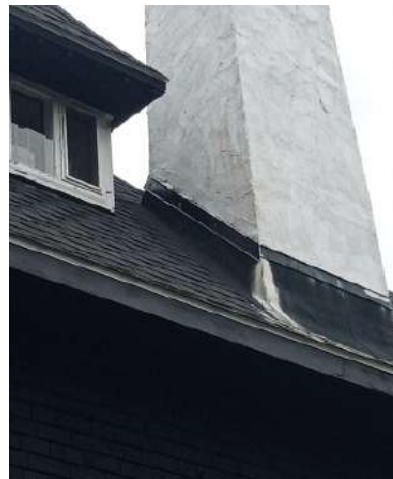
Left Chimney

Unlike the front chimney, the base of the left chimney is not parged, but painted concrete in good condition. The parging above the roofline appears to be sound and was probably done later than the front chimney, possibly when the roof was redone in 2017. The white plume over the flashing is probably leeching mortar.

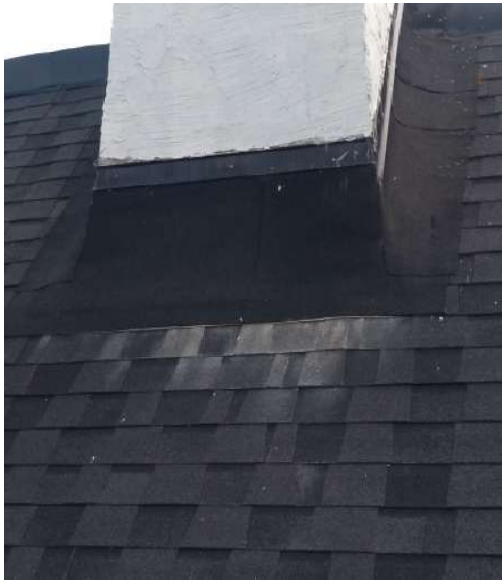
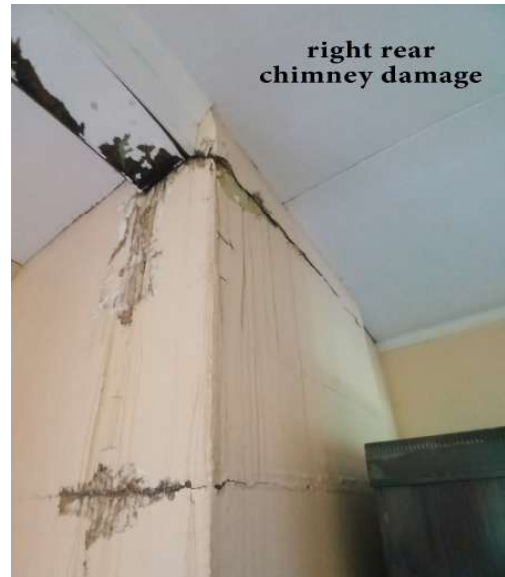
Right Rear Chimney

Similar to the left chimney, the right rear chimney is parged above the roofline. The obvious water damage around the chimneys is probably from before the latest roof was installed in 2017. I believe the leaks are not active and were fixed when the new chimney flashing was installed.

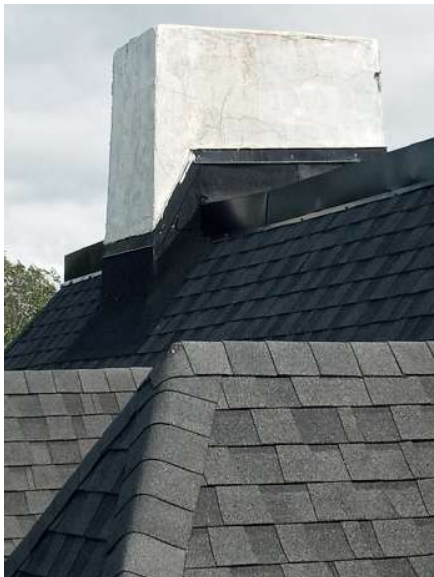
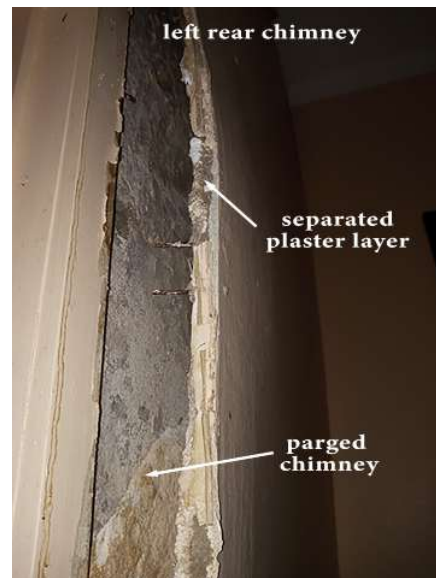
Left Rear Chimney

The left rear chimney is similar the right rear. I believe it has been recently parged and flashed to solve the leaking problem. The old parging (similar to that of the front chimney) can be seen behind the separated plaster wall in the third floor hallway and was possibly done when the building was built.

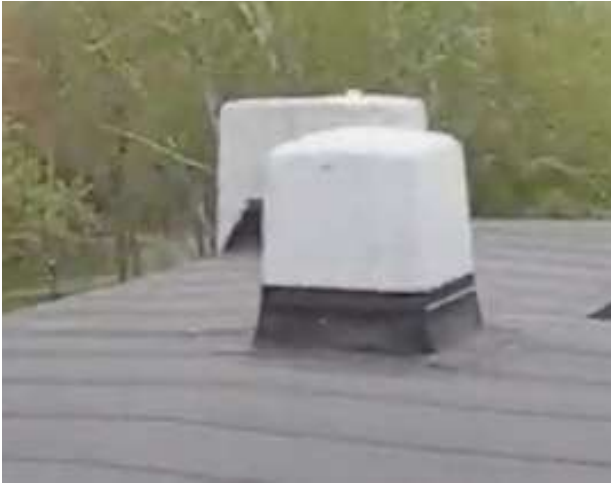
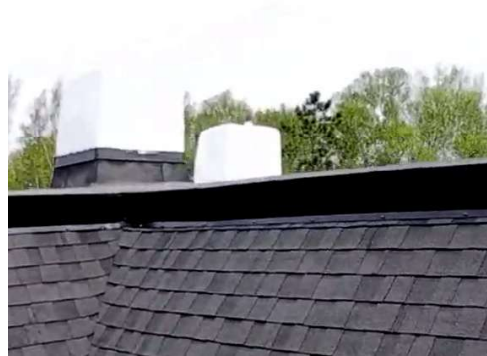
Center Chimney

The center chimney was not visible from the ground.* It is sealed at the top and flashed to the very low-pitched torch on roof using standard flashing techniques.

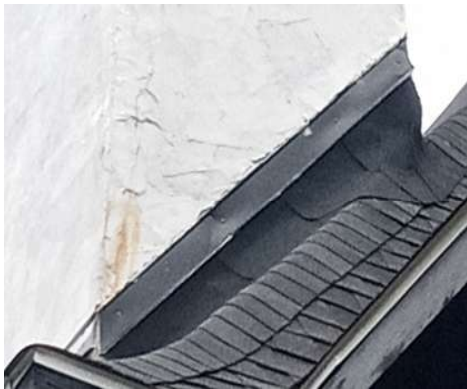
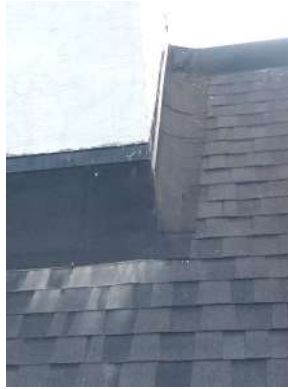
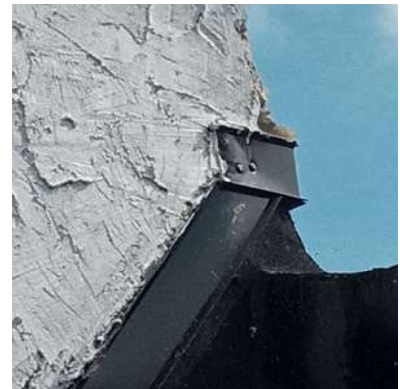
Chimney Flashing and Gutters

Chimney flashing is designed to prevent leaks where the chimney meets the roofing materials. When done properly the flashing directs water away from the chimney and protects the house and the chimney itself from water damage. Before the roof was renewed, the chimney flashing failed in at least two of the chimneys leading to serious water damage below. The new flashing on the shingled portion of the roof is not the best practice and uses non-durable materials adhered to asphalt tab shingles. The rough nature of the parging makes me think the chimneys were re-parged when the roof was renewed.

My concern is where the chimney goes through the higher-slope asphalt shingle roof. It appears self-adhered roofing materials, either torch-on, which uses heat, or peel and stick, have been used over the shingles. This is not recommended. Heat can damage existing asphalt shingles and peel and stick adhesives do not bond well to asphalt shingle granules.

For best practices, the flashing done with self-adhered roofing over asphalt shingles should be removed and replaced with lead or copper flashing properly installed. A groove will need to be sawn in the concrete walls of the chimneys. Best practices for flashing chimneys to a tab shingle roof follow: (https://www.youtube.com/watch?v=9jJgV_k4nFs&t=70s and <https://www.youtube.com/watch?v=-PowXyjDfZM>).

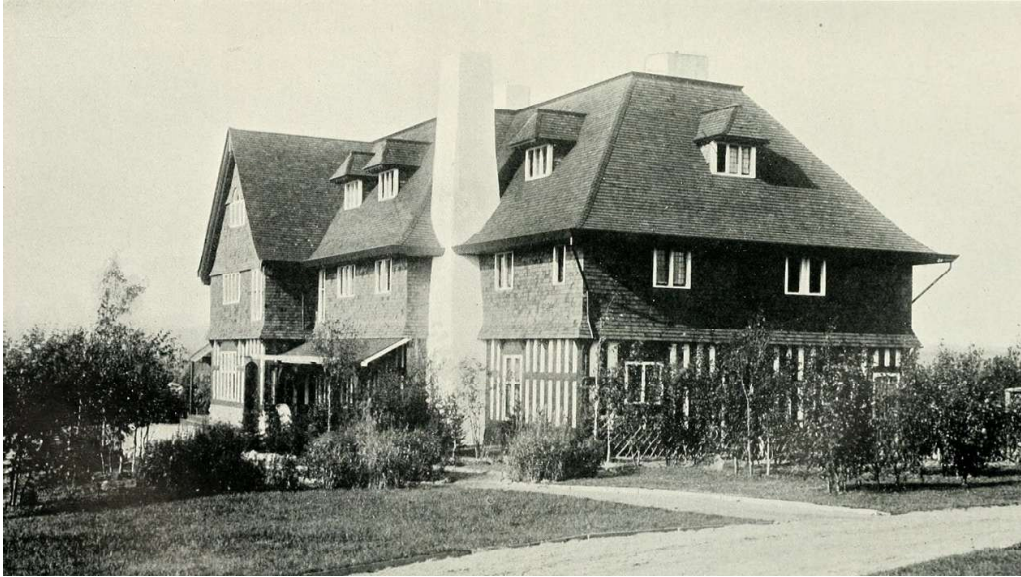
The architect's drawings for the house shows gutters and long angled downspouts. They were still present in 1958, but are gone by 2010. The eaves have a significant overhang and rain runoff falls well away from the house. I do not believe gutters are necessary for water management.
