## Burgess Property, Whiteway, NL: Site and Building Survey.

Heritage NL

*By Maryssa Barras and Dale Gilbert Jarvis, with  
notes from Robert and Ian Burgess*

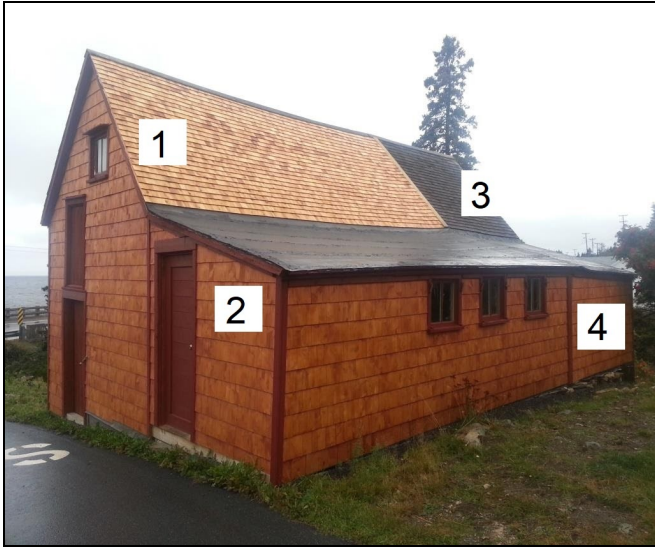
**Fig. 3 - Evolution of the Stable/Store**

The most probable sequence of construction [see Fig. 3] for the building is as follows: 1) stable, 2) right hand linhay/store, 3) loft extension and first floor stable addition, 4) linhay addition to connect the stable extension and store, 5) the recent deck addition (not pictured). A more detailed architectural analysis, including detailed building measurements, is needed to fully assess this structure. Red ochre was used on the original shingles and is still visible in places.

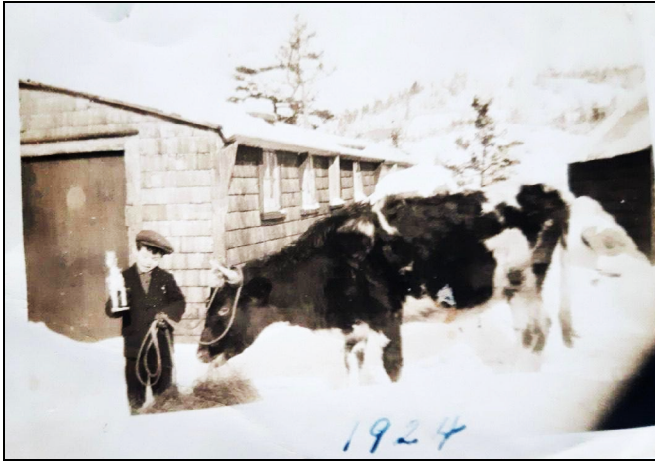
**Fig. 4 - Store addition, 1924**

The fishing store addition was potentially added onto the stable after 1915, because it is not mentioned alongside the stable in Henry Charles' will written at that time. This evidence is inconclusive though, because the store may have been implied as included as part of the stable, which is mentioned. A photo from 1924 shows both the store and its extension, meaning that all components of the building predate that year.

Initially built to be used for fish and fishing gear storage, the Burgess family eventually began using the store and stable extension for barrel production. A chimney, which is not pictured in the 1924 photograph, was also attached to the store at some point. Living memory from Burgess family members today places the chimney being in place in 1960 and attributes it to being part of the barrel-making process that took place on site, possibly for the making of hoops.

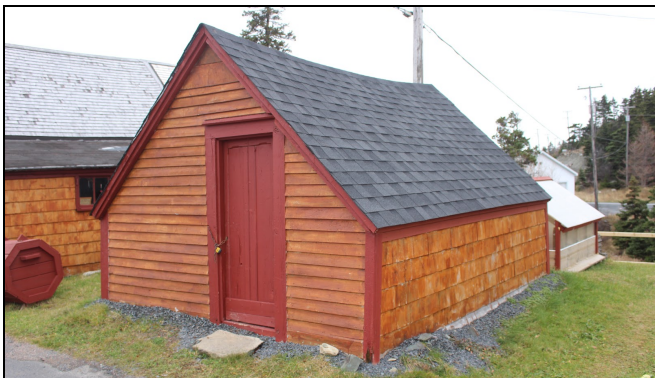
**Fig. 5 - Root Cellar Exterior, 2020**

The property's root cellar is likely the second oldest building on the property after the stable, but no records conclusively date its construction. The cellar is of typical construction, as a small, squat building measuring 3.5m wide by 4.73m long, covering an underground cellar space accessed via ladder. The above ground building is used to store some related items, like a water barrel and some gardening tools.

The below ground portion of the cellar is a small space typical of Newfoundland root cellars, lined with wooden bins in which vegetables are stored over winter. The cellar is concrete; earlier iterations may have been dry stone.

The cellar was consistently used until the 1990s, after which the building fell into disuse. In 2015, as part of property renovations, the building was repaired and has since been regularly used to store root vegetables by the current Burgess property occupants.

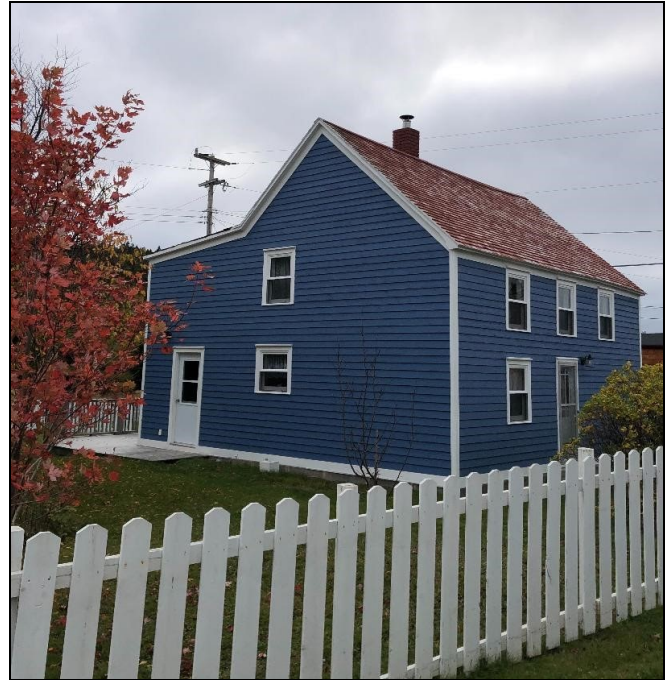
**Fig. 6 - Photo of current dwelling exterior**

The Burgess house, as indicated by its full two storeys and flattened roof, is a typical example of a third generation modified saltbox house (Mills 1975), built on a flat stone foundation [Fig. 7, below]. This style of home was built between approximately 1880-1935, and represents an altered version of earlier, smaller, saltbox homes (Mills 1975). It is likely that this house is substantially different in form from the earlier house.

Over the past 120 years, the Burgess dwelling has undergone a number of renovations and changes to accommodate the changing needs of the Burgess family. The original, typical centre hall with staircase plan was changed with the construction of a later stair in the northwest corner of the house. At the time of its construction the home did not have any internal plumbing, running water, or electricity. Instead, an outhouse for the family was located on the edge of the riverbank in such a way that the river could naturally 'flush' everything away. It was used until about 1972 (Burgess & Burgess 2020).

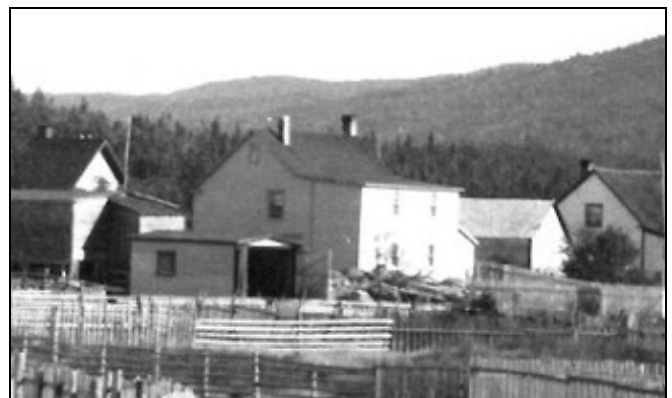
**Fig. 8 - Original chimneys, garage addition**

In 1948 a new oil/wood stove was purchased, and in 1956 this new stove was installed in the center of the building to replace the two original chimneys. This renovation altered the floorplans of both the first and second floors. Today, remains of the original staircase are visible in the ceiling beams of the first floor. The current staircase was installed to replace the one which was removed in what was the Burgess' "breakfast room."

Other changes to the fabric of the house include the addition and removal of porches and a garage (see Fig 8). The date of construction for the porches is unclear, and they may have been part of the original construction of the building circa 1902-1903. The back porch was removed between 1948 and 1958. The front porch was removed likely in the early 1960s.

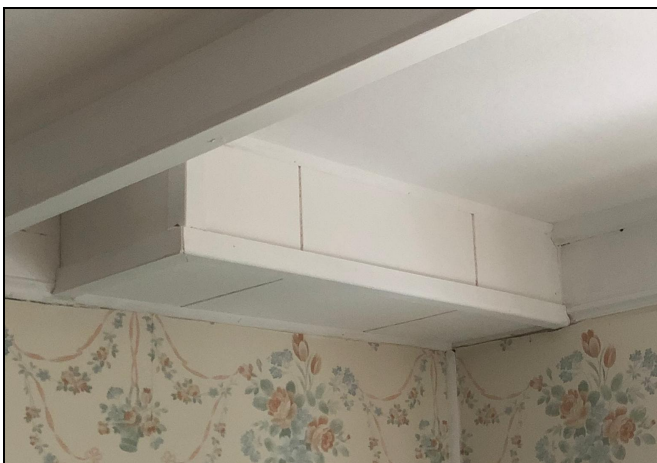
**Fig. 9 - Location of original Waterloo Stove**

The home was heated entirely by wood until the 1990s when the home was re-wired with baseboard heaters (Burgess 2021). Originally, the 1902 layout of the house featured two chimneys - both for stovepipes - at both gable ends of the house. The ocean side chimney (in the foreground of Fig. 8, next page) serviced the original parlour stove and, on the opposite end of the house, was a Waterloo stove, whose remains are still visible in the ceiling of the second floor (Fig. 9, below).

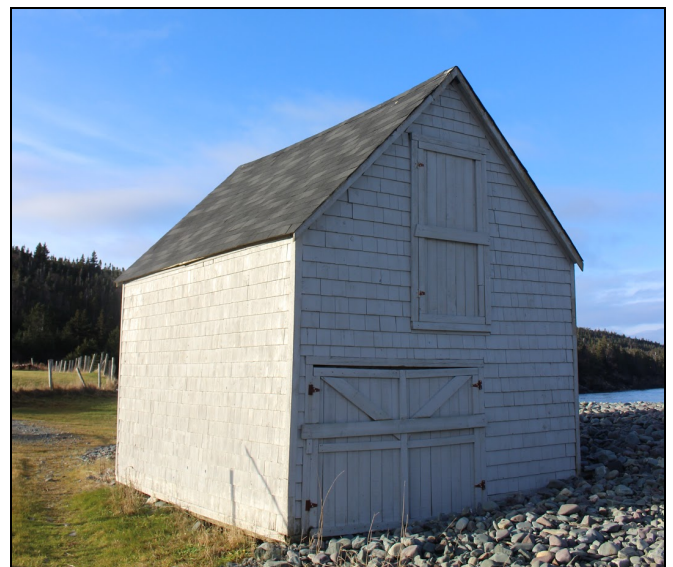
**Fig. 10 - Fishing Stage Exterior, 2020**

While fishing buildings would have been constructed soon after the Burgesses first came to Whiteway in 1862, the current two storey fishing stage was a later addition to the Burgess property built by Richard and Charles Burgess around 1900. The lower part of the building was filled with framed pounds used for bulk salting the split cod fish, while the upper part of the building was used to store prepared dried and salted fish. Originally the only access to the lower part of the shed was through a small door facing the water. The double door was added by William Burgess to store his boat and fishing gear in the off-season.

When exactly the fishing structures came down is unclear. Photos from the 1980s show the stage in a serious state of disrepair alongside the remains of the Burgess flake, with no other buildings.

The decline of the fishing stage began in the early 1960s and late 1950s, with the stage being completely abandoned as a working enterprise by 1969. By the 1950s, in fact, the family's main fishing activities focused on herring and squid, reflecting the overall decline of the Newfoundland cod fishery at the time.

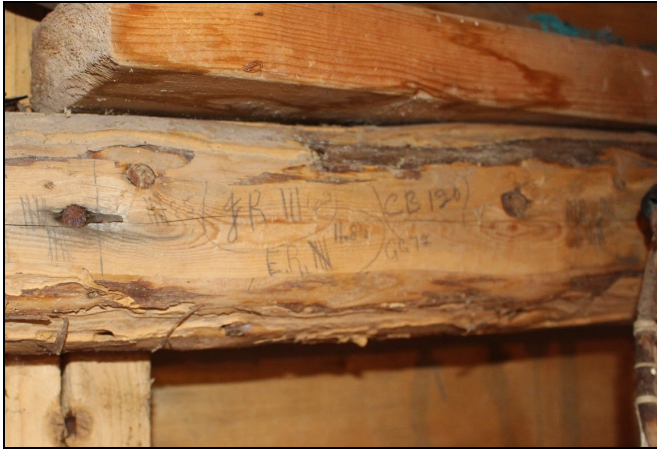
**Fig. 12 - Notes on sawmill beams**

The sawmill is the newest building on the property. It was not listed in Henry Charles's 1915 will, unlike all the other Burgess buildings. A 1919 receipt for a gas powered, water-cooled stationary engine remains in the family's records (Burgess Property 2019). This places the construction date for the sawmill as likely being sometime between 1916-1918, with the addition for the engine constructed circa 1919.

The sawmill itself is a long and low building on a wood post foundation with one large open room. The mill engine was housed at the very back of the building, in a small extension. Exposed beams along the walls of the building are covered in writing used to record the first date of milling and the amount of milling done annually [Fig. 12, next page]. By 1941 there were three competing sawmills in Whiteway, each processing and selling wood used for making barrels, boat and house building, etc. along the south coast of Trinity Bay.
