BUTLER **HERITAGE BARN**, CUPIDS, NL, CANADA

REPORT

RESTORATION PROJECT 2023

Butler Heritage BARN, Cupids.
Restoration Project, April – August 2023

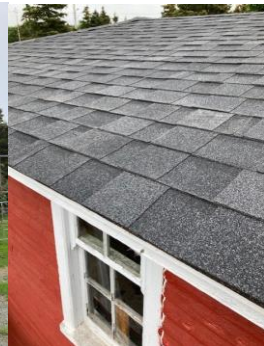
ROOF: Old shingles removed. Roof boards renailed. Rotted roof sheathing was replaced with new wood, and/or “Dutchman” repaired. The entire roof was re-shingled. All fascia boards were rotted and replaced with new fascia boards.

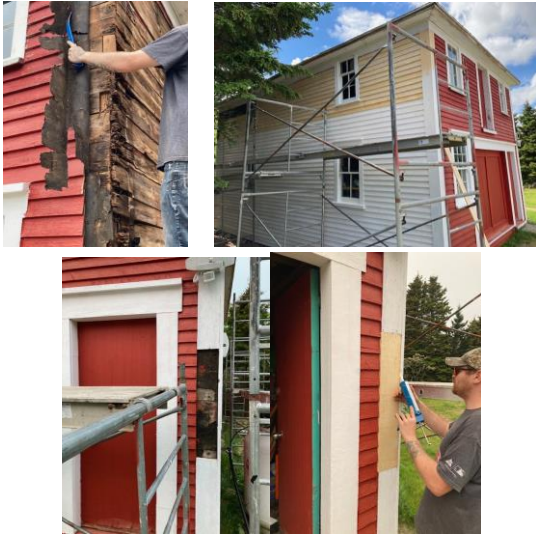
WEST SIDE (treed side): Rotted sheathing sections were repaired prior to installation of new wood trim, and new clapboarding. Clapboard could not be saved due to extensive rot.

WEST SIDE: West facing side of the barn (treed side) required significant sheathing and corner rot replaced and or Dutchman repairs. All of the original barn interior framing was saved; the East barn sheathing/clapboard was restored and re-used.

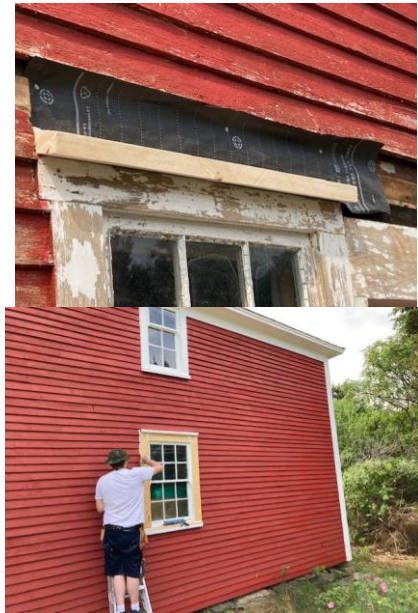
SOUTH SIDE: The South facing side (road/door side) was fairly rotted, with significantly deteriorated under sheathing. We preserved as much as the original wood

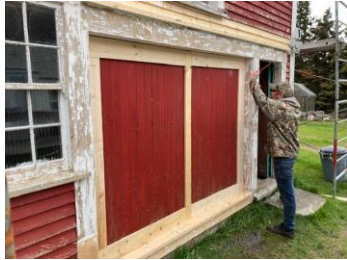
SOUTH SIDE (road side): Trim board and doors had significant rot. Dutchman repaired as much of the original wood on trim, door sils, corner boards and the 3 doors. The 3 windows refurbished.

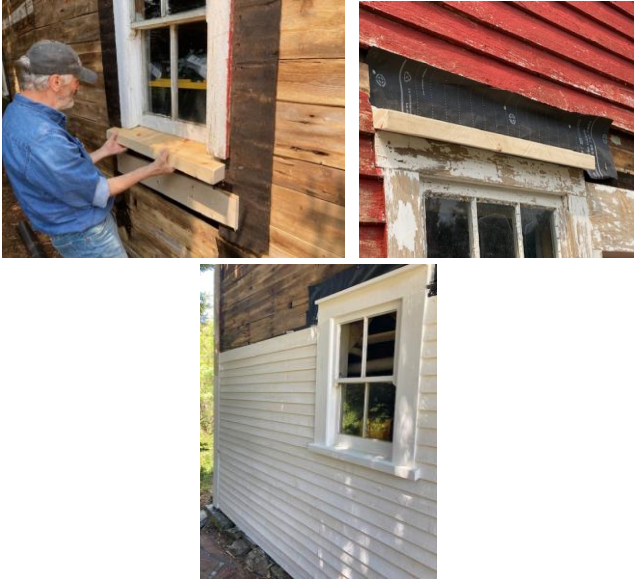
NORTH SIDE: The north side (rear) of barn had significant wood deterioration. Rotted sheathing was cut out and replaced with new wood and or Dutchman repaired to save as much of original wood as practical.

The back window was repaired, and missing glass panes replaced with new. Original clapboard rotted, and replaced with new.

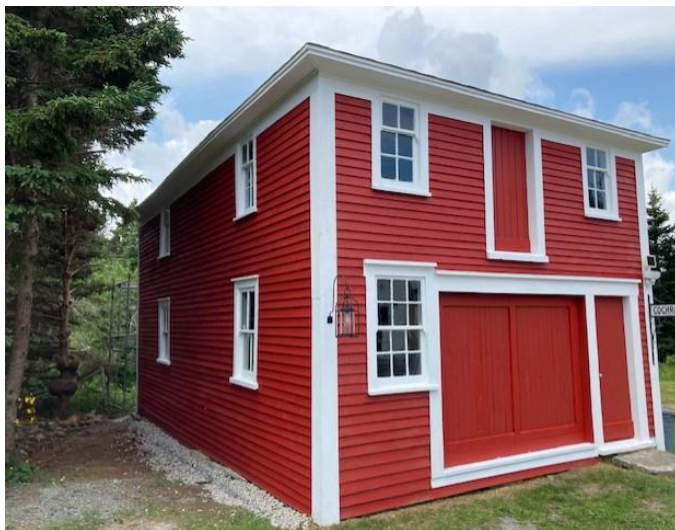
WINDOW RESTORATION: All the original windows were restored and some of the original glass panes were reused. Many glass panes were broken, or missing, and were replaced with new.
