## Fences and Walls of the St. John's Ecclesiastical District

Heritage NL

By Michael Philpott

This report describes the walls and fences of the district as observed during a field survey on June 8th, 2021. Description is divided into the following sections: the Anglican Cathedral and its churchyard, St. Andrew's Presbyterian Church (the Kirk) and environs, the Basilica and related Roman Catholic properties, and Belvedere Cemetery.

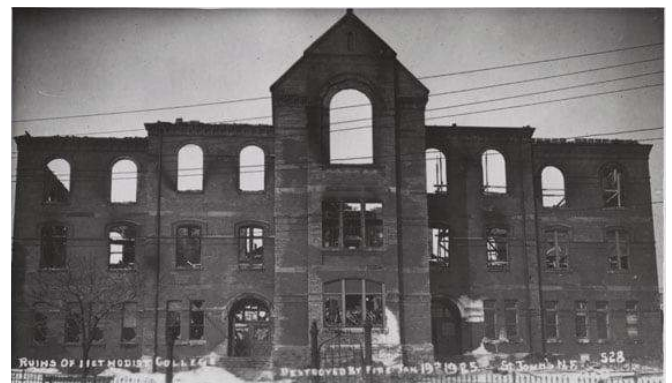
Fig. 12. The Methodist College/Holloway School following the 1925 fire. Source: Terrence Dawe

Above the Kirk is a further section of spear-headed fence, though of a simpler style with alternating simple points and spearheads. These sections are supported by posts similar to those leading up the Kirk with a large endpost. The eight-sided, tapered post is topped by onion dome or flame (figures 10 & 11) and likely formed part of a gate or marked the end of the property. The same posts were once installed at the front of the Methodist College (figure 12).
