***REPORT ON AN ASSESSMENT OF
GRAND FALLS HOUSE
in
GRAND FALLS-WINDSOR, NEWFOUNDLAND
by
Rex Passion
for
Heritage Newfoundland and Labrador
on
June 18, 2025***

**Report submitted
July 31, 2025**

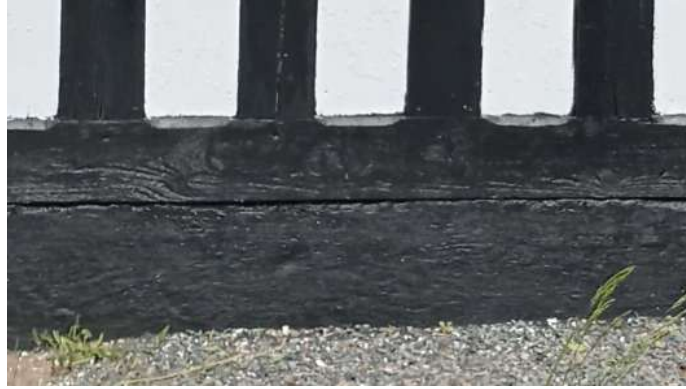
9 1/2 inch exposure on back elevation to the left of the addition

It is curious that the foundation is 9 1/2 inches above grade on the rear elevation to the left of where the addition was added, but is 36 inches above grade on the same elevation on the other side of the addition.

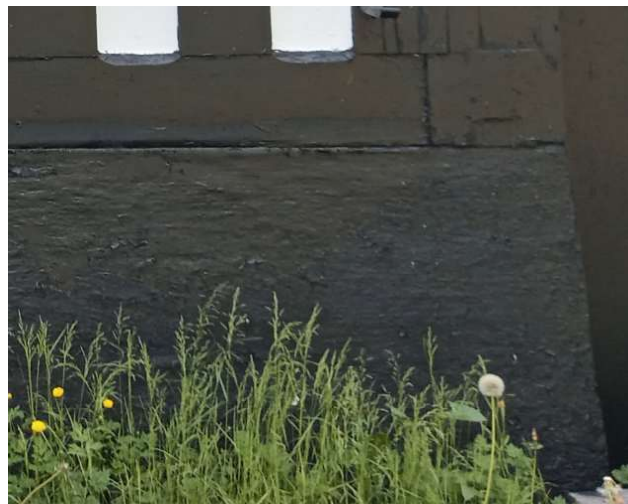
36 inch exposure on the back elevation to the right of the addition

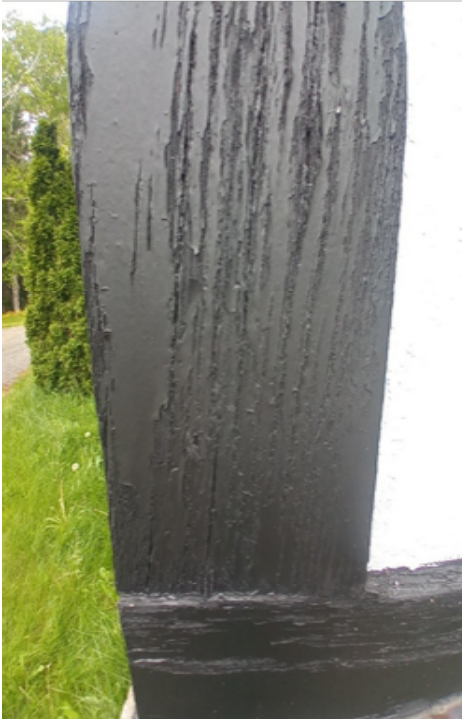
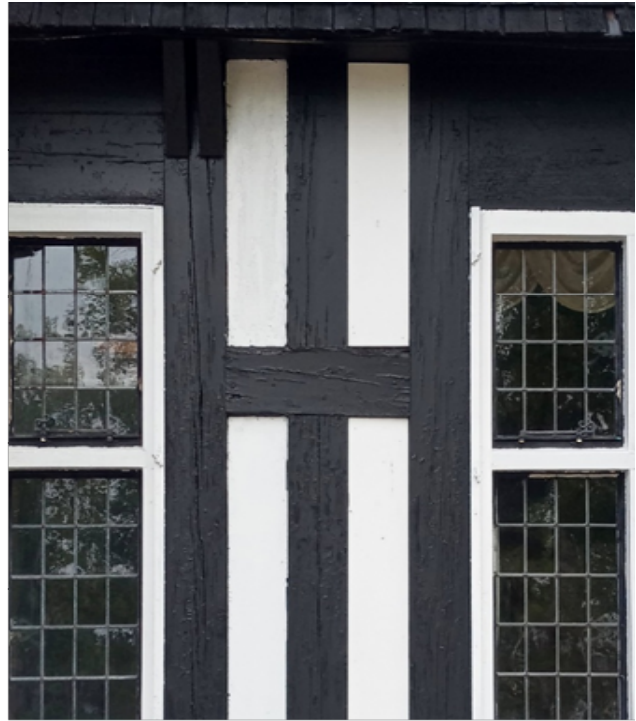
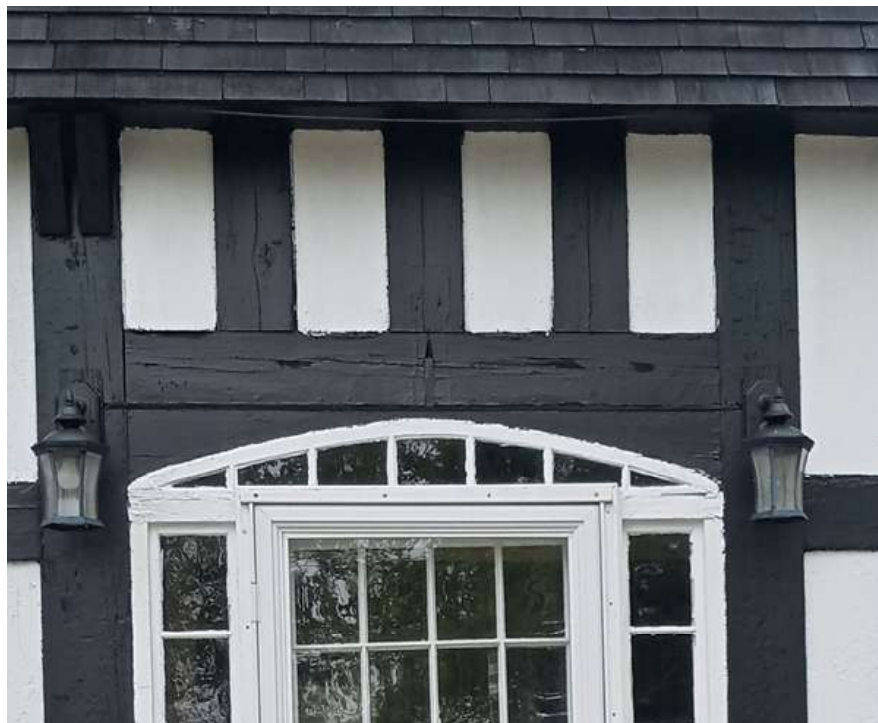
Most of the timbers appear to be English oak, which is a very durable wood with great longevity. They show a good deal of cracking, some of which is wide and deep. However, the wood is hard inside the cracks and I saw no signs of rot in any of the oak timbers with one possible small exception on the rear of the building. I have seen pictures of sound 500-year-old oak timbers with similar cracks. In some places, the cracks at Grand Falls House have been filled with caulking material.

The oak timbers of Grand Falls House typically have cracks, some of which are quite deep. I probed these cracks and found the wood inside was as hard as the wood at the surface. This cracking is typical of oak timbers and does not effect their strength. In some places, the cracks have been filled. I believe this is unnecessary and could possibly damage the wood by allowing water to accumulate behind the fill. I would recommend careful removal of filling from the cracks without damage to the wood.

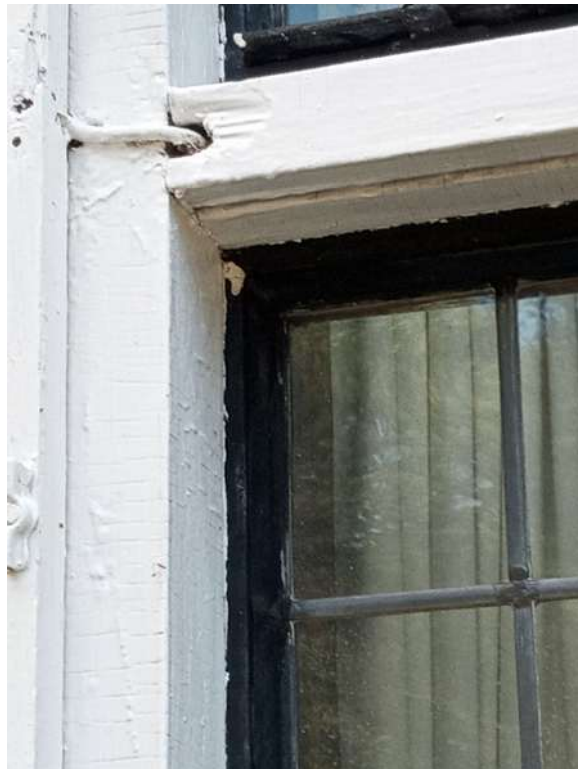
In the frame of the center window on the left (northwest) end of the house there is a hole drilled for a cable. This hole should be filled with an appropriate material to seal out the water.

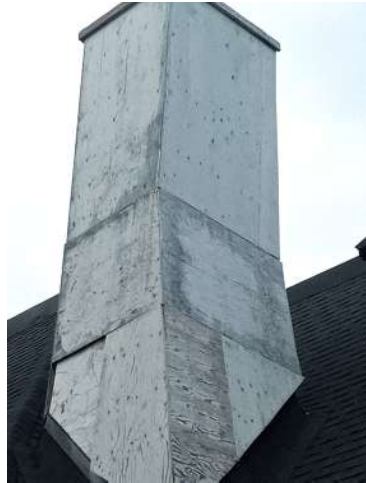
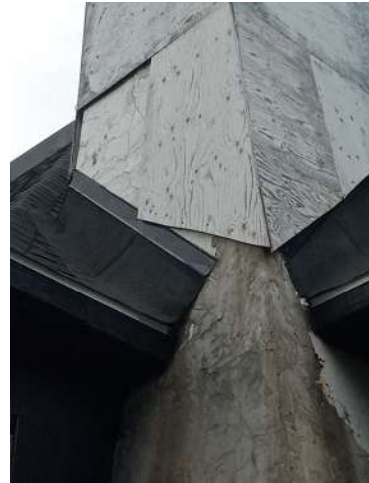
The most prominent chimney is on the front of the house. It appears to be made of poured concrete covered with parging which is peeling badly. There was white paint on the concrete chimney as well as the parging flakes indicating a poor bond between the mortar and the concrete.

Above the roofline, the chimney is covered with sheets of plywood. I assume these were installed to prevent the falling mortar from damaging the roof or causing injury. This is the only one of the four chimneys which has a plywood covering.

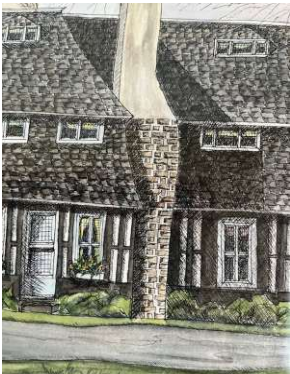
Although it was suggested that the chimney was originally of field stone construction, I found no evidence of this. This drawing was taken from an old photo; I think it shows the bottom of the front chimney with a covering of stone veneer.
