TOWN OF FOGO ISLAND PROPERTIES

# ARCHITECTURAL INVENTORY

# Architectural Inventory – Fogo Island Town Buildings

This project was undertaken to provide the Town of Fogo Island with an architectural inventory of all the buildings owned by the town. When the Town of Fogo Island was created in 2011, with the amalgamation of 4 previous towns and a regional council, the new Town of Fogo Island inherited over 40 buildings. The ones currently owned by the town are included in this survey.

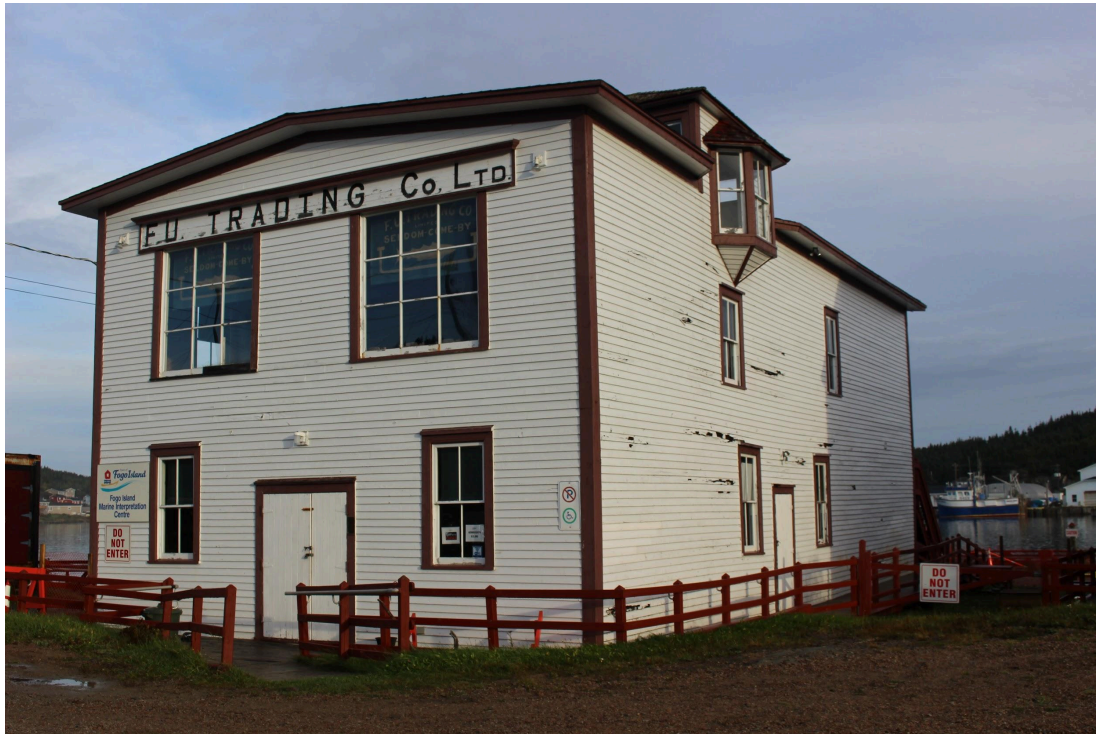
TFII-003

***Marine Interpretation Center Building #1, the Fishermen's Union Trading Company Premises Registered Heritage Structure, 2023. Front and side facade.***

Two main entrances in the front and rear of the building for road and water access, which allowed fishery activity to directly access the building from the harbour. The building displays a FU Trading Co. sign on the exterior and contains the original store features on the second floor

interior, including artifacts on display. Interesting architectural features of the building include a dormer window shaped like a three-sided bay on the right facade. The Fishermen's Union Trading Company Premises was designated a Registered Heritage Structure by Heritage NL in 2009.

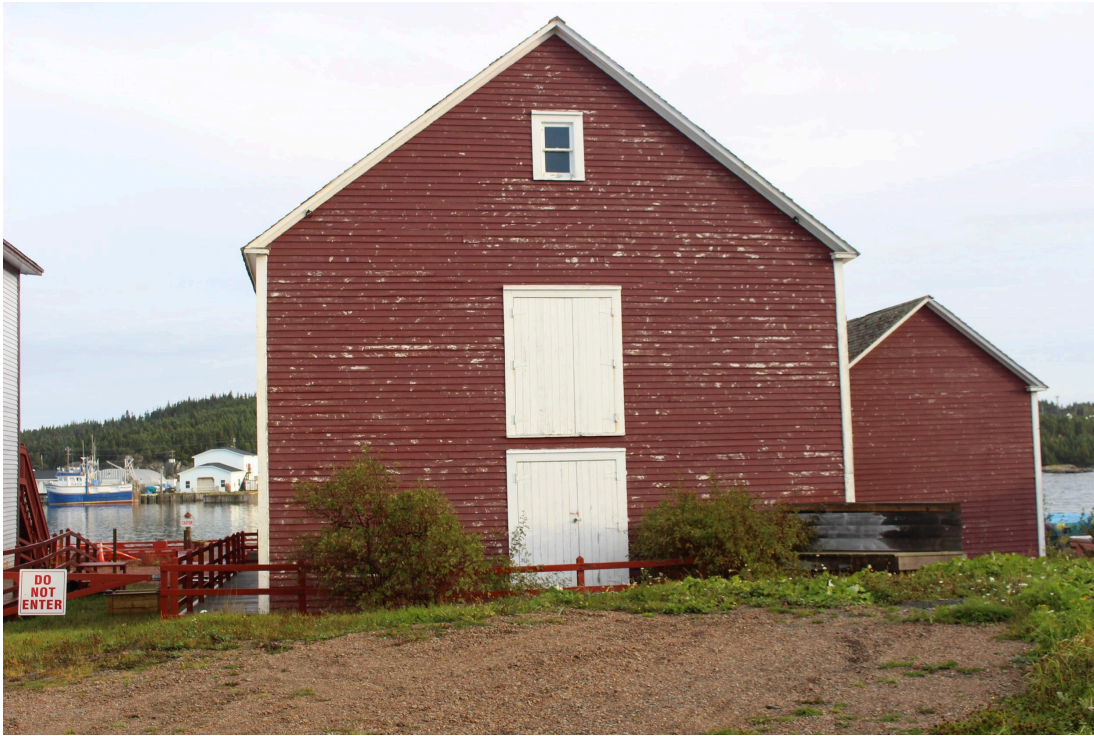
TFII-004

***Marine Interpretation Center Building #2, Red Fish Store, 2023. Front facade.  
Photo by Juliet Lanphear.***

Located in Seldom and also called the “Red Fish Store,” this building was built over 100 years ago. Used to store loose salt for salting fish, kerosene, and other fuels. Fisher’s would ship their dried salt fish to the store where it would be sorted into separate grades. The salt fish would be packed in barrels and stored on the second floor before being shipped to other markets.

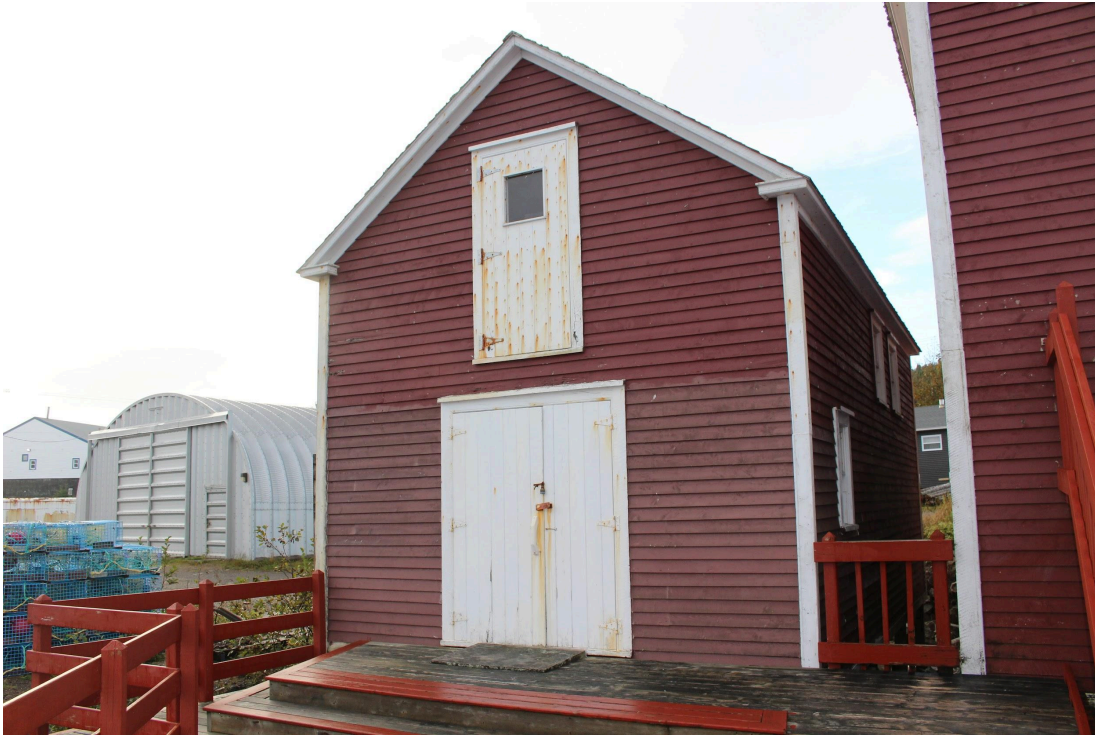
**Marine Interpretation Centre Building #3 / Cod Liver Oil Factory**  
TFII-005

***Marine Interpretation Center Building #3, Cod Liver Oil Factory, 2023. Front and side facade. Photo by Juliet Lanphear.***

The Marine Interpretation Centre Building #3 is also known as the “Cod Liver Oil Factory.” Fishers would process the cod livers harvested from their fish into cod liver oil by storing them in drums and selling the oil to merchants. The oil was boiled to render out waste in the cod liver oil factory before being stored in holding tanks to be sold.

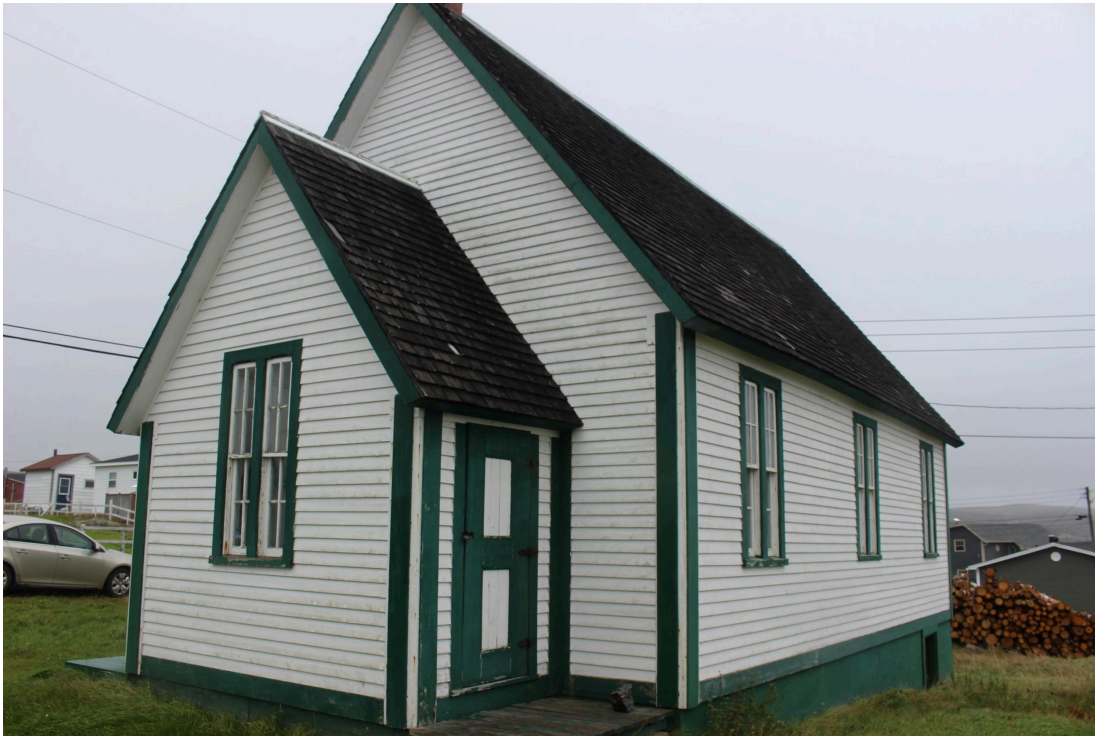
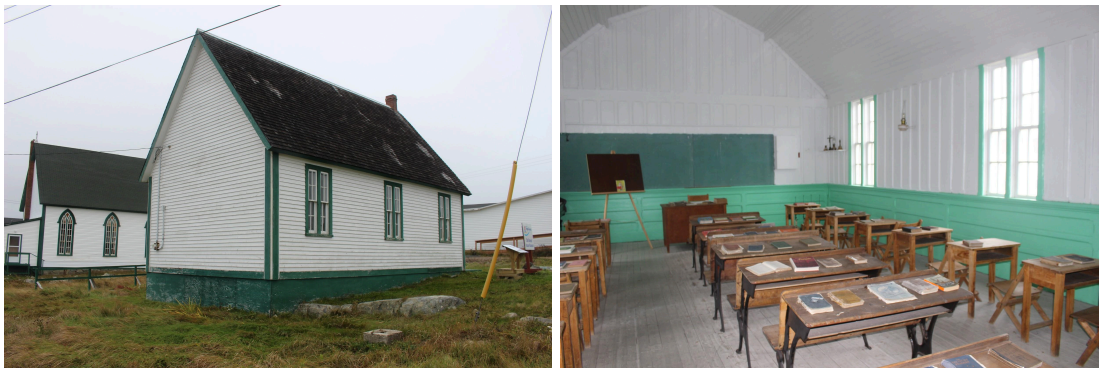
TFII-007

***Old Roman Catholic Schoolhouse, 2023. (Above) front and side facade,  
(bottom left) back and side facade, and (bottom right) interior of the schoolhouse.  
Photos by Juliet Lanphear.***

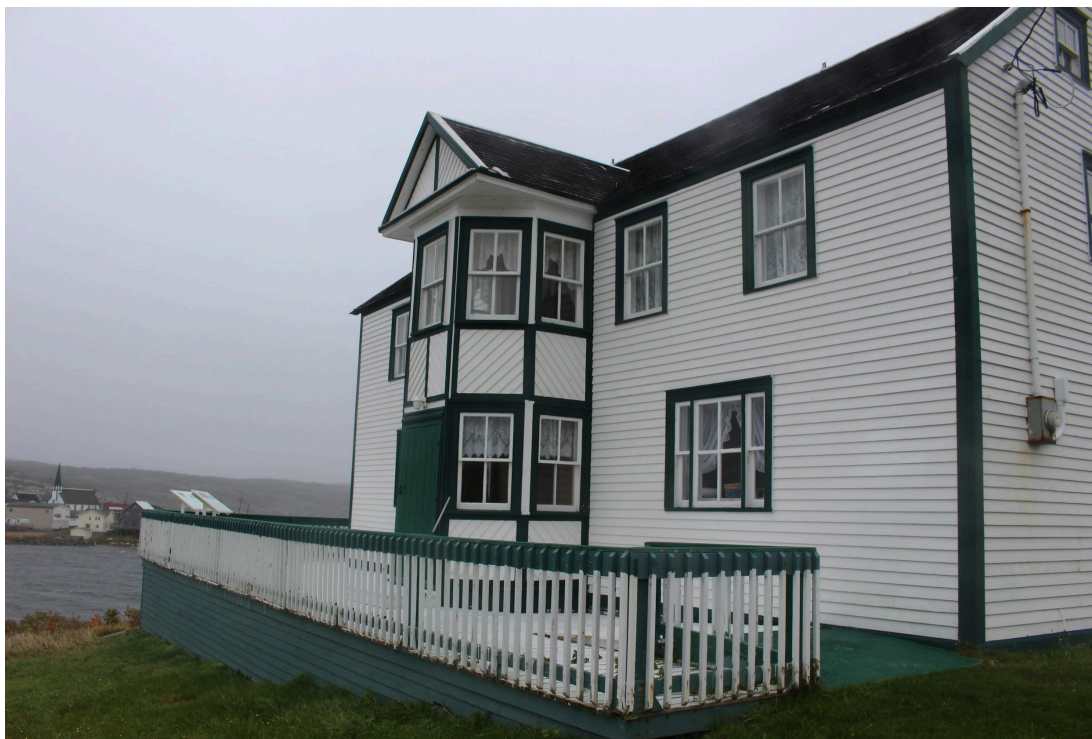
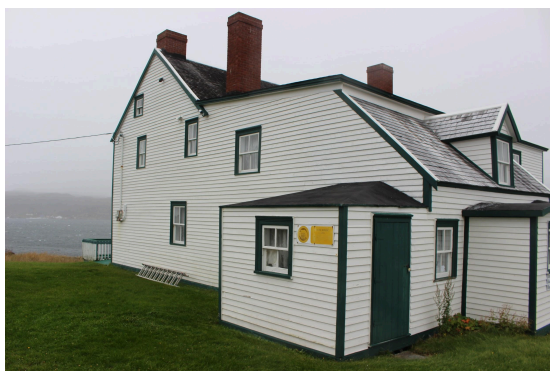
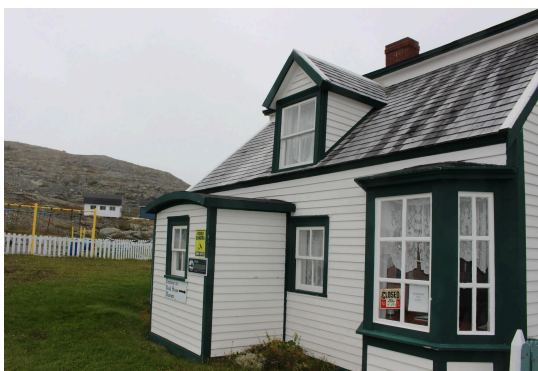
**Bleak House Registered Heritage Structure and Municipal Heritage Site  
TFII-009**

***Bleak House 2023. (Above) front and side facade, (bottom left) side and back facade, (bottom right) back facade. Photos by Juliet Lanphear.***

Located on a hilltop along North Shore Road in the community of Fogo, Bleak House is a prominent landmark in the community. The house is an example of 19th-century merchant housing in outport Newfoundland and was owned by important Fogo merchant families, beginning with the Slades of Poole, England. Elaborate architectural elements include a rear gabled dormer window, 2-storey centre bay window on the front façade with a pediment, and decorative use of wooden clapboard. Throughout its history, Bleak House has undergone

several alterations, including an addition in the rear of the building and the replacement of a front porch with a central tower with a bay window and pediment.

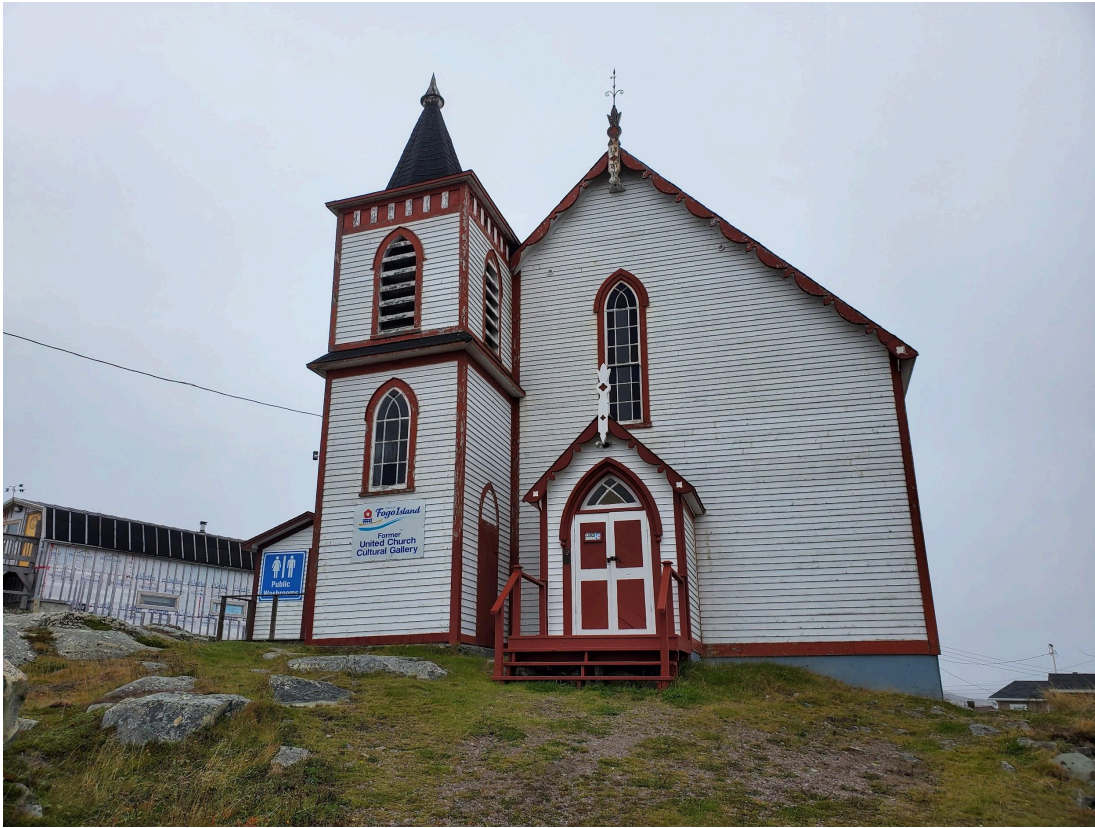
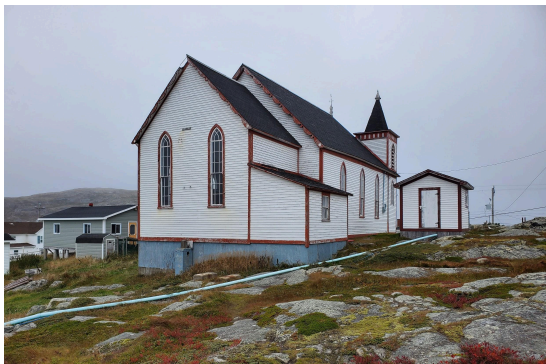
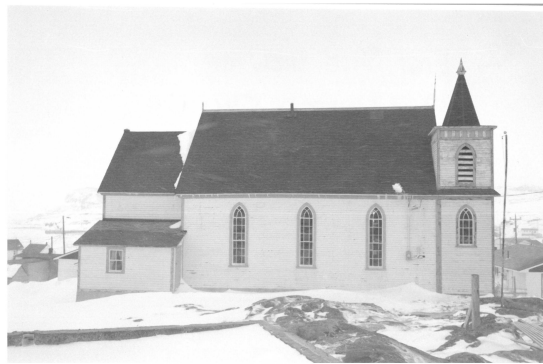
TFII-011

***Fogo United Church, 2023. (Above) front facade, (bottom left) back and side facade. Photos by Juliet Lanphear. (Bottom right) historical photo, post-1948, source unknown.***

Fogo United Church is an outpost interpretation of the Gothic Revival architectural style, its steep pitched gable roof is accentuated with ornate bargeboard finials, placed on the front gable peaks. The Gothic arch windows have curved muntins and stained glass. The small transom window and moulded trim over the main door add definition to the front facade. The louvered bell tower, a later addition in 1948, is capped with a steep turret and finial. Prior to 1948, the bell was housed in an external bell house or campanile.

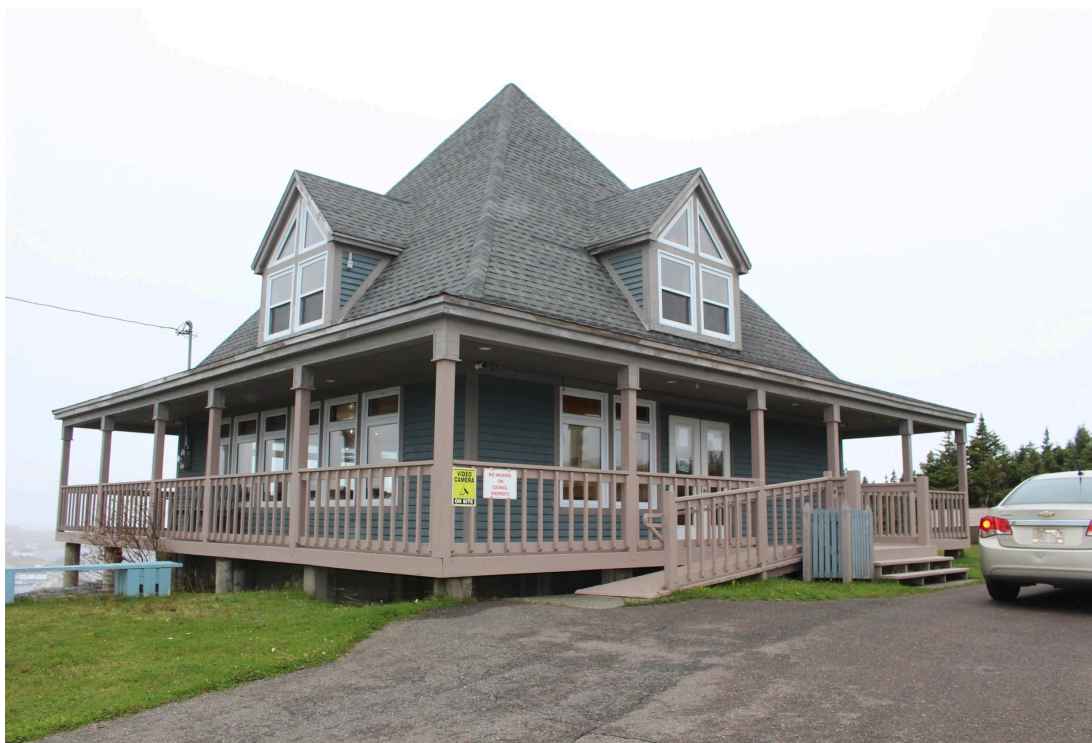
TFII-012

***Marconi Wireless Interpretation Center, 2023. Front and side facade. Photo by Juliet Lanphear.***

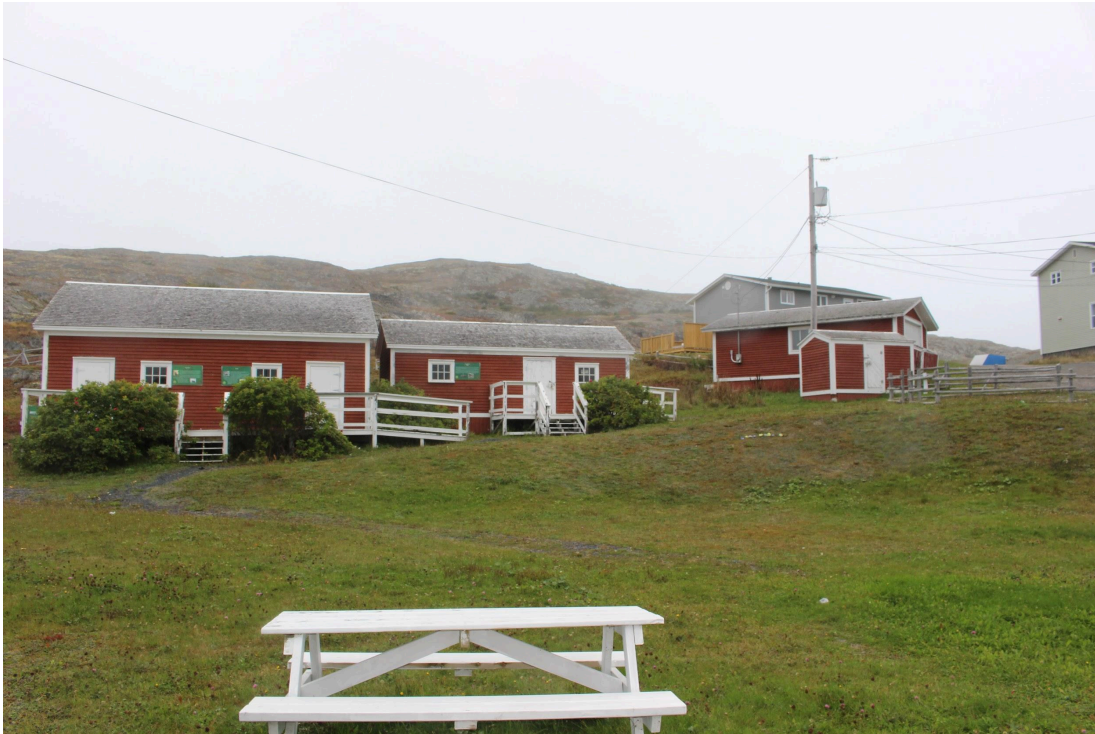
TFII-014-017

***Experience Fogo Site, 2023. Buildings from left to right: TFII-014 (Building #1 Trap Store and Stable), TFII-015 (Building #2 Carpenter's Shop), and TFII-016 (Building #3).***

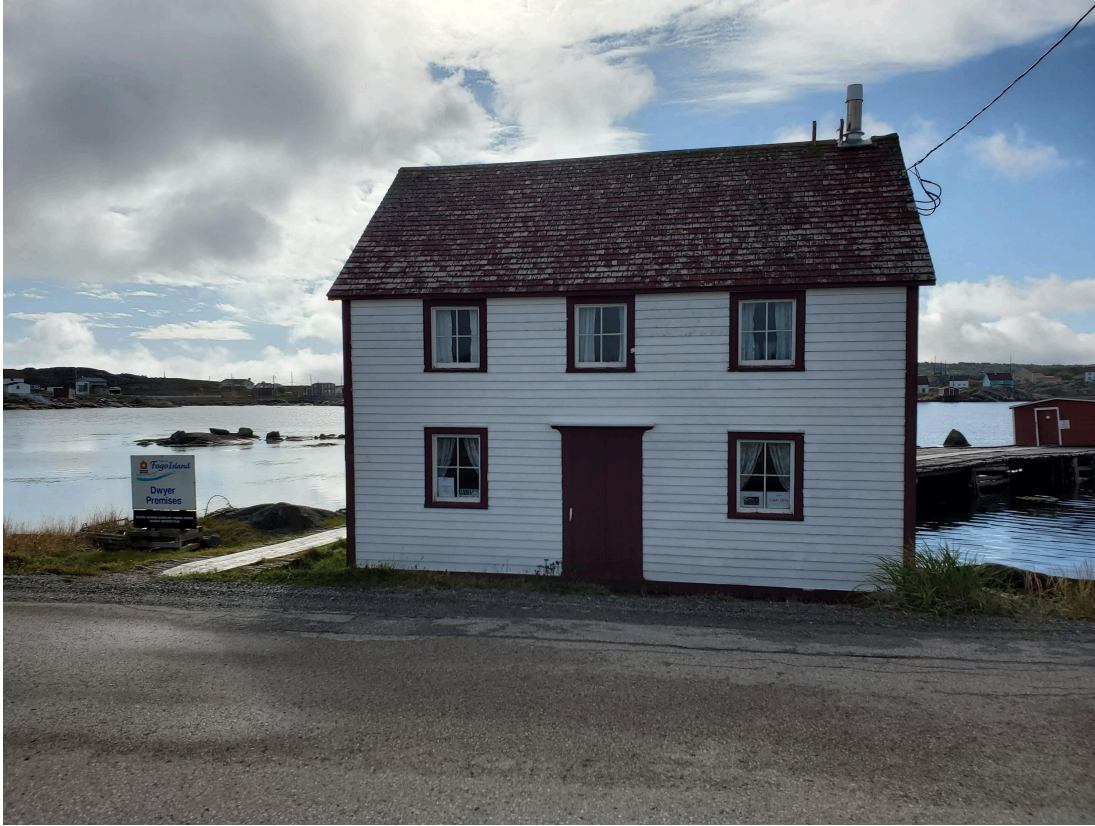
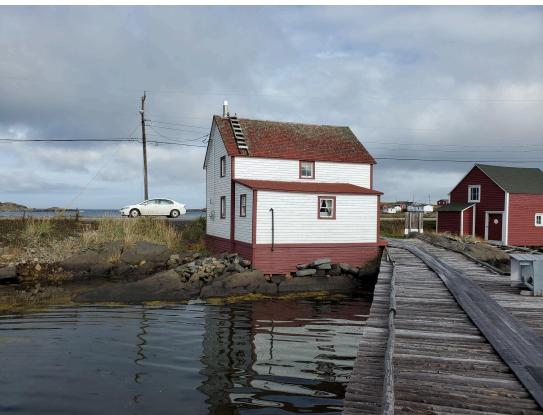
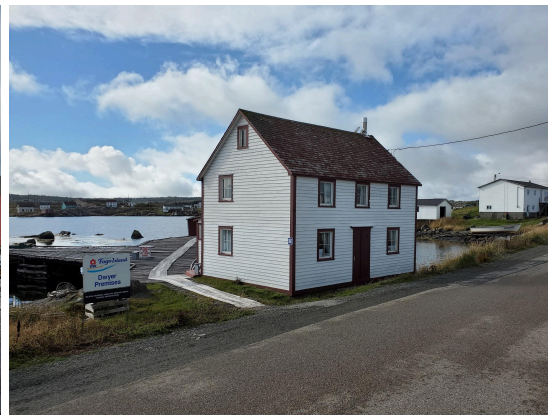
## Dwyer Premises TFII-025

**Dwyer Premises, 2023. (Above) Dwyer House front facade, (bottom left) rear and side facade from wharf, (bottom right) front and side facade. Photos by Juliet Lanphear.**

Located on the eastern side of the harbour at 143 Main Street in Tilting, the Dwyer Premises consists of a house, store, flakes, shed, and a stage. The house was built by Vincent Bryan between 1890-1900 and was later purchased by Albert Dwyer in 1925. The layout is typical of Tilting's centre hall-type plan.

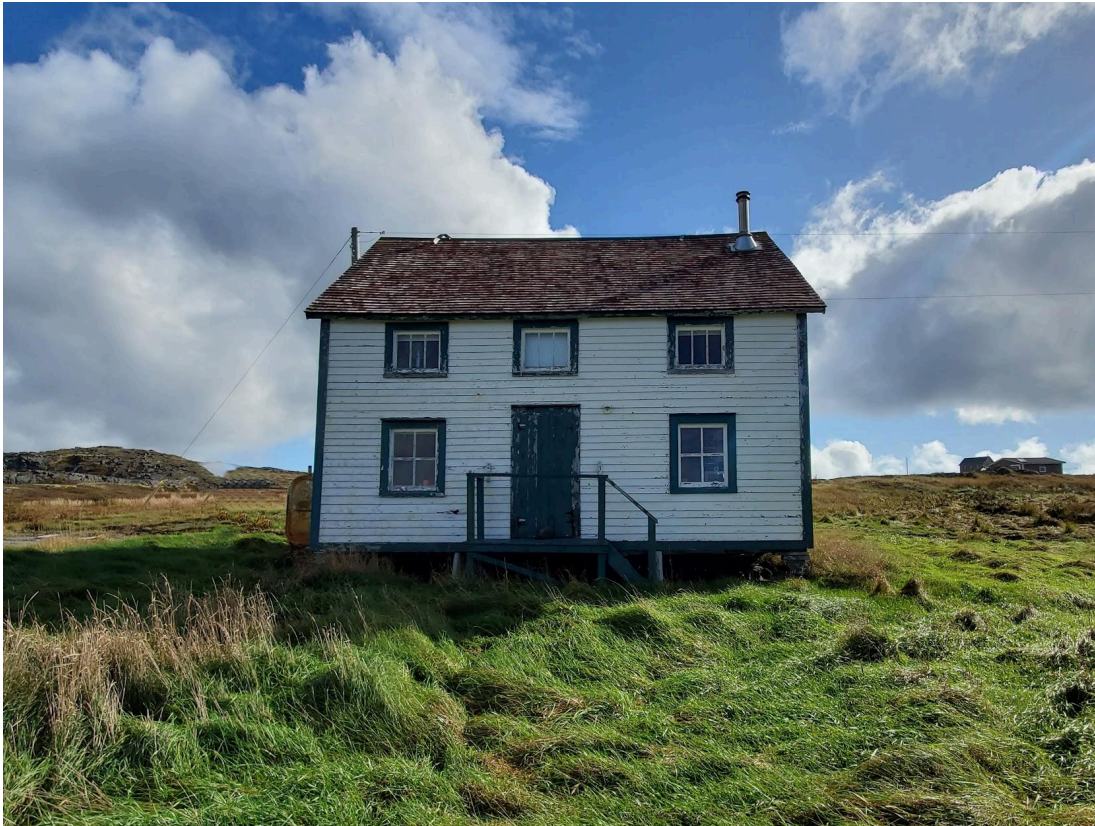
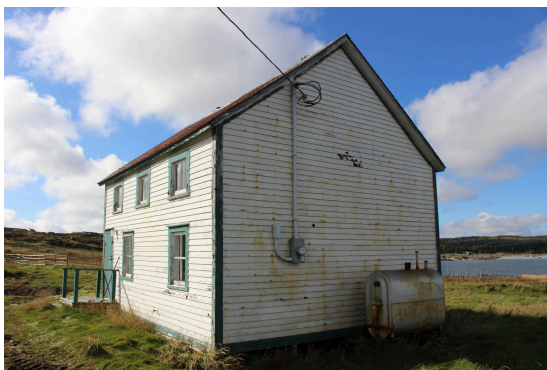
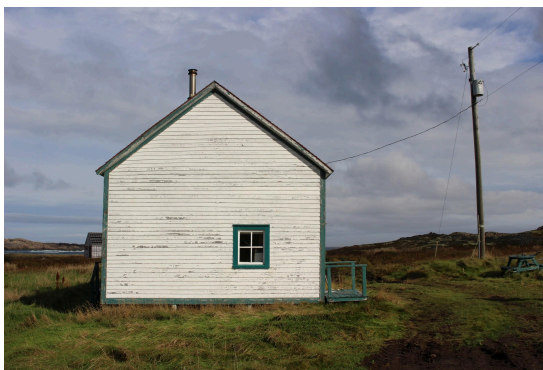
**Reardon House**  
TFII-026

***Reardon House, 2023. (Above) front facade, (bottom left) rear and side facade, (bottom right) side facade. Photos by Juliet Lanphear.***

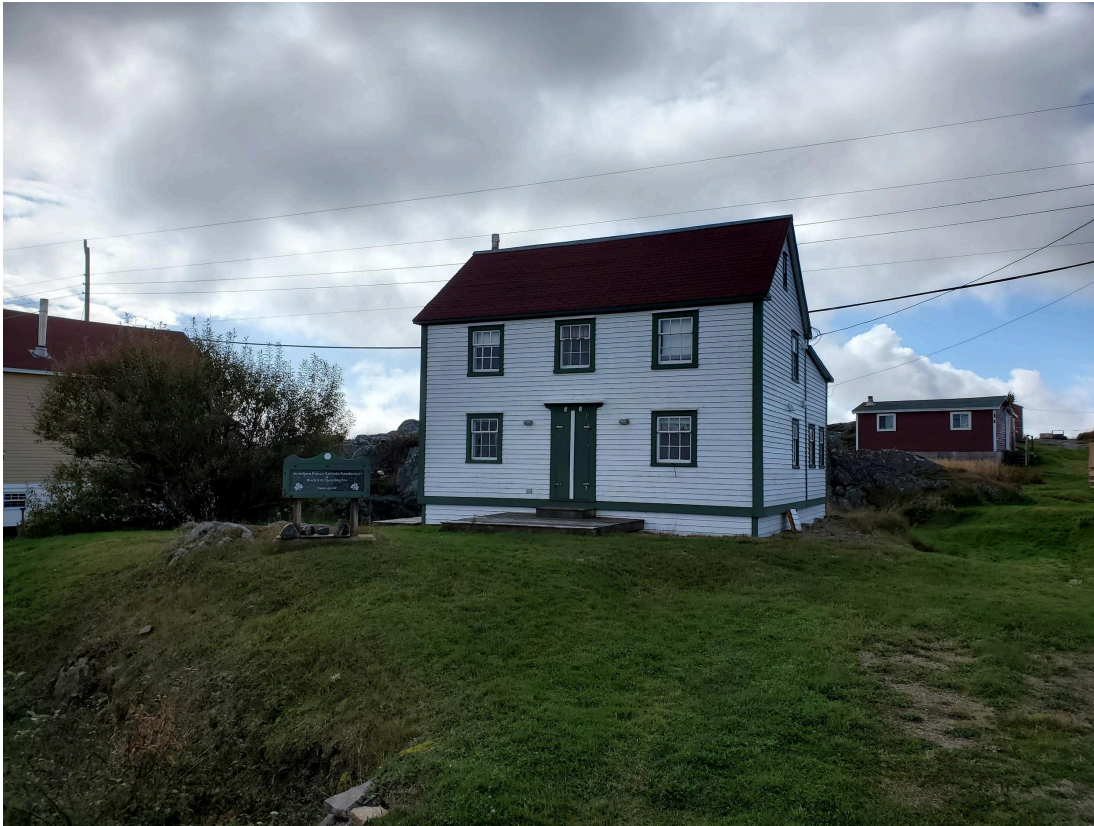
TFII-027

*Jenny Keefe Studio, 2023. Front and side facade. Photo by Juliet Lanphear.*

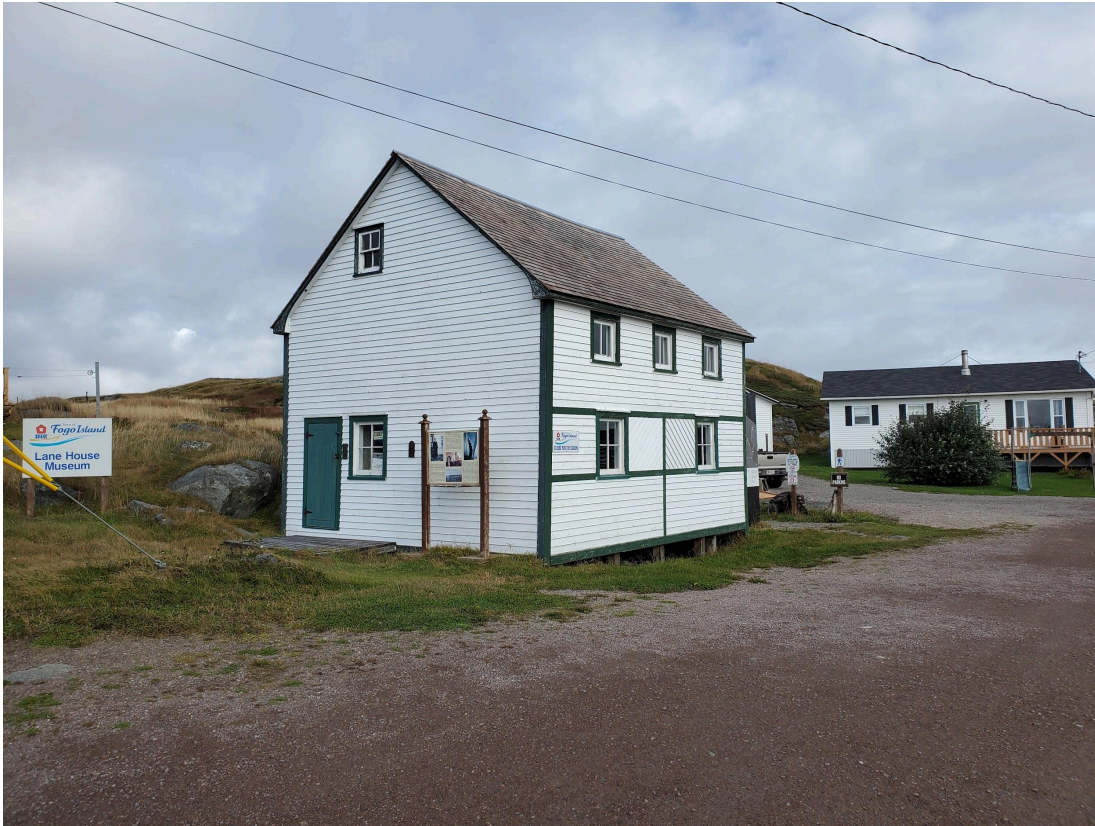
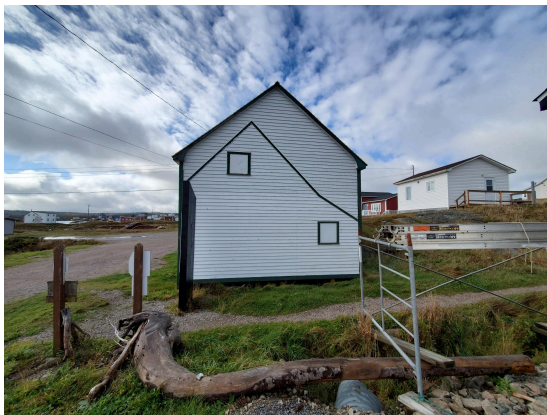
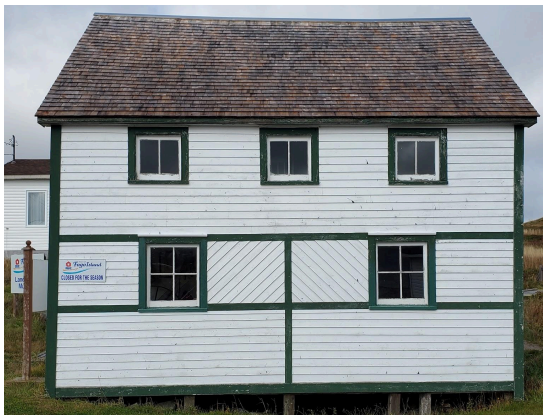
TFII-028

***Lane House, 2023. (Above) front and side facade, (bottom left) side facade with trim outlining the original roof line, (bottom right) close up of front facade showing diagonal clapboard. Photos by Juliet Lanphear.***

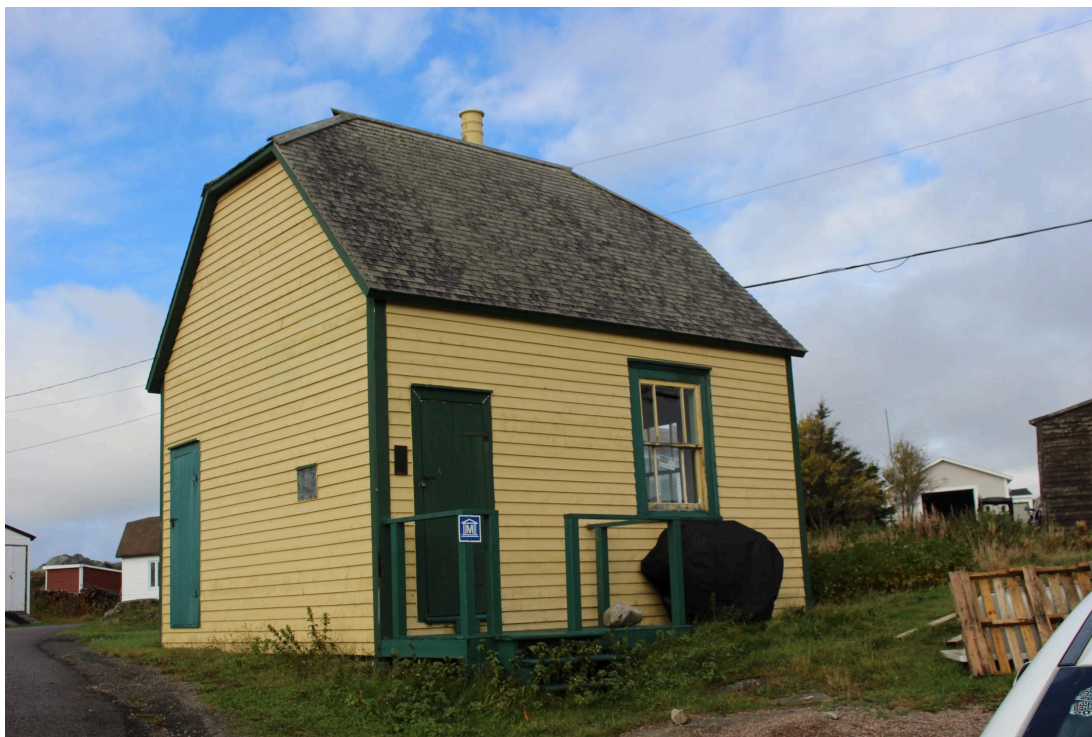
TFII-029

*Old Post Office, 2023. Front and side facade. Photo by Juliet Lanphear.*

The Old Post Office in Tilting is located at Post Office Lane. Construction on the Old Post office began in 1907 and was completed the following year. It is a small building with a partial hip roof. It had a small waiting room, a storage room for coal, and an office.

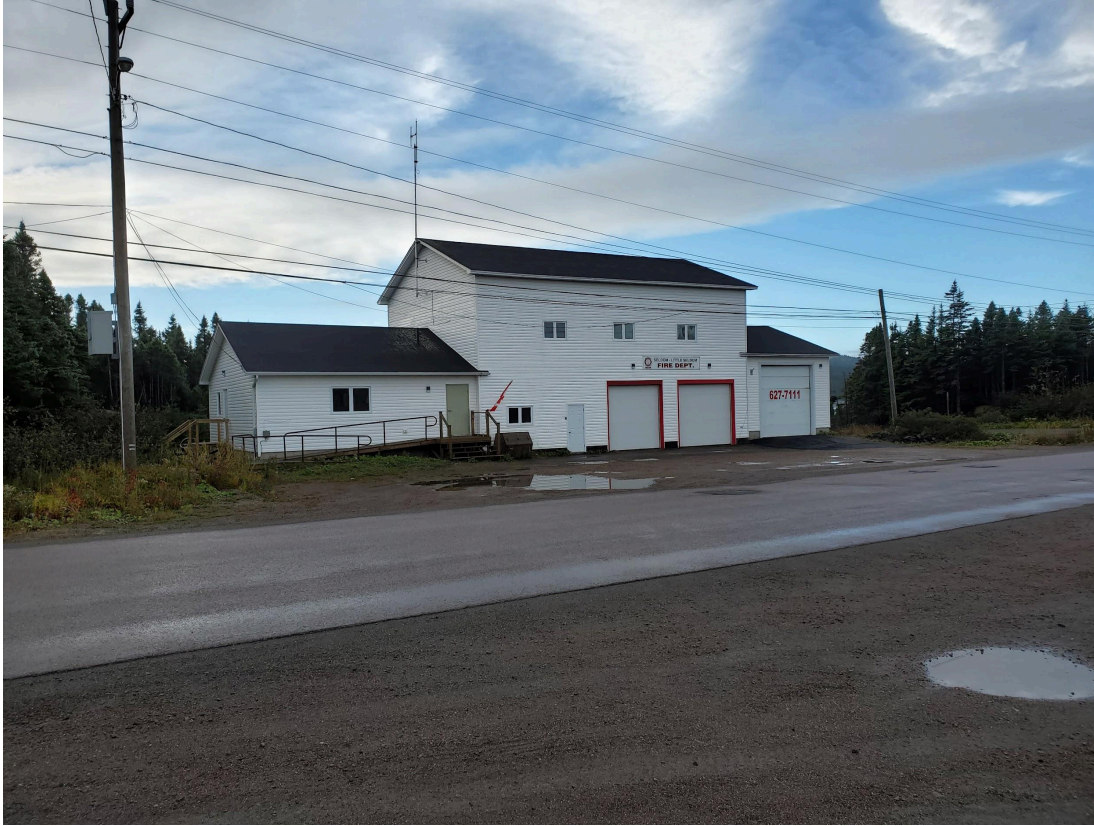
TFII-001

*Seldom Fire Hall, 2023. Front Facade. Photo by Juliet Lanphear.*

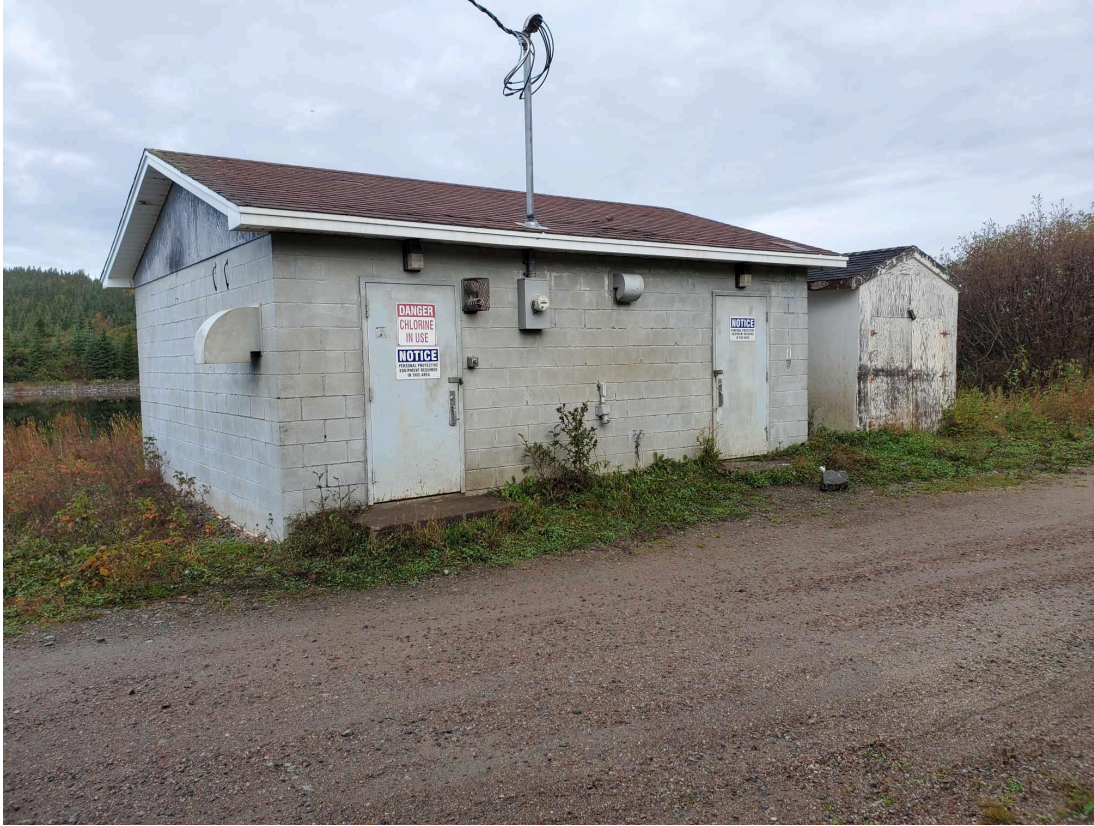
TFII-002

*Seldom Pump House, 2023. Front and side facade. Photo by Juliet Lanphear.*

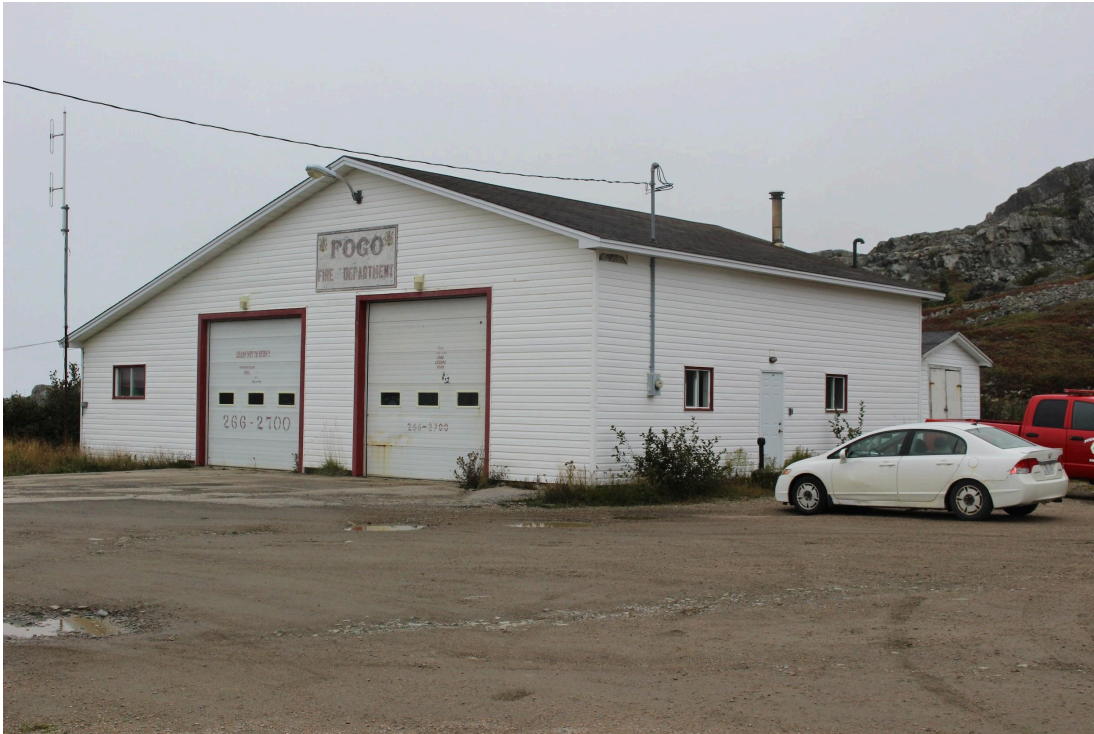
**Fogo Fire Hall**  
TFII-006

*Fogo Fire Hall, 2023. Front and side facade. Photo by Juliet Lanphear.*

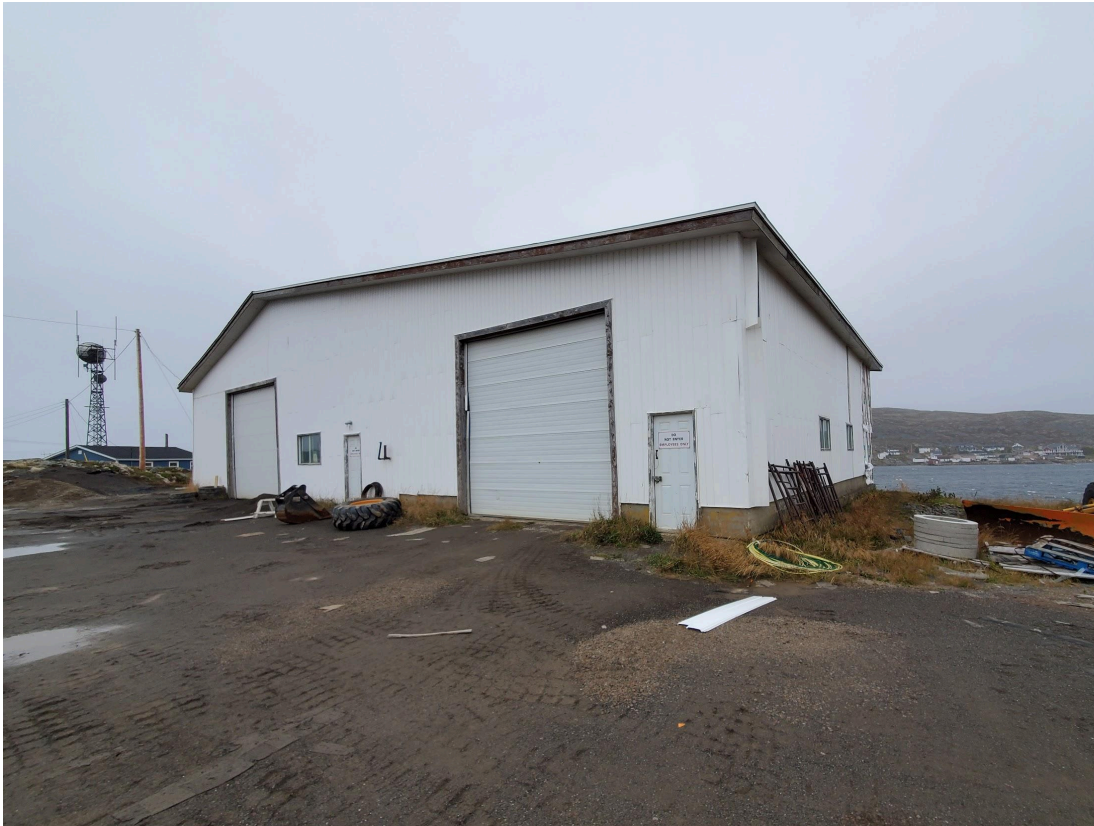
**Fogo Town Garage**  
TFII-008

*Fogo Town Garage, 2023. Front Facade. Photo by Juliet Lanphear.*

| Exterior Sheathing | Vinyl (poor condition) |

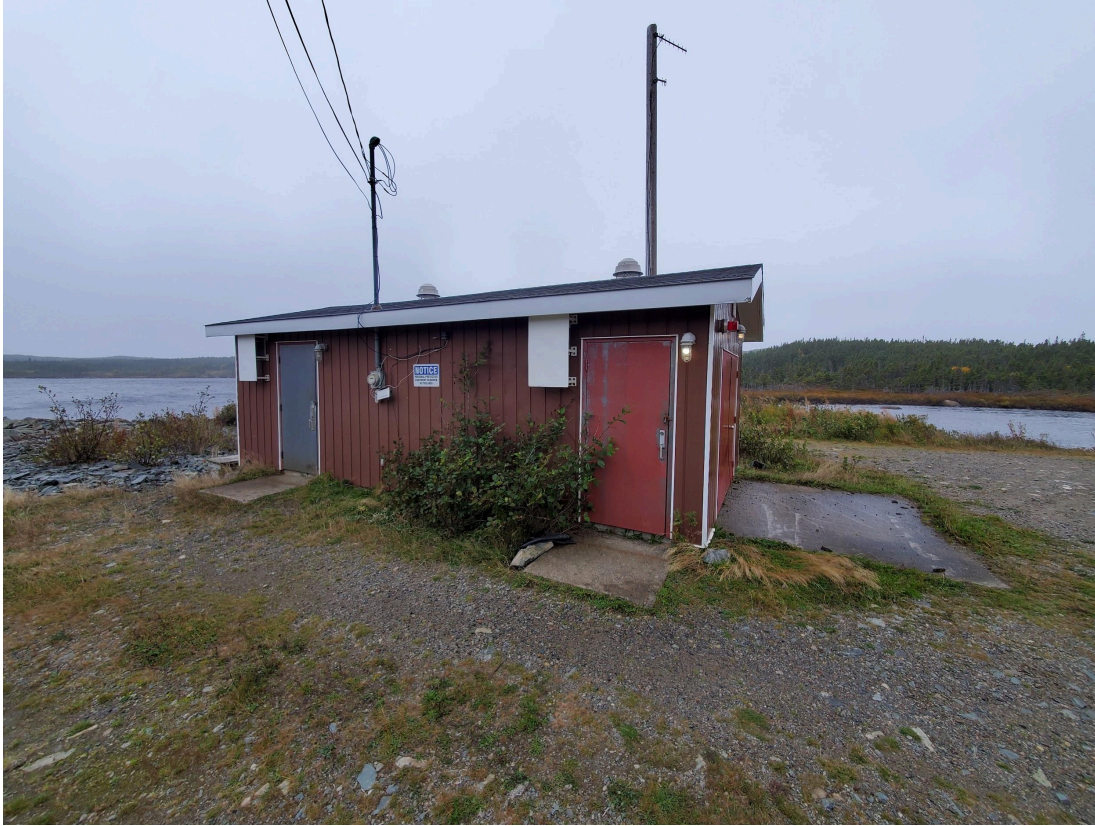
**Fogo Water Chlorination Building**  
TFII-010

***Fogo Water Chlorination Building, 2023. Side Facade. Photo by Juliet Lanphear.***

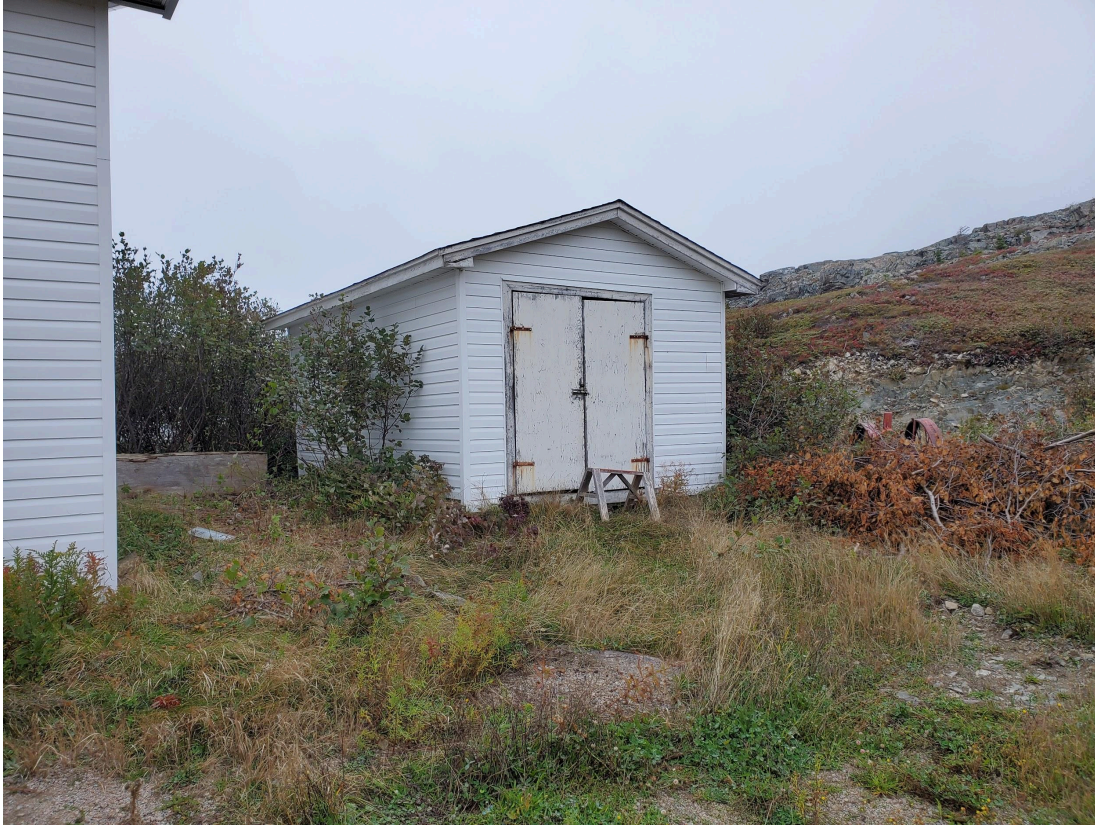
TFII-013

*Fogo Shed, 2023. Front and side facade. Photo by Juliet Lanphear.*

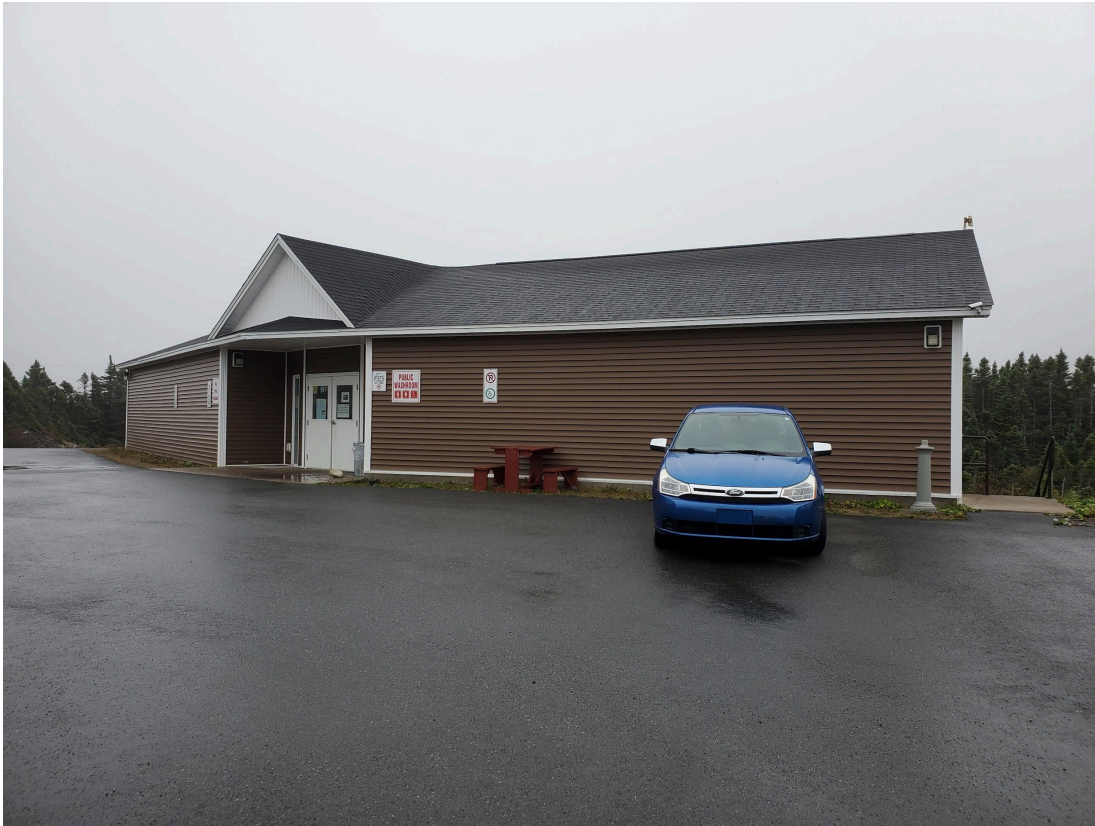
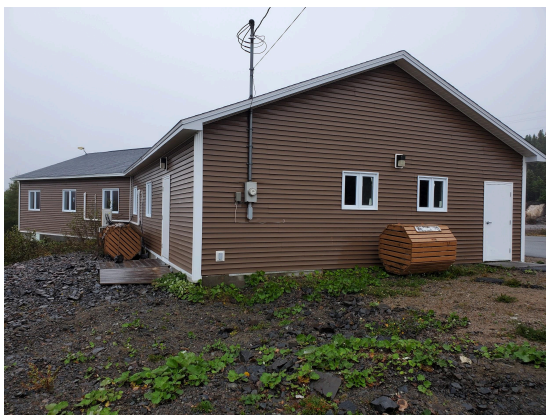
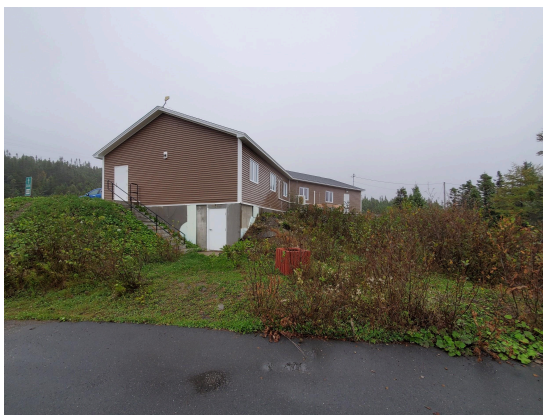
**Visitors Information Centre**  
TFII-018

***Visitors Information Center, 2023. (Above) front facade, (bottom left) side and rear facade, (bottom right) side and rear facade. Photo by Juliet Lanphear.***

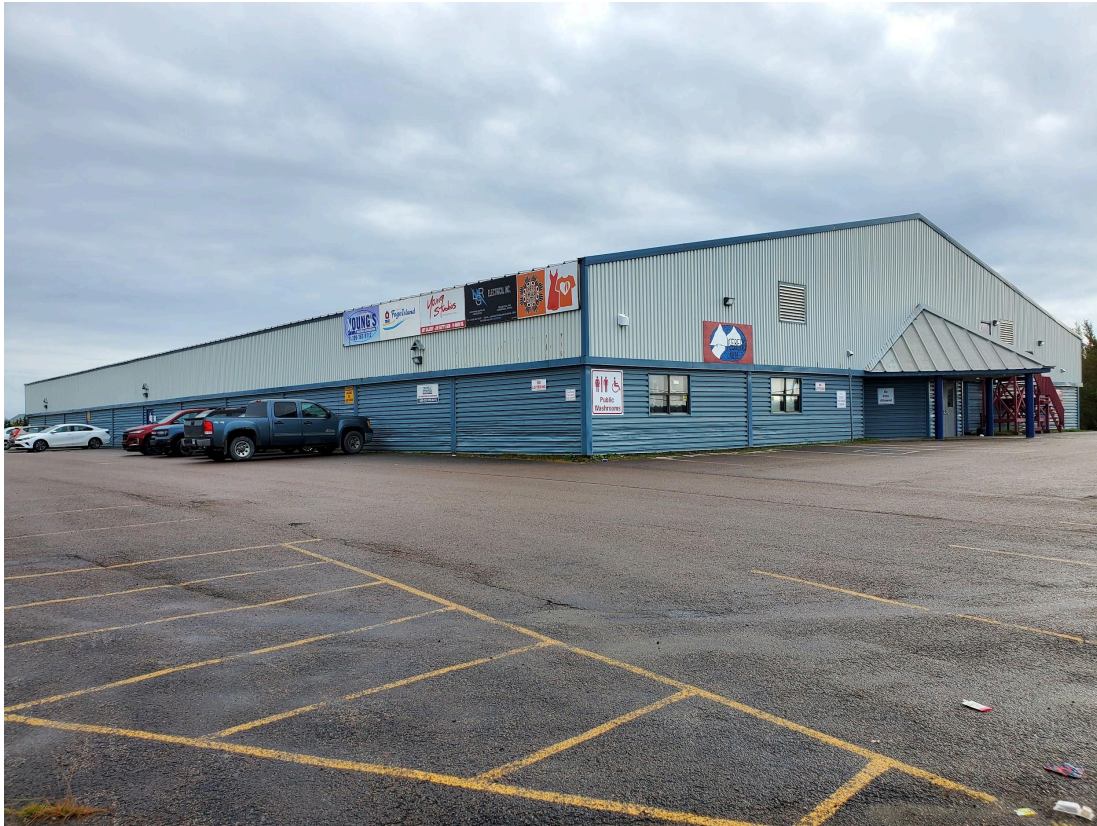
TFII-019

***Stadium, 2023. Front and side facade. Photo by Juliet Lanphear.***
