TOWN OF FOGO ISLAND PROPERTIES

# ARCHITECTURAL INVENTORY

# Architectural Inventory – Fogo Island Town Buildings

This project was undertaken to provide the Town of Fogo Island with an architectural inventory of all the buildings owned by the town. When the Town of Fogo Island was created in 2011, with the amalgamation of 4 previous towns and a regional council, the new Town of Fogo Island inherited over 40 buildings. The ones currently owned by the town are included in this survey.

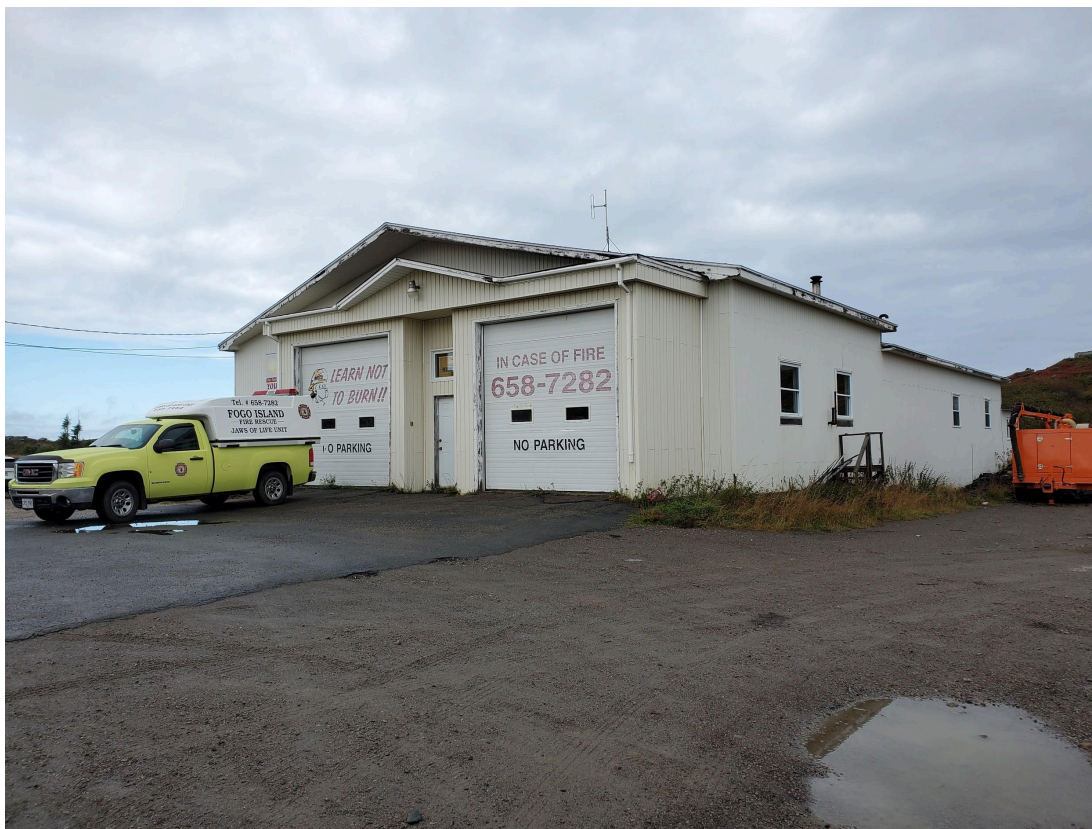
TFII-020

*Joe Batt's Arm Community Hall / Fire Hall, 2023. Front and side facade. Photo by Juliet Lanphear.*

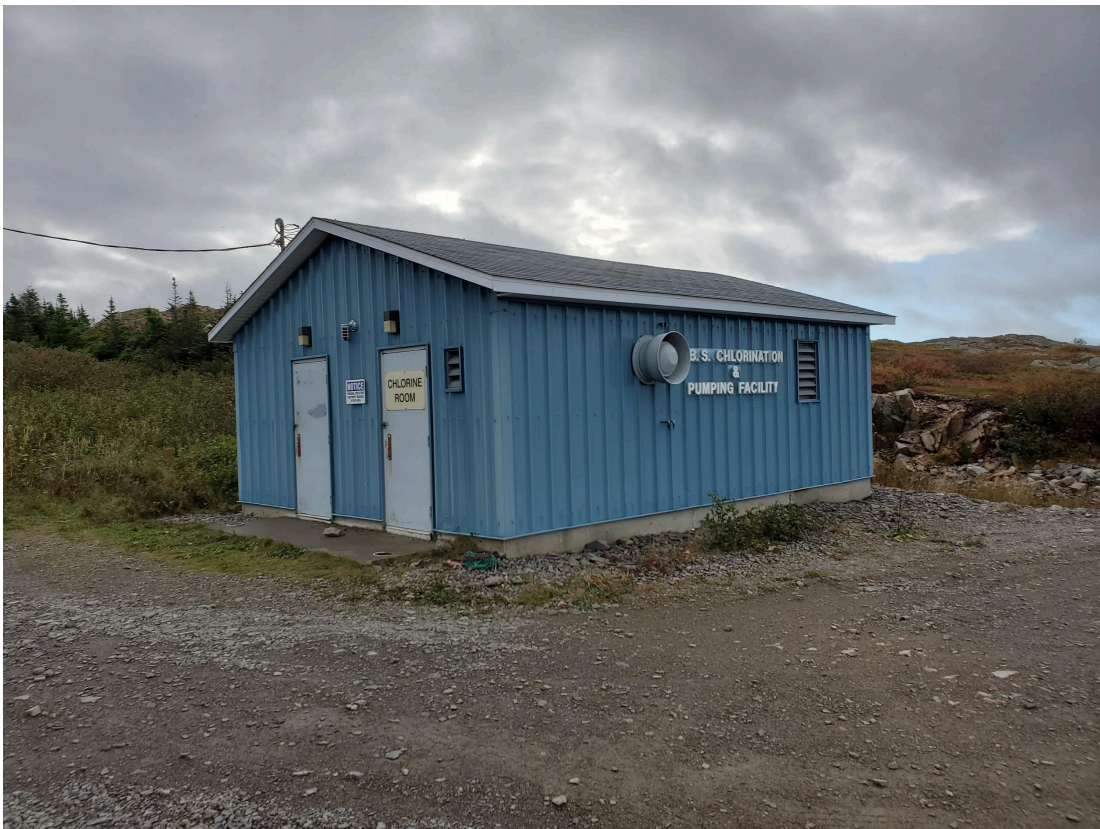
**Joe Batt's Arm Pump House**  
TFII-021

*Joe Batt’s Arm Pump House, 2023. Front and side facade. Photo by Juliet Lanphear.*

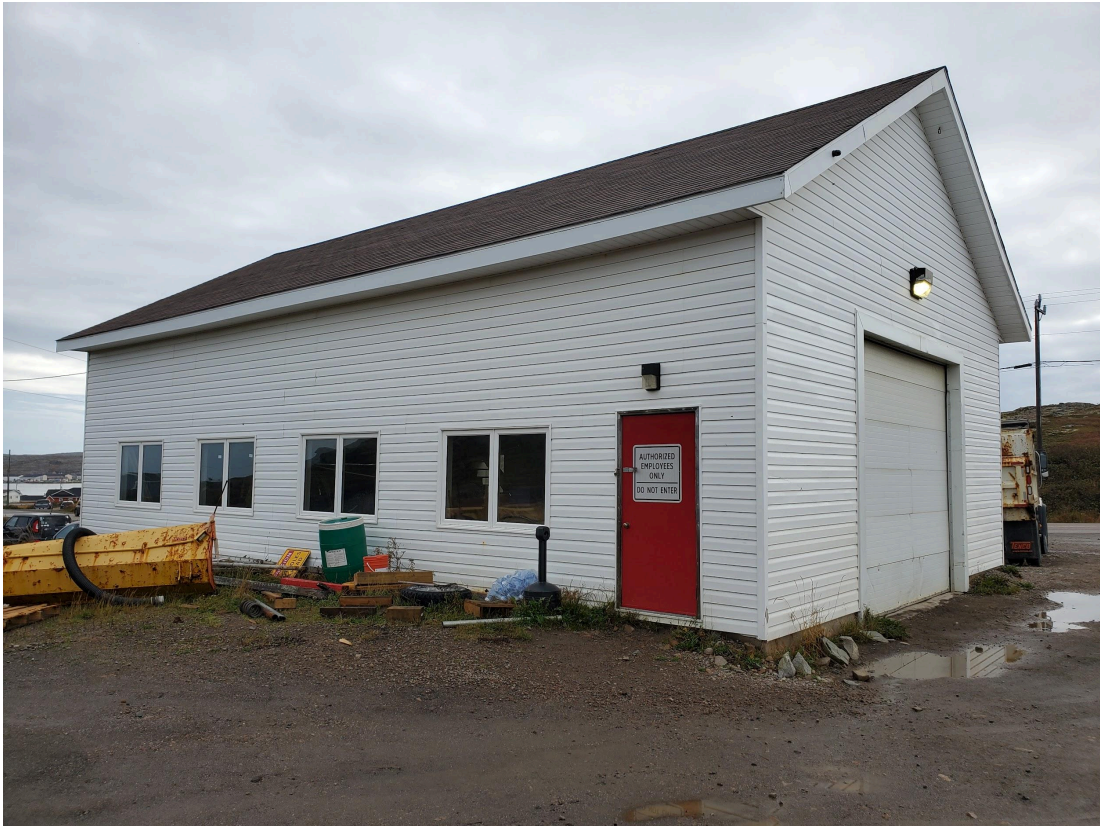
**Joe Batt’s Arm Town Garage**  
**TFII-023**

*Joe Batt’s Arm Town Garage, 2023. Rear and Side Facade. Photo by Juliet Lanphear.*

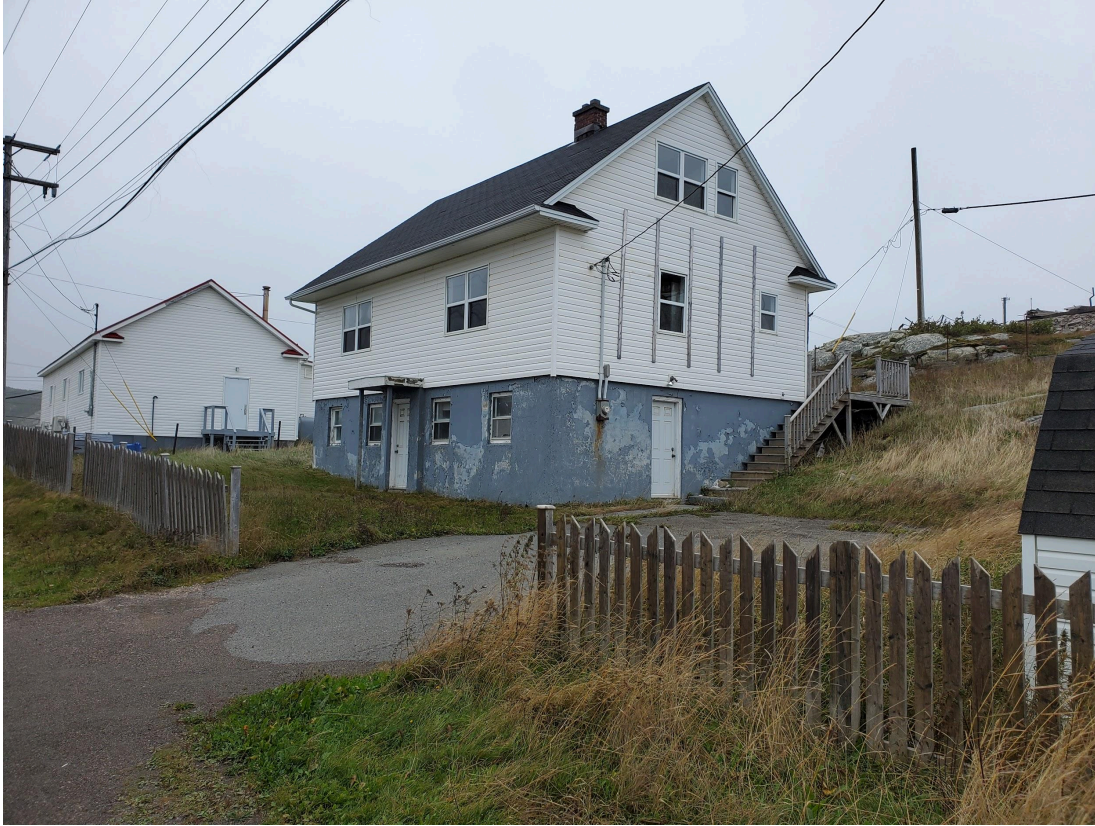
TFII-030

***RCMP House, 2023. Front Facade. Photo by Juliet Lanphear.***

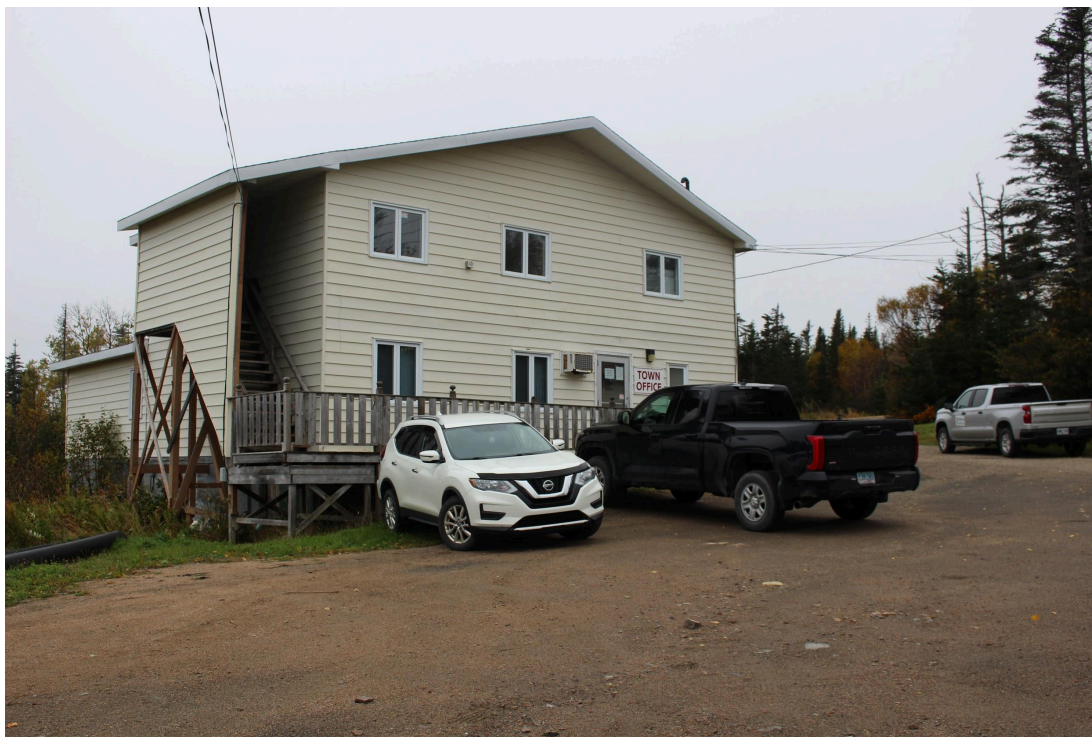
**Town Office**  
TFII-031

*Town Office, 2023. Front Facade. Photo by Juliet Lanphear.*

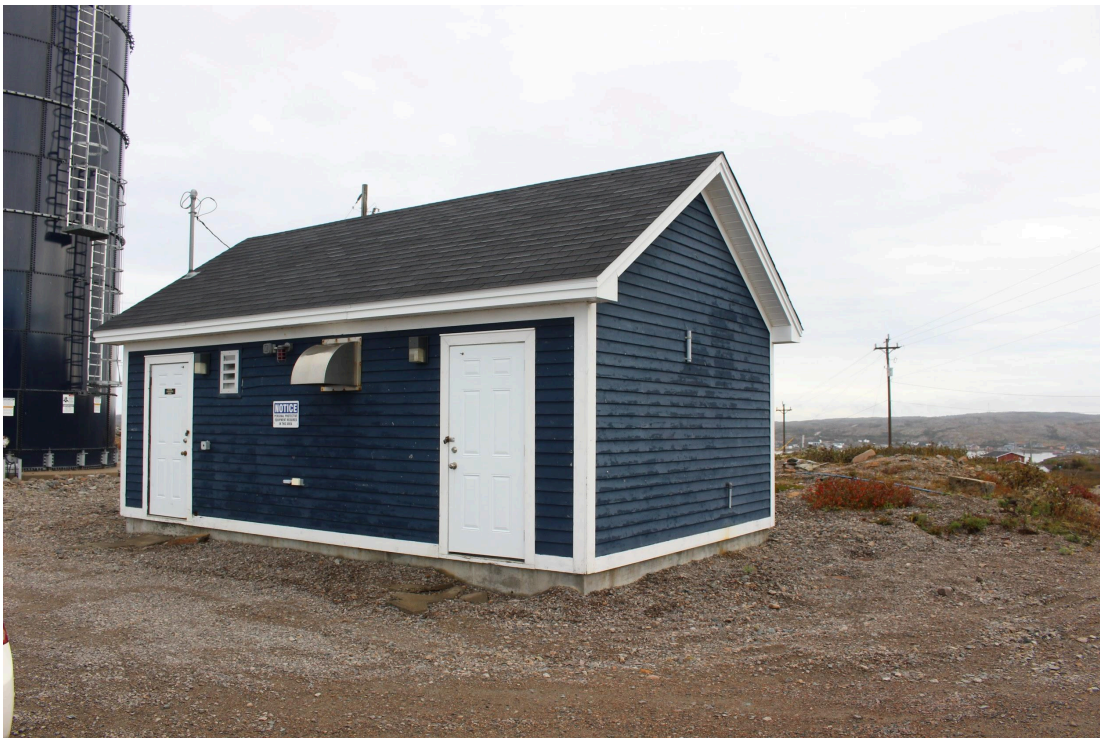
**Joe Batt’s Arm Chlorine Building**  
TFII-032

*Joe Batt’s Arm Chlorine Building, 2023. Front and side facade. Photo by Juliet Lanphear.*

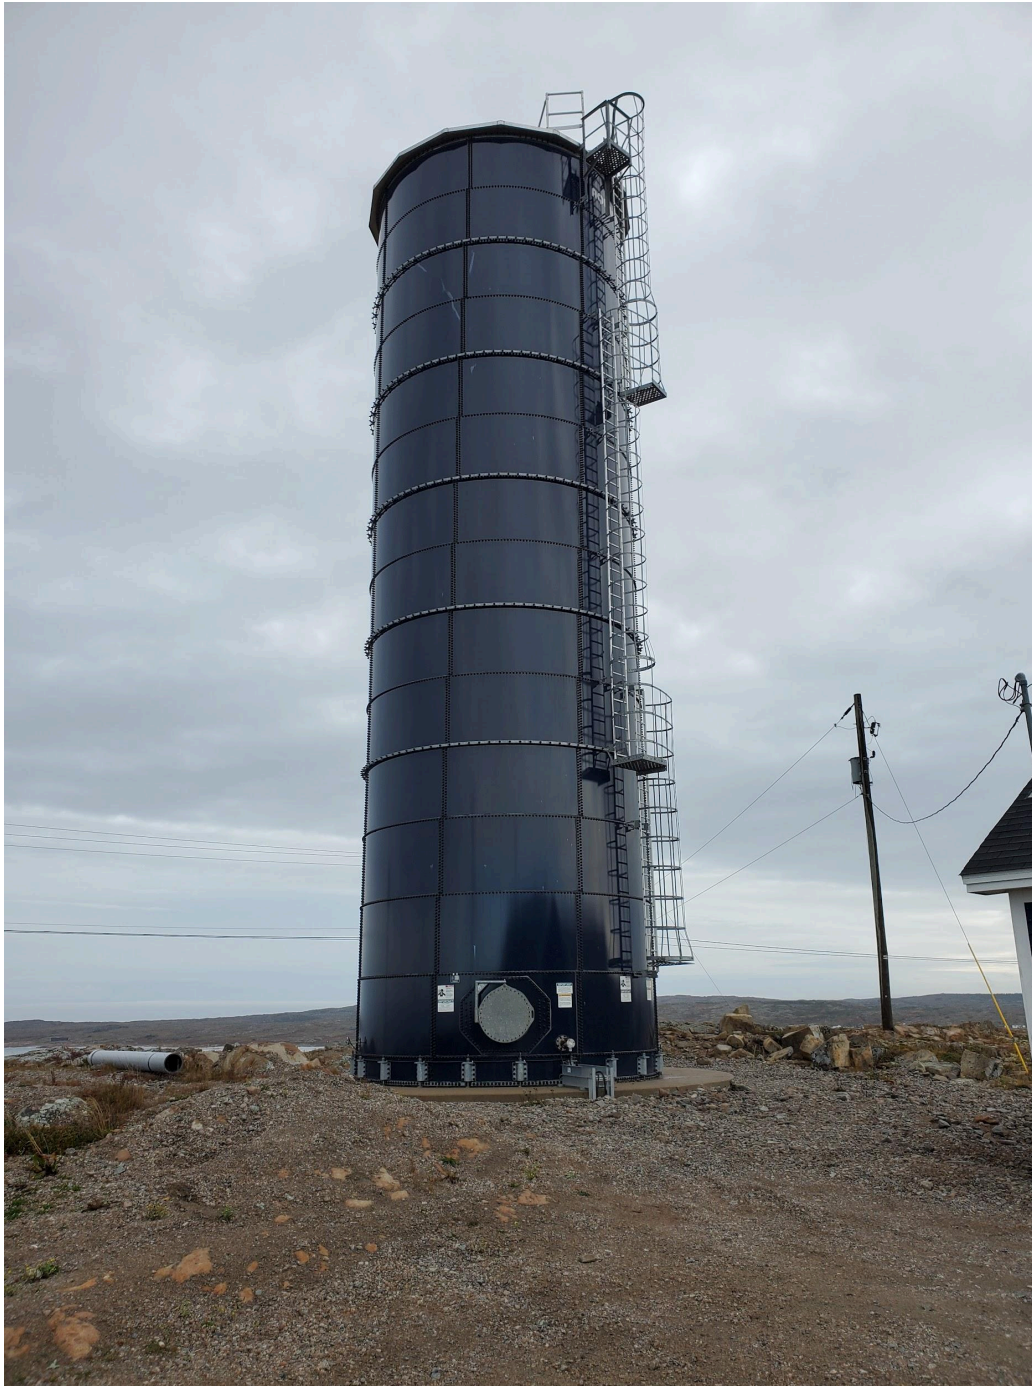
**Joe Batt's Arm Water Tower**  
TFII-033

*Joe Batt's Arm Water Tower, 2023. Front facade. Photo by Juliet Lanphear.*

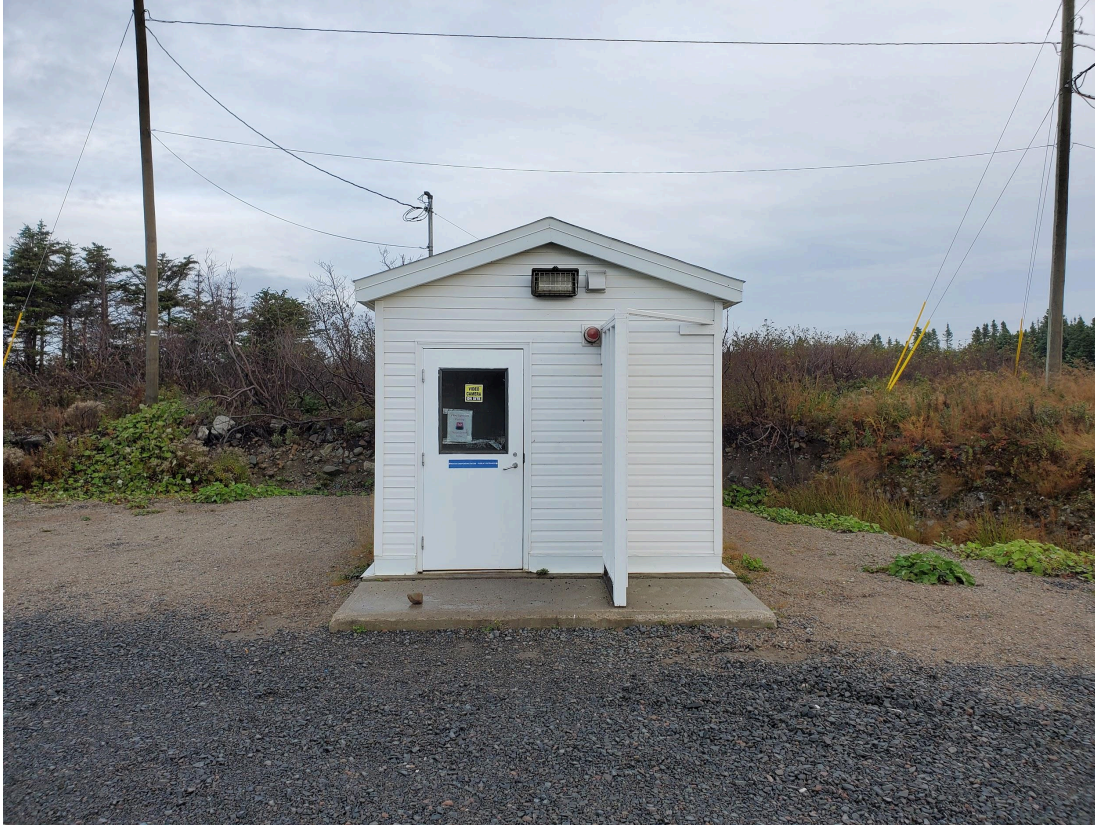
TFII-034

*Seldom Chlorine Booster Station, 2023. Front Facade. Photo by Juliet Lanphear.*

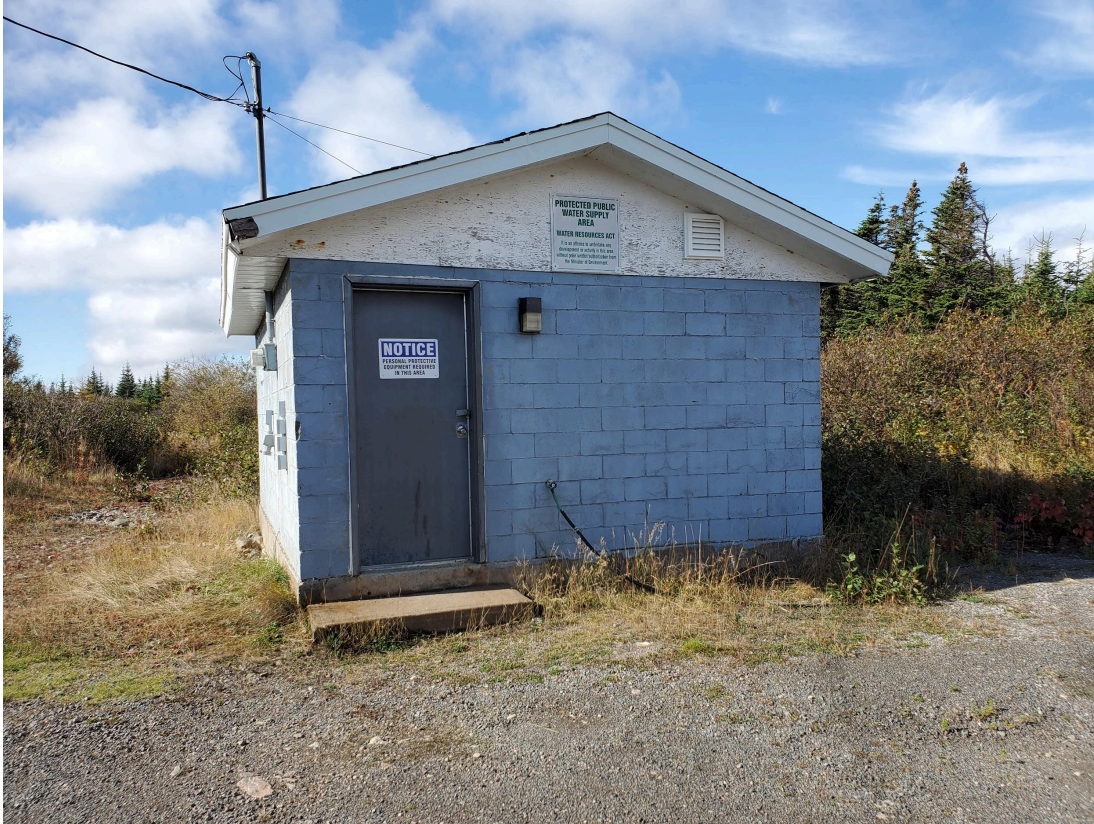
TFII-035

*Tilting Pump House, 2023. Front Facade. Photo by Juliet Lanphear.*

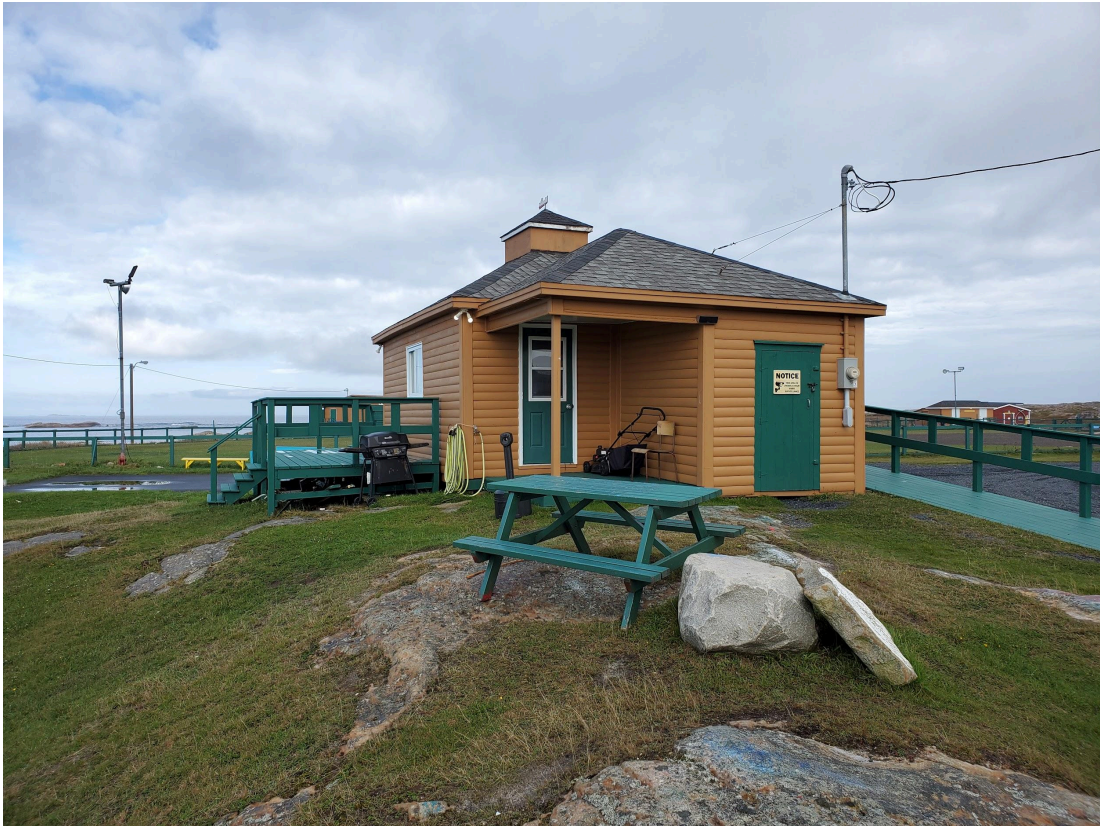
**Etheridge’s Point Festival Grounds**  
**TFII-036**

*Etheridge’s Point kitchen, 2023. Front and side facade. Photo by Juliet Lanphear.*

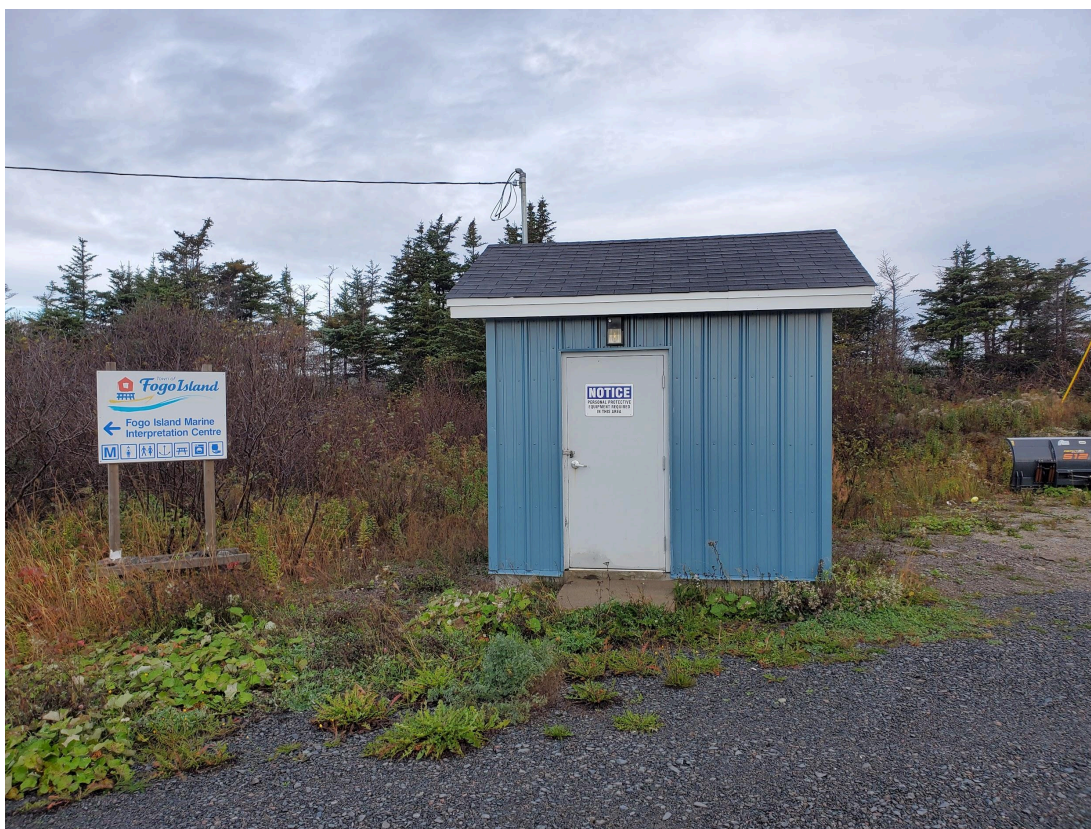
**Seldom Advanced Drink Water System Building****TFII-037**

*(TFII037-01) Front Facade 2023. Photo by Juliet Lanphear.*

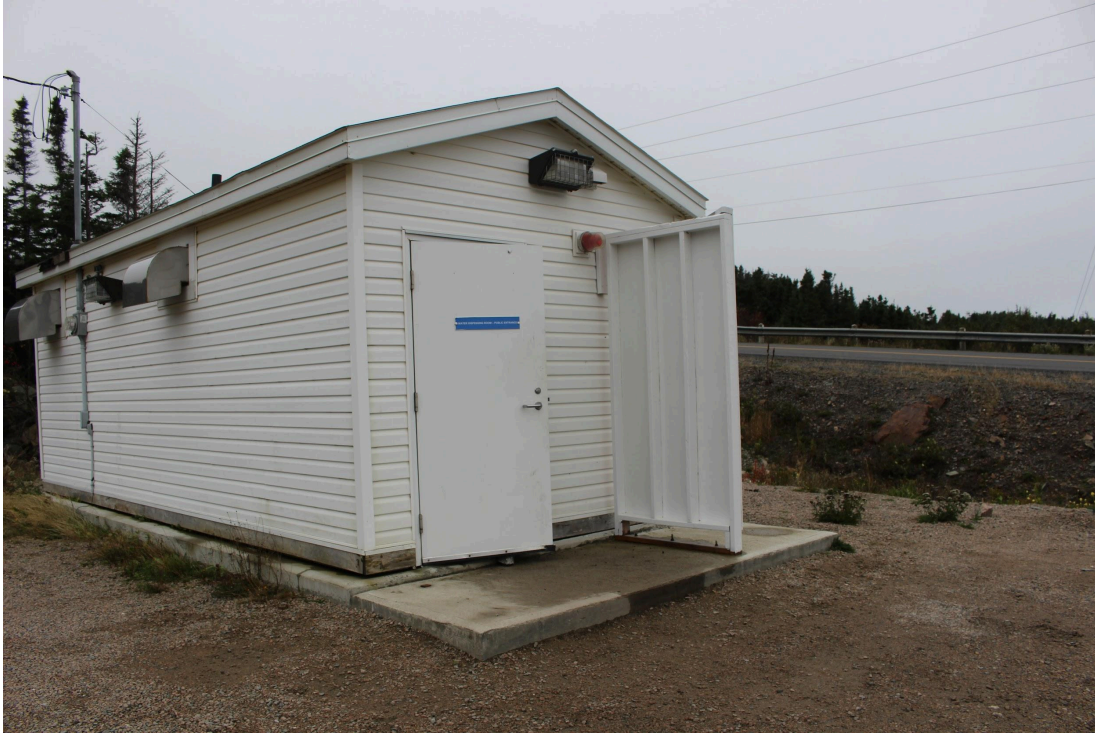
TFII-038

*Fogo Advanced Drink Water System Building, 2023. Front and side facade.  
Photo by Juliet Lanphear.*

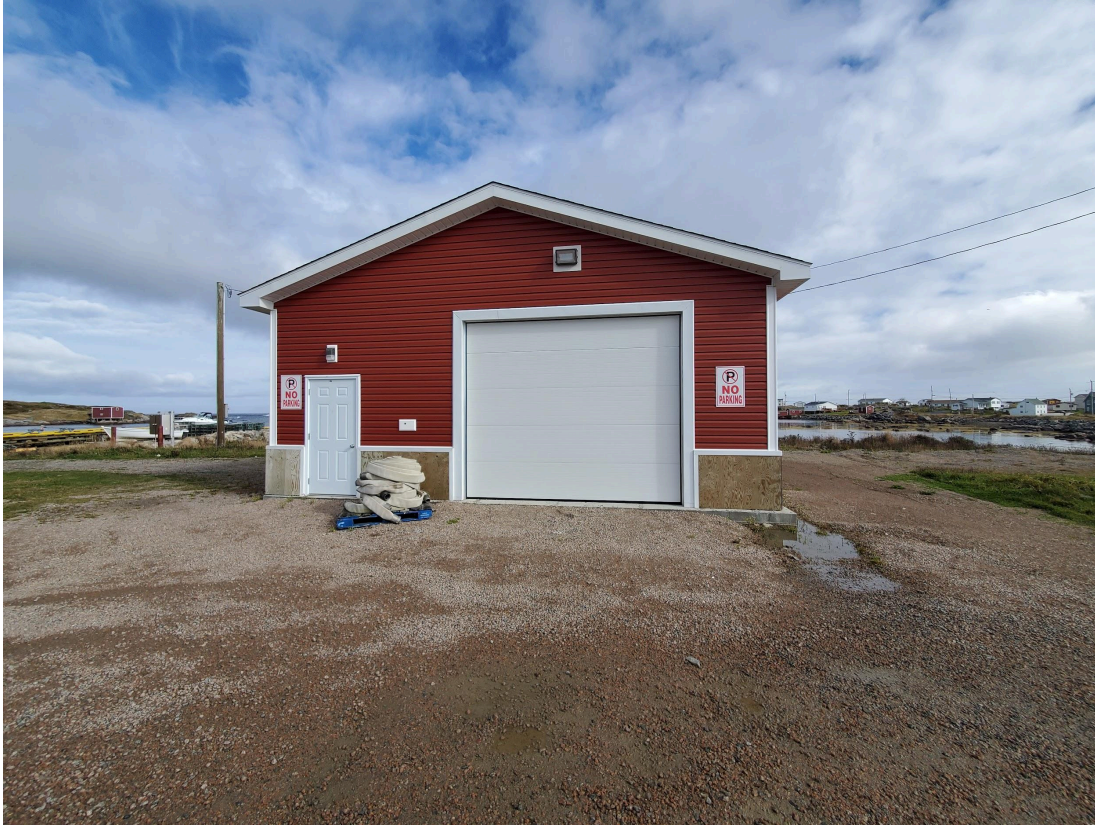
TFII-039

*Tilting Fire Shed, 2023. Front facade. Photo by Juliet Lanphear.*

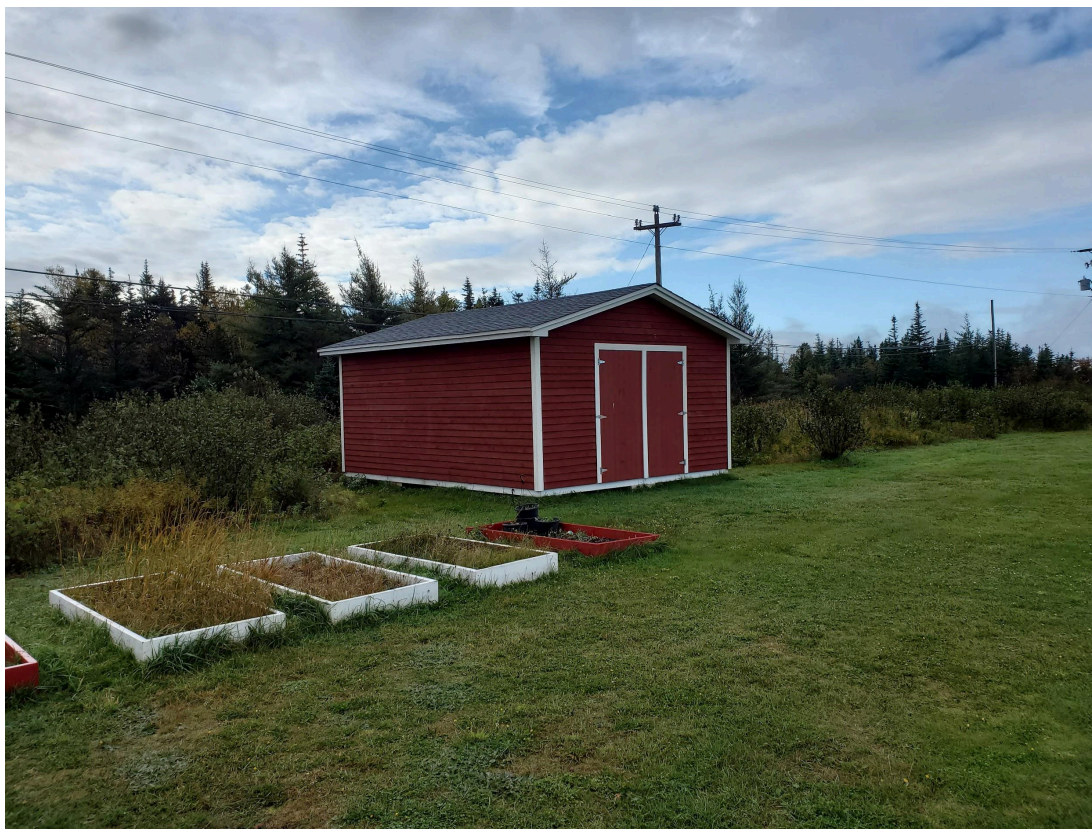
TFII-040

***Stage Shed by Stadium, 2023. Front and Side Facade. Photo by Juliet Lanphear.***

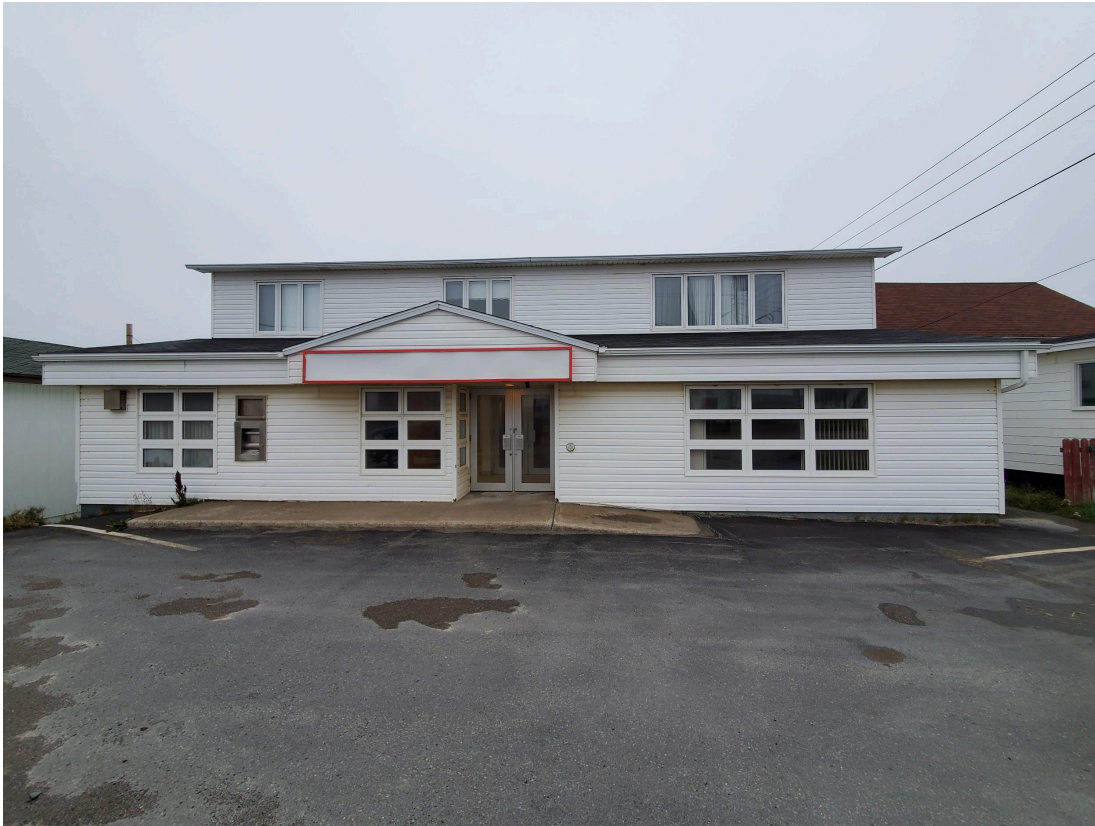
TFII-041

***Scotiabank Building, 2023. Front facade. Photo by Juliet Lanphear.***
